# IMSAI 8080 Restoration for The Centre For Computing History at Cambridge, UK.

## **BLOG PART 1: What Have We Actually Got?.**

09/11/2019 - Ross Milbourne.

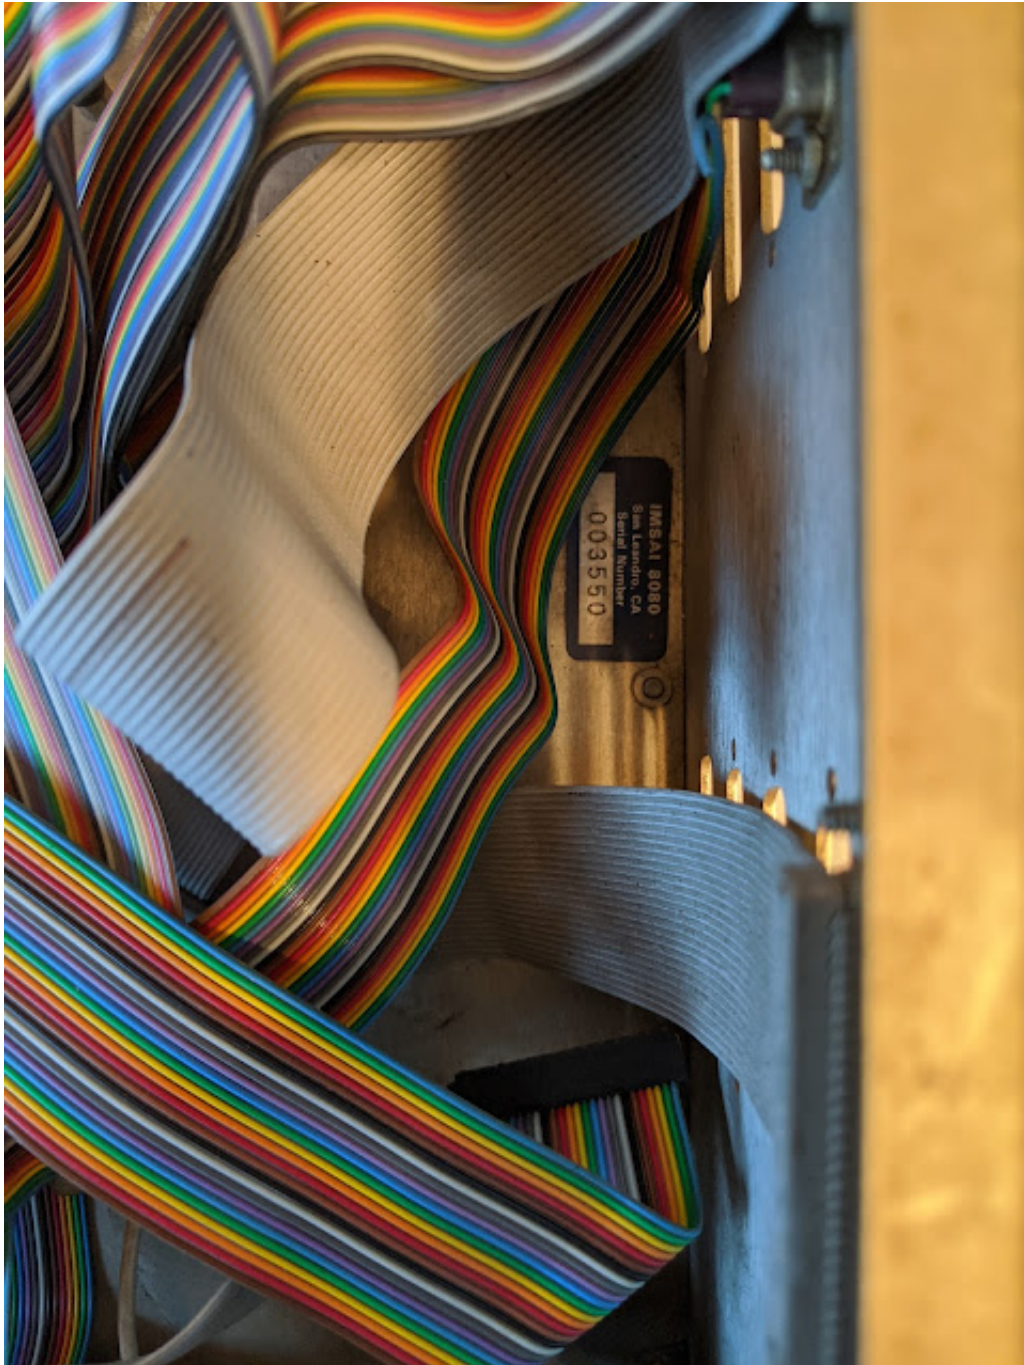
Serial Number 003550

A good starting point is to attempt to date it as accurately as possible, so that we can determine what should or might have been present when originally purchased. One of the most helpful items in that respect, with the IMSAI 8080, is the serial number. This is to be found on a metallic label, usually on the outside of the rear panel. In our case, however, it was lurking on the inside, behind the backplane:

The back panel is now clear of cables. It is very unusual for the serial number label to be found inside the machine. It makes it likely that we are dealing with a kit-built machine by a home hobbyist. Although IMSAI made few if any machines themselves in the early days, the dealers built them for customers and invariably put the label on the outside of the Back Panel.

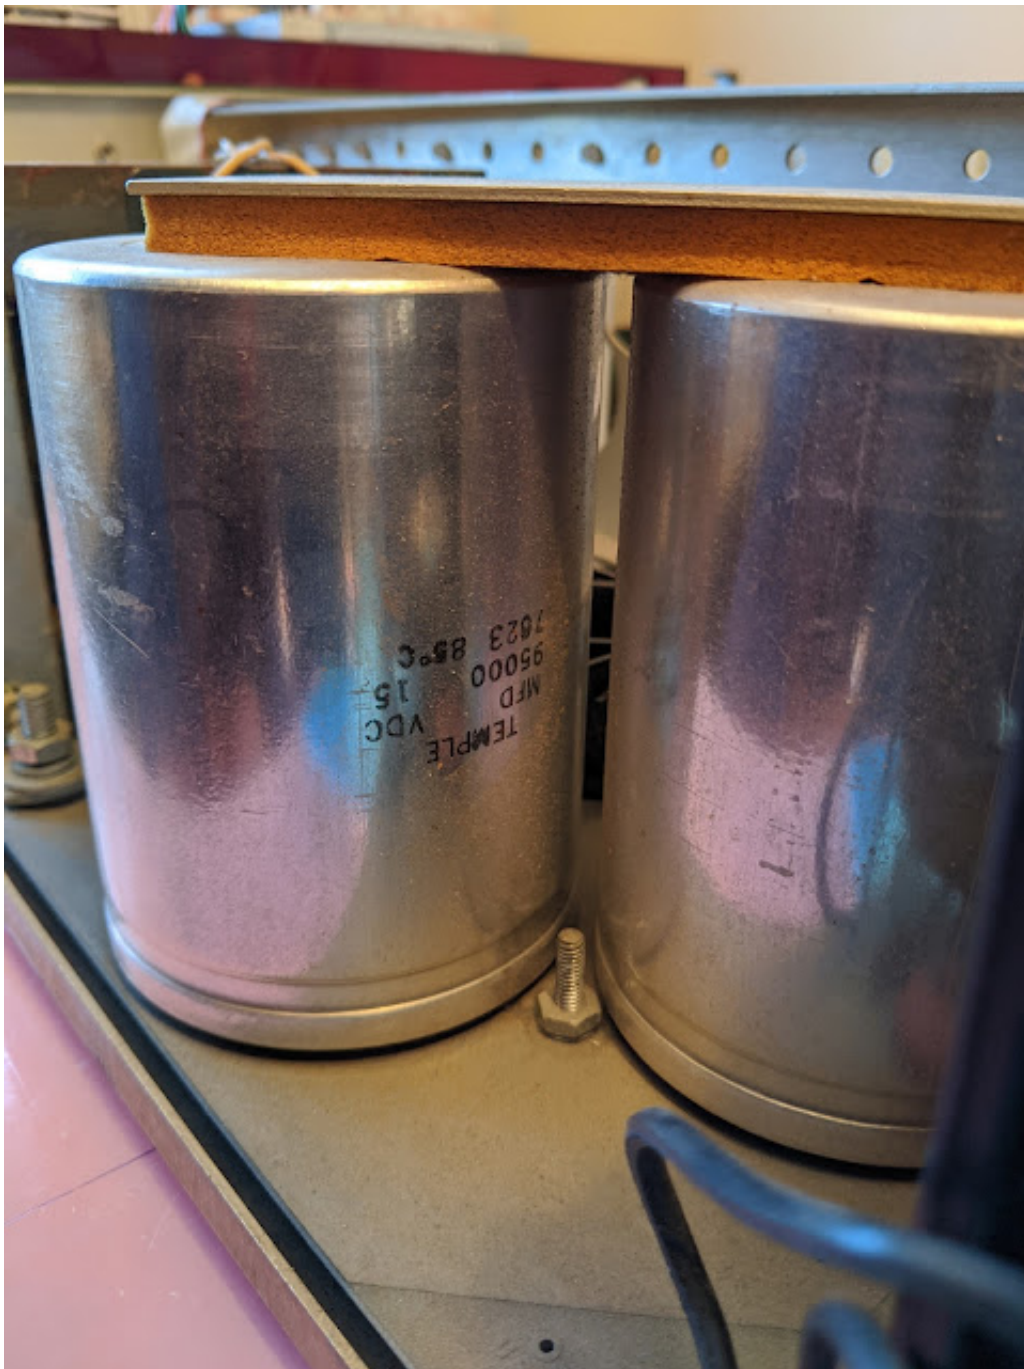
Further help is available by looking at the large capacitors in the PSU. Very often, there are a pair of 95,000uf units and another pair of 10,000uf units. These nearly always have a date code stamped on them, and our machine is no different.

Manufactured Week 23 of 1976

As these capacitors do not appear to have been replaced then, from these dates, we can now say with certainty that the computer was manufactured sometime after May 30th 1976 (i.e. the end of week 22).

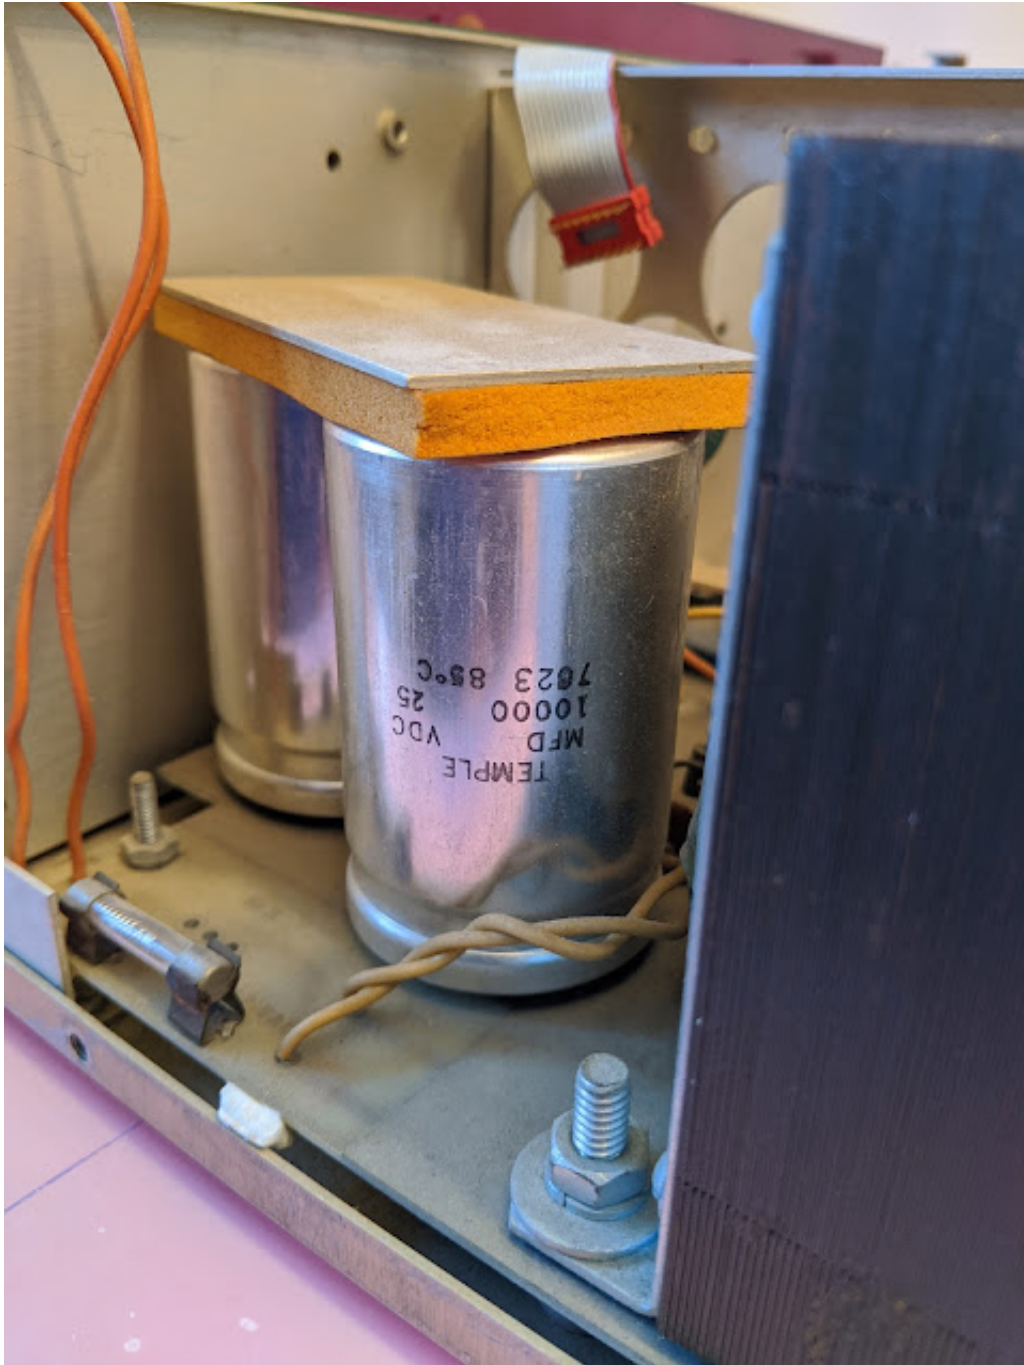
Manufactured Week 23 of 1976

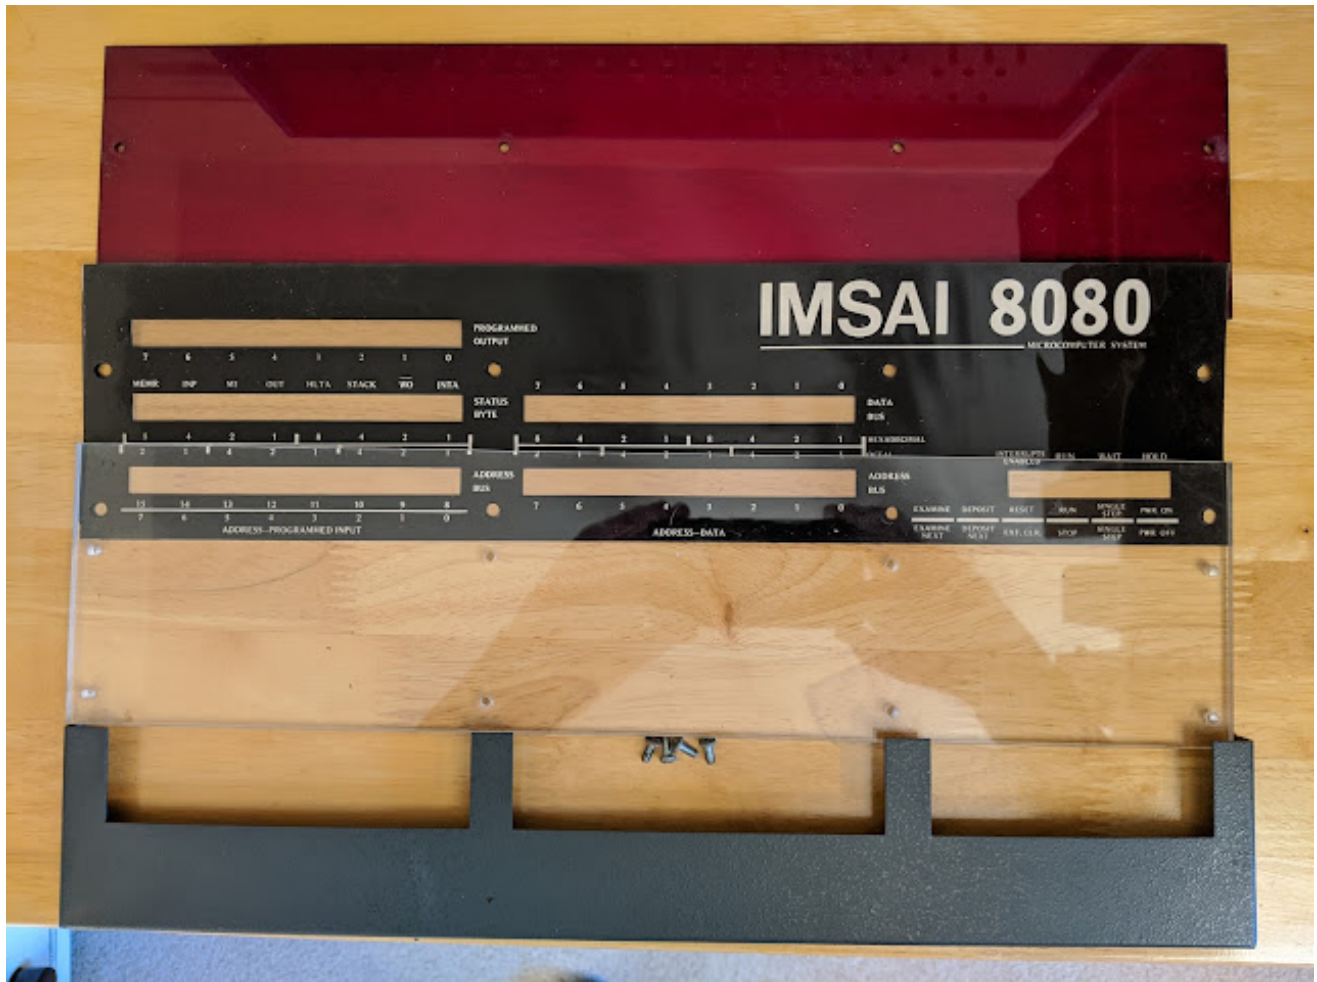
Front Panel Artwork Plus Escutcheon

The main panel artwork consists of several layers as can be seen here:

The pcb itself is actually plugged into the front S-100 slot and that is all that is holding it in place now. The entire unit, including the paddle switches can simply be unplugged and laid on the workbench in order to work on it. The only constraint in that respect is that, in our case, the mains power switch cables are soldered to the board. They can be de-soldered if required. Many people cut these cables and use simple plug connectors to make maintenance easier going forward.

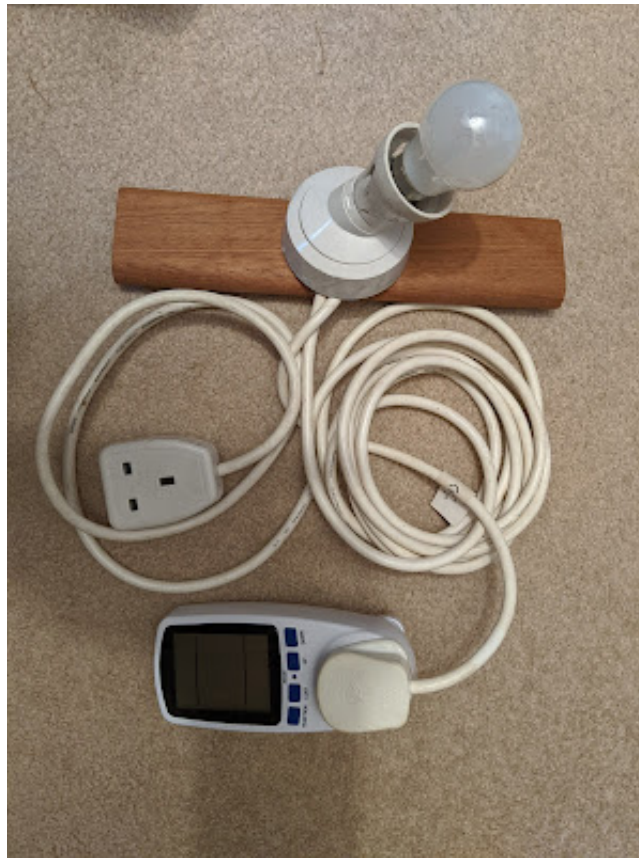
Current Limiter

(The power meter attached to the circuit in the picture is optional).

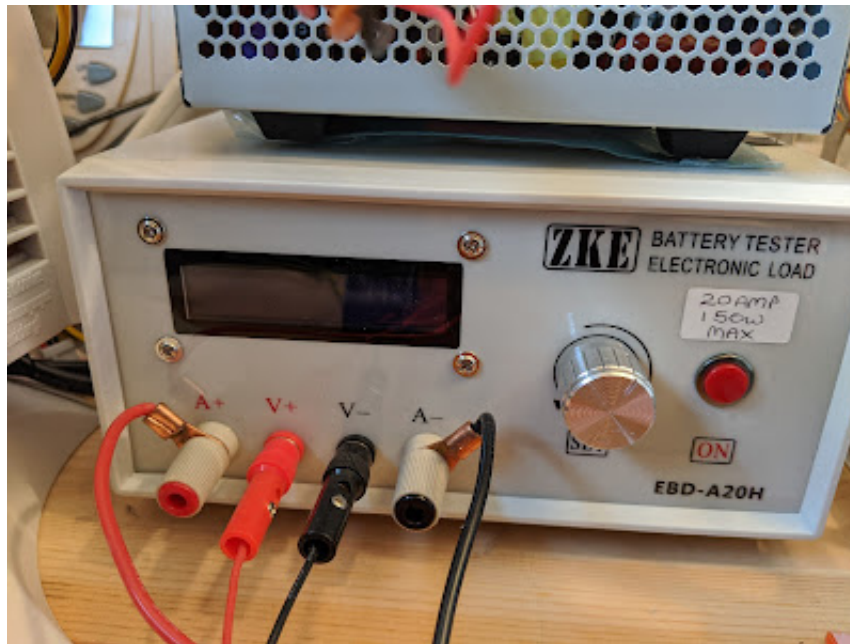
ZKE EBD-A20H Electronic Load Tester. 20Amp, 30v max.

After disconnecting our circuitry from the PSU outputs, we can see what voltages are being produced by the PSU, and simulate running each of the outputs at different loads, up to their stated maximum, using this equipment. It provides current up to 20amps and voltages up to 30v, which is more than sufficient for most vintage microcomputers like the IMSAI 8080.

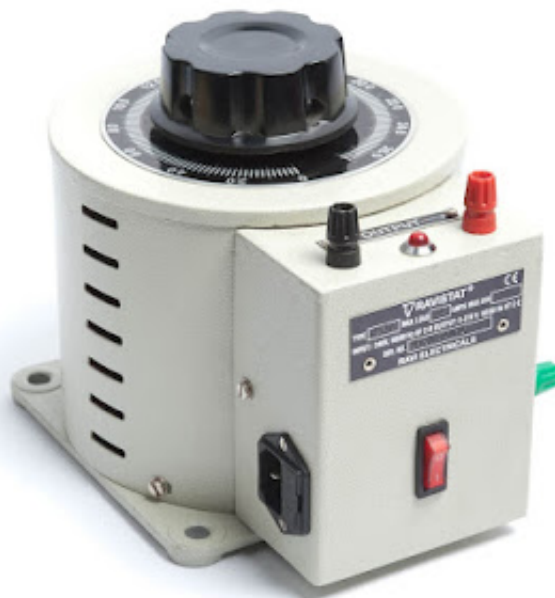
Ravistat 10-P-1 Variable Transformer (Variac) - 10amp continuous load max.

A Variable Transformer (Variac) is a good way to achieve this. There are a number of very poor quality units for sale on Ebay, but one notable exception is the Ravistat:

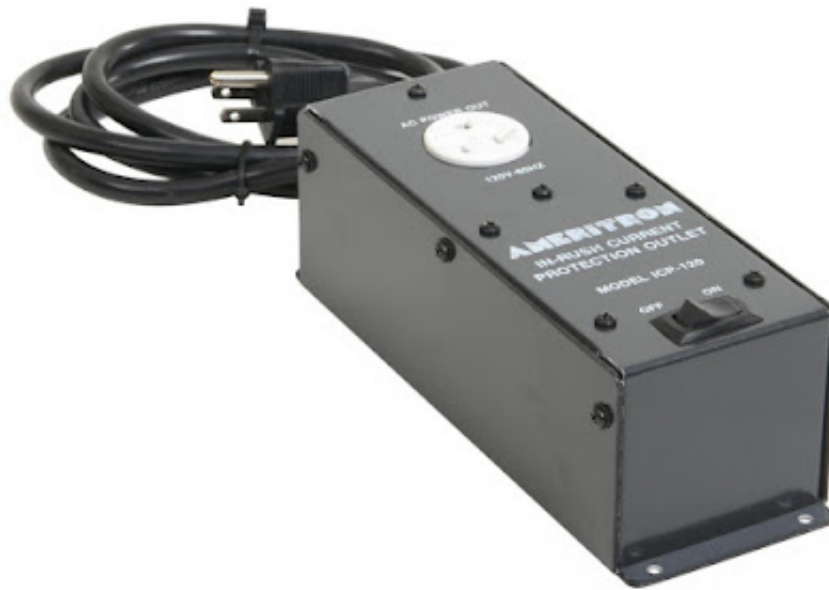
Ameritron ICP-120 In-rush Current Limiter

Whenever we are going to switch the machine on, it is important to have an inrush current-limiter fitted into the supply circuit. This serves to protect against sudden, often momentary, current surges being created. Large capacitors in the PSU, such as the four in our PS-28D assembly, will rapidly soak up a large amount of current, until they become saturated. That can put an big strain on the transformer, causing the windings to fail, as well as on the rectifier components.

We have also seen that using a Variac has significant benefits that we wish to take advantage of, but there is a snag. Even when turned right down, a huge momentary current of several hundred amps can be generated across the windings, causing component failures downstream. This too can be safely absorbed by the in-rush current limiter.

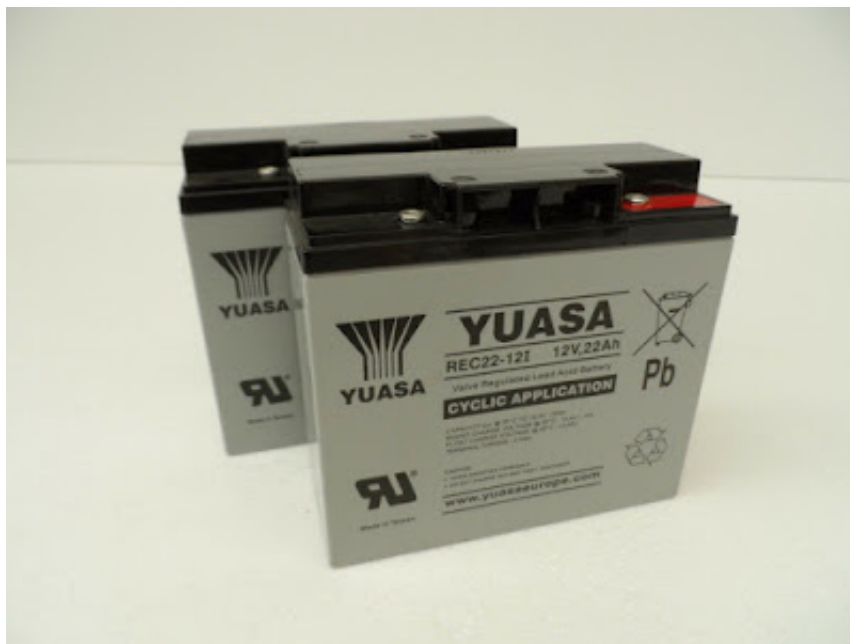
In our case, we will use a pair of 12v Yuasa REC-22-12I, 22Ah deep-cycle batteries wired together in parallel, to provide a 44Ah capability.

Two Deep Cycle 12V 22AH AGM/GEL Batteries Wired in Parallel

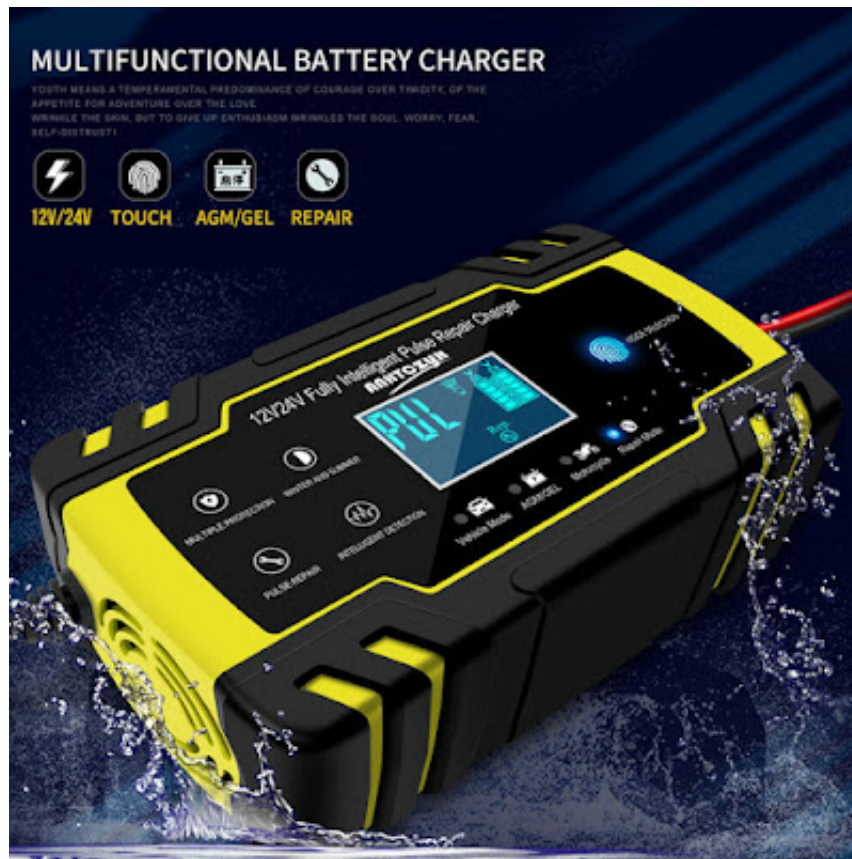
An intelligent 3-stage 8A pulse charger is permanently connected.

Permanently Connected AGM/GEL 12V Battery Charger

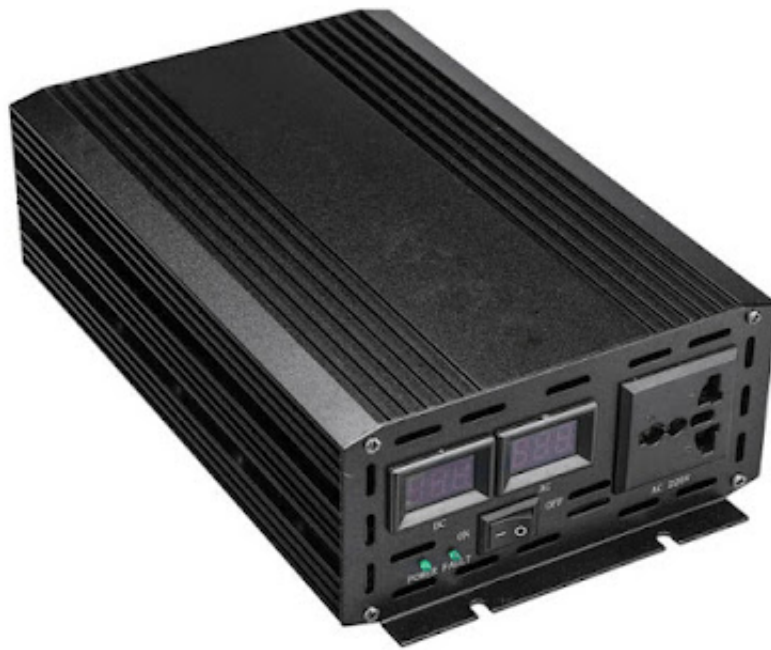
The batteries are connected to a 3000 watt peak, 1800 watt continuous, 60Hz, pure sine wave 12vdc to 110vac inverter made by Peak Power:

We need a pure sine wave inverter, to make the supply closely match a normal sine wave, and avoid potential damage to components.

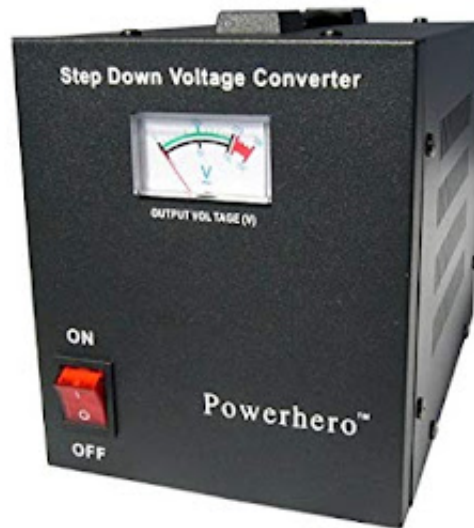
Instead of batteries and an inverter, we could have used a normal 2Kw, 240vac to 110vac step-down transformer:

The only difference is that we would be running at 50Hz rather than 60Hz. In this case, it does not matter, because the Tranex 4-3751 transformer in the PS-28D PSU assembly can safely handle both of these mains supply frequencies.

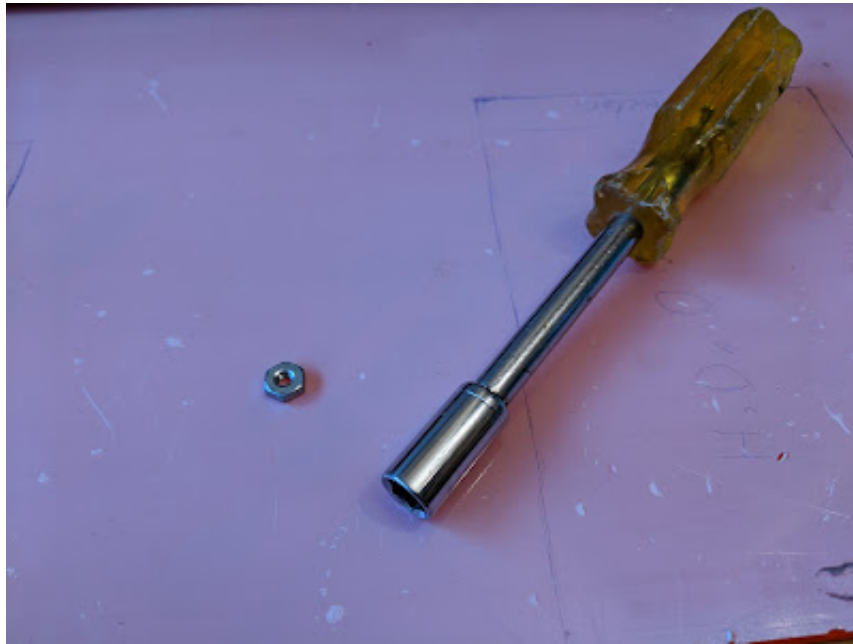
The Wunderbuss backplane is held in place by nylon bolts with metal nuts down each side. Care must be taken if your machine is fitted with these nylon bolts, as they tend to go brittle with age and can easily break when removing the nuts. A tiny amount of PTFE-based lubricant does not go amiss on those where you feel resistance. Fortunately, those on this machine still felt supple and the nuts came off without a problem - albeit slowly! Only 5 needed some lubrication. If you feel resistance, stop and

An invaluable tool for removing and refitting the Backplane nuts

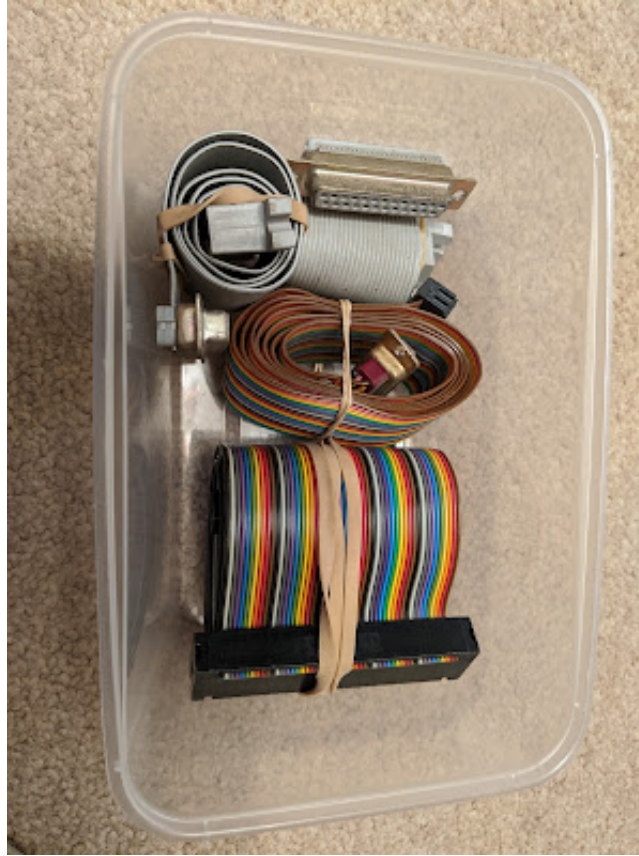
Old Data Cables From Rear Panel

The redundant data cables from a past life have been removed and placed into storage.

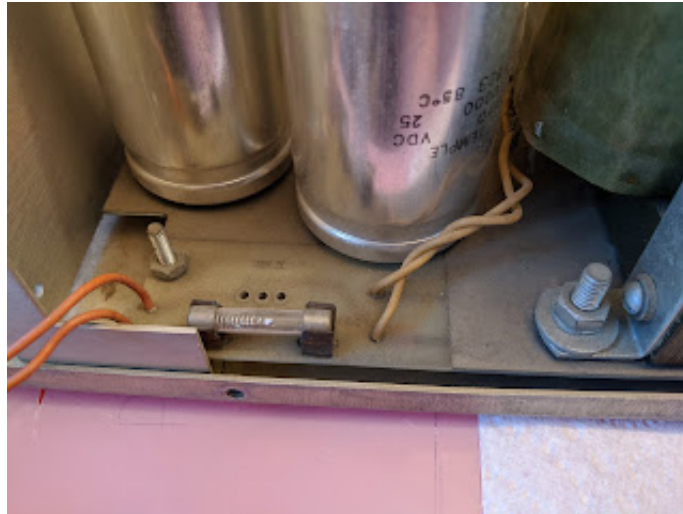
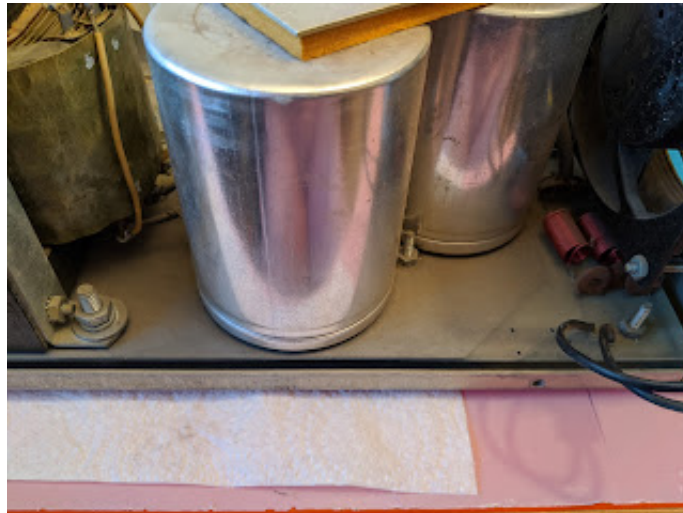
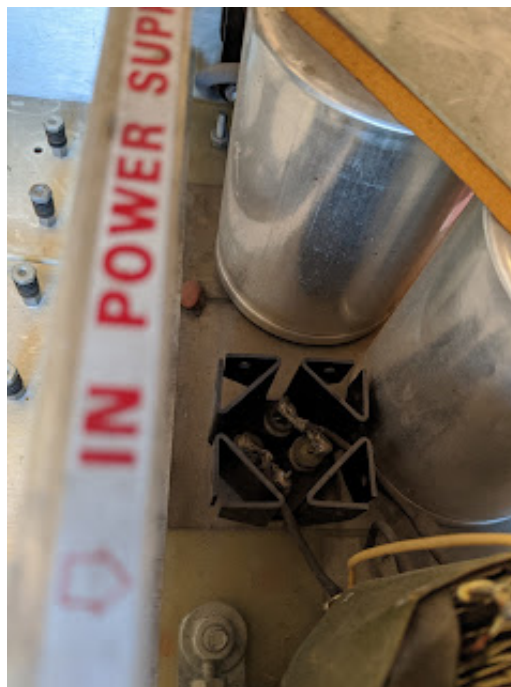
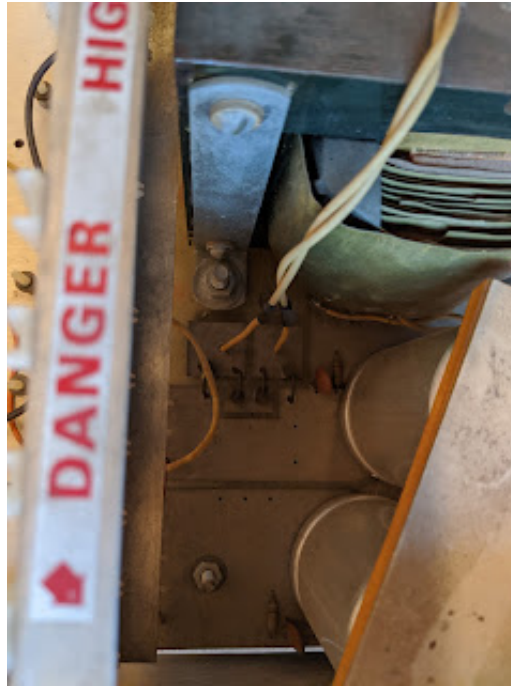
The next task is removal of the PSU. This is quite a difficult job, and there are various ways to tackle it. Firstly, the nine nuts and washers holding it down need to be removed, as can be seen in the following photos:

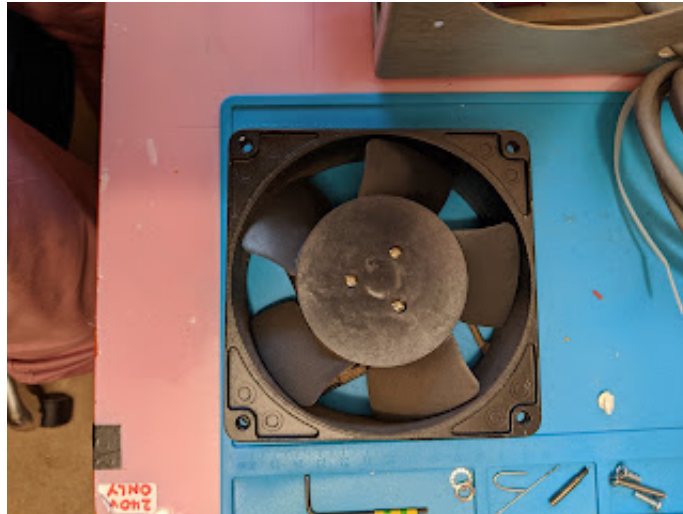
At this point, the fan should be disconnected and then it and the fan guard unbolted from the back plate. Luckily, in this case there is a removable plug on the side of the fan itself.

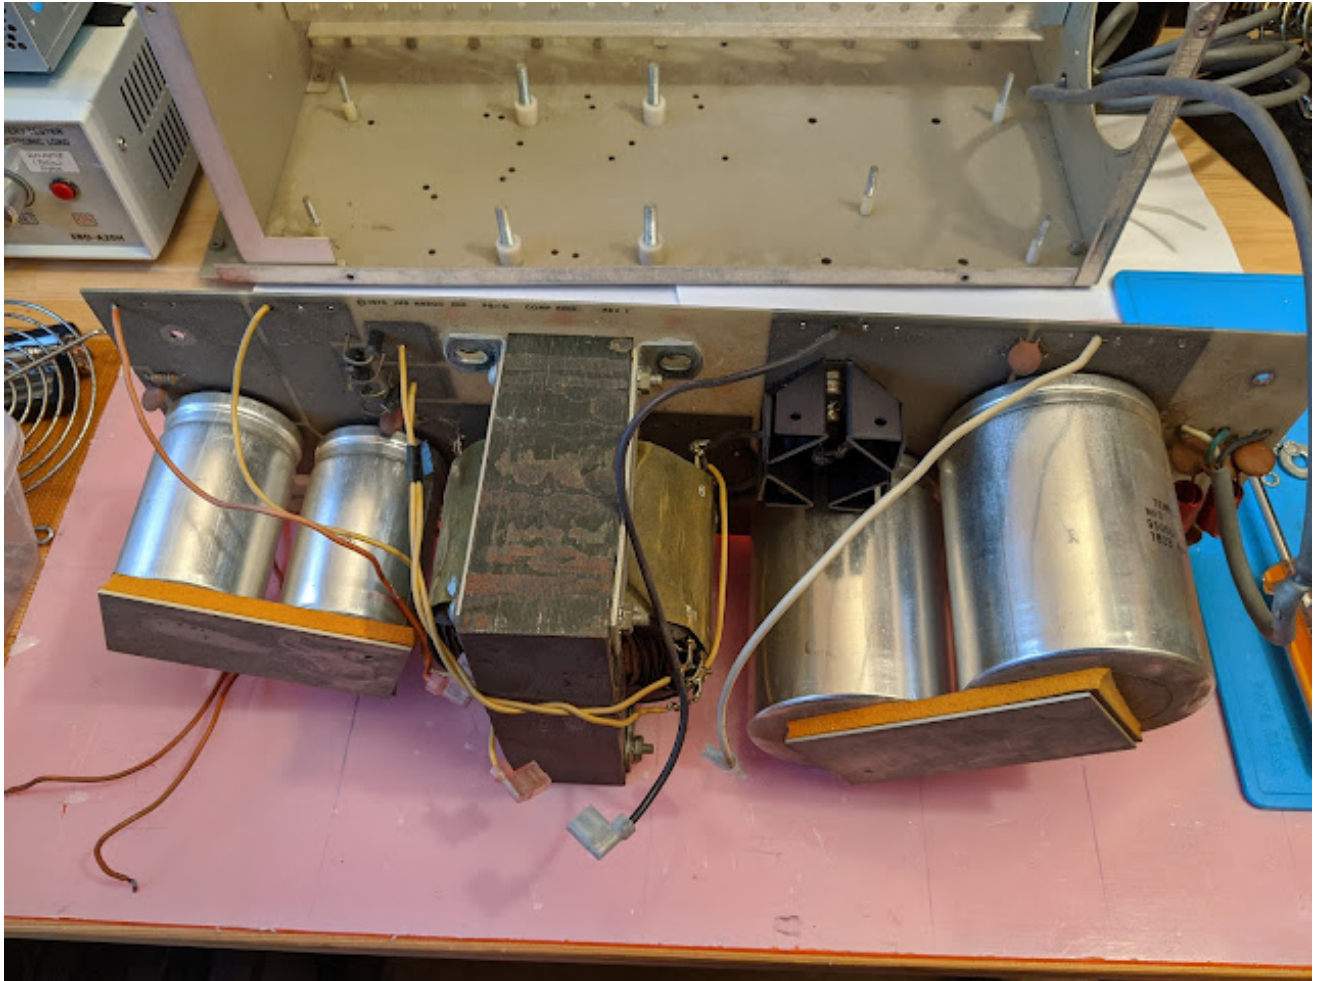
Now carefully lift the whole assembly over onto its side, making sure the transformer is applying no weight to the pcb.

Finally, we have the PS-28D Assembly where we can get at the underside

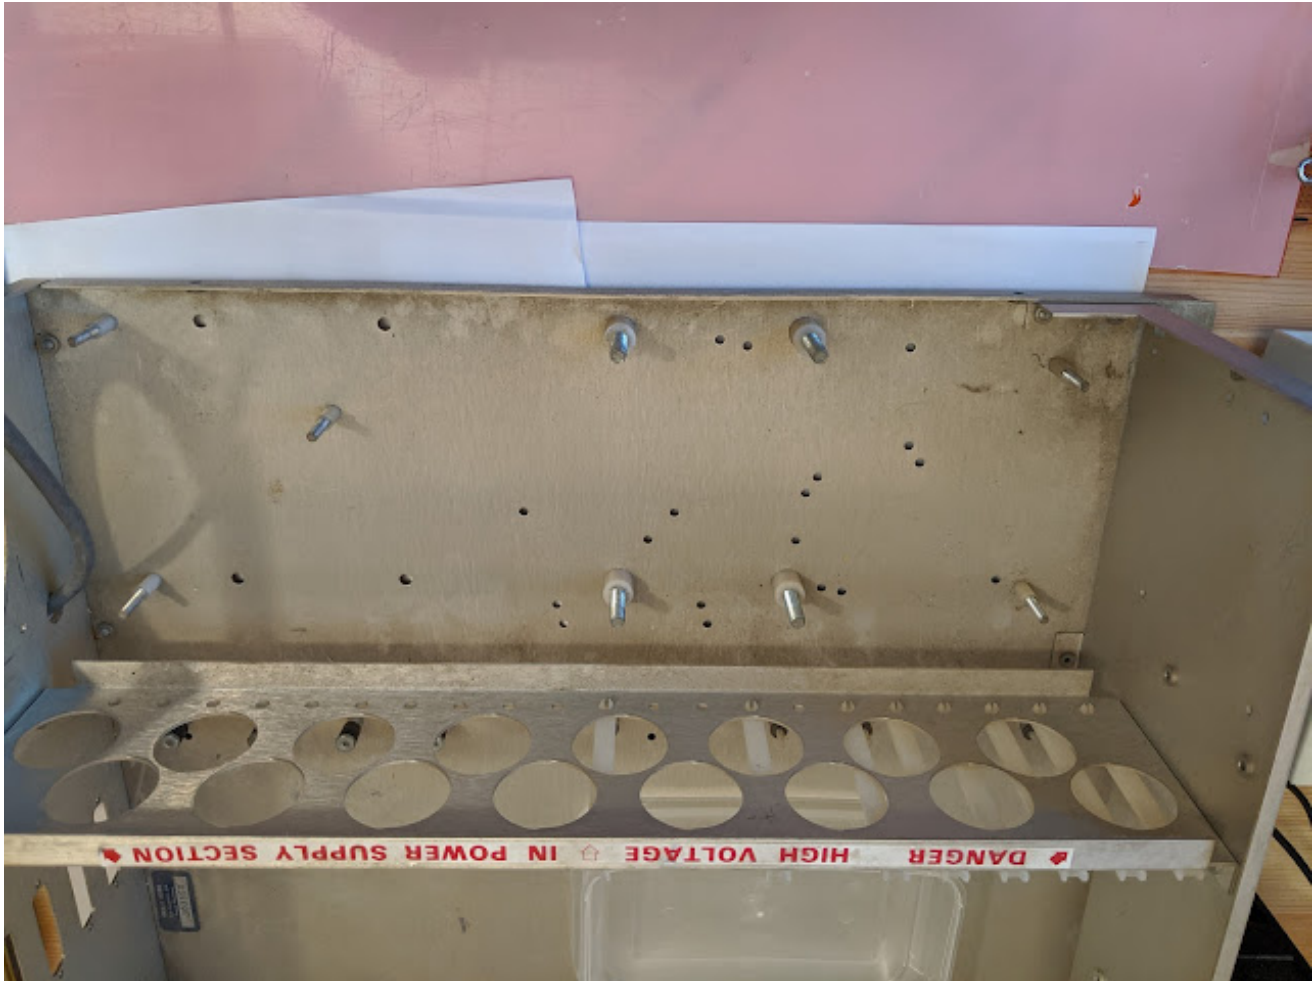
PSU area of Chassis

At this point, it is easy to check the number and condition of the rubber feet on the underside. As can be seen, there are none along the centre line, so more will need to be added, after cleaning. The IMSAI 8080 weighs a lot, especially the transformer, and the bottom can become distorted in that area over time without good, evenly spread, support.

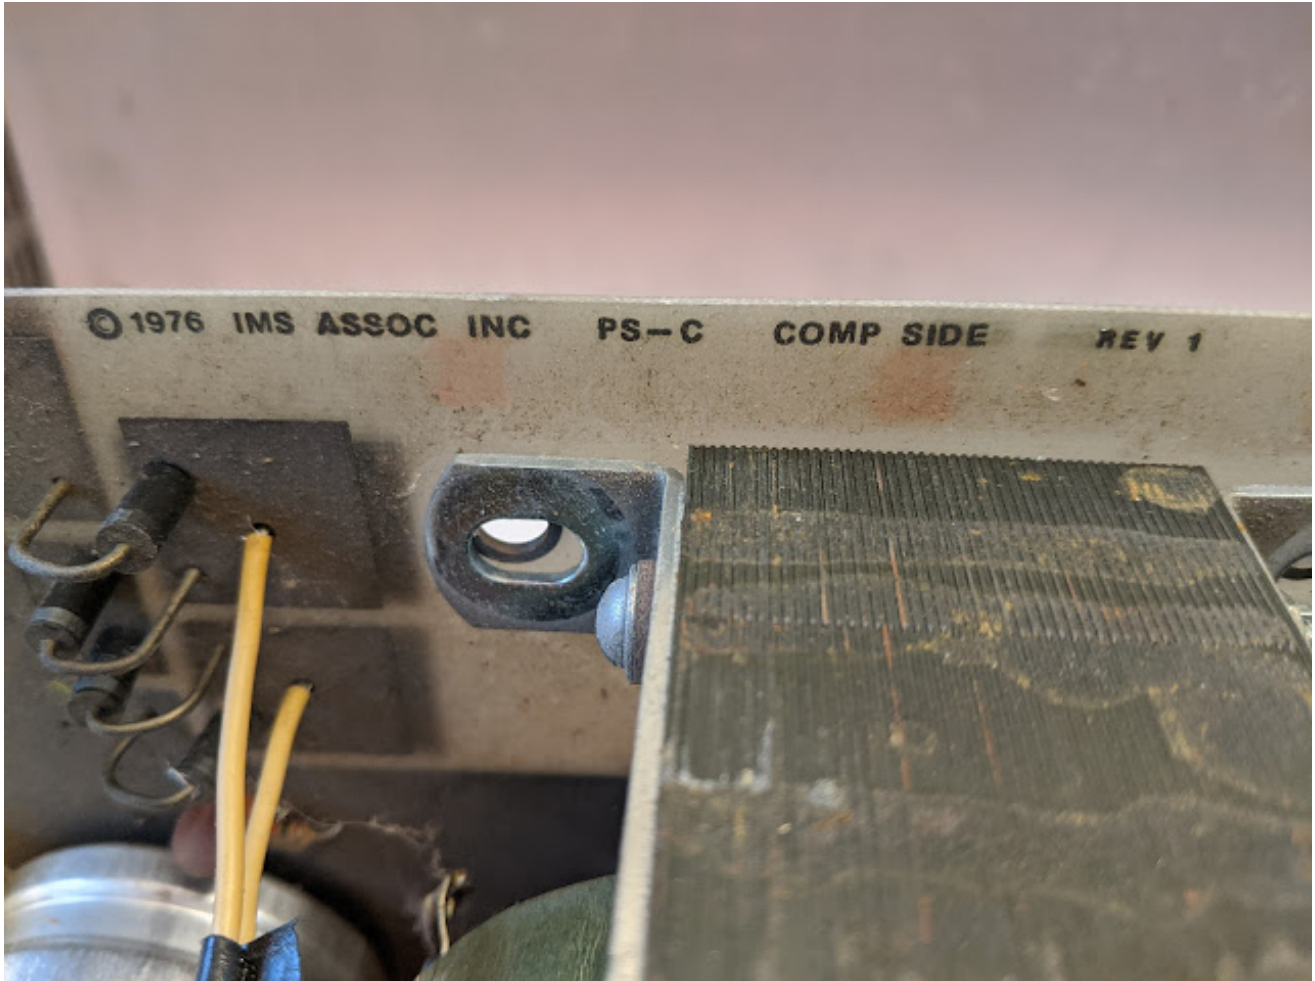
Check the pcb version of the PSU for future reference, e.g. when referring to the manuals.

PSU PS-28D assembly, pcb Version Number

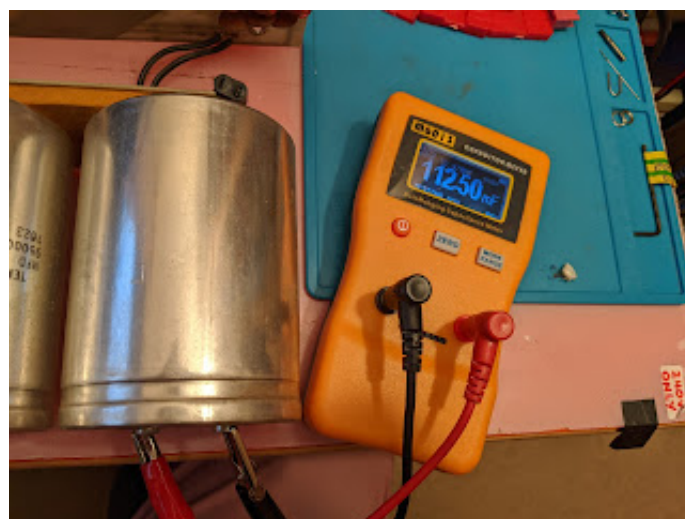
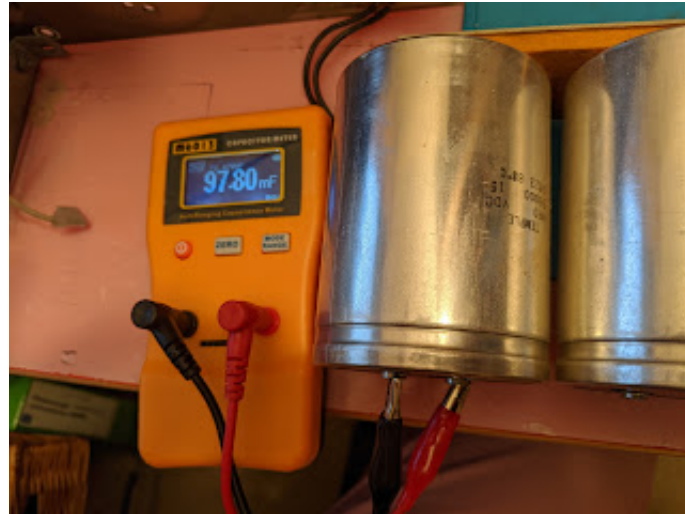
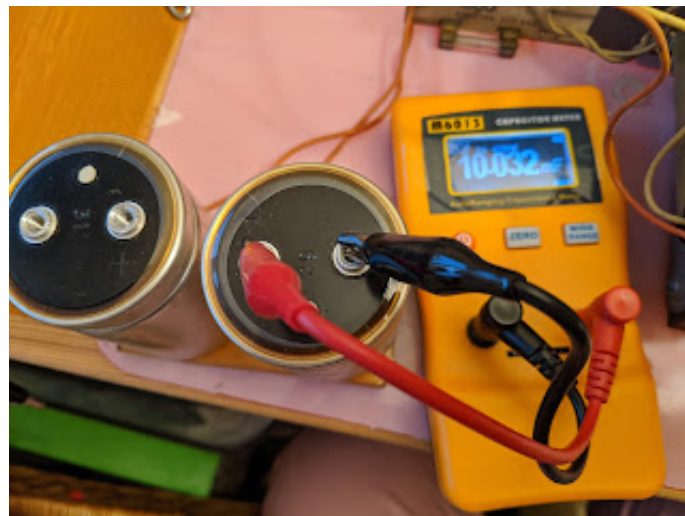
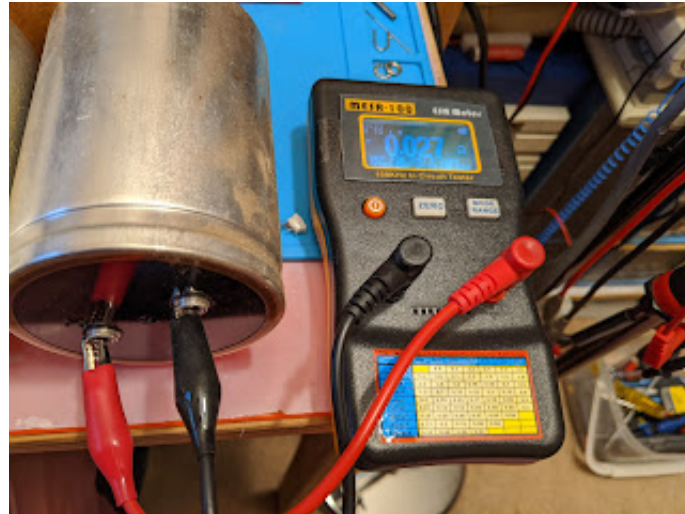
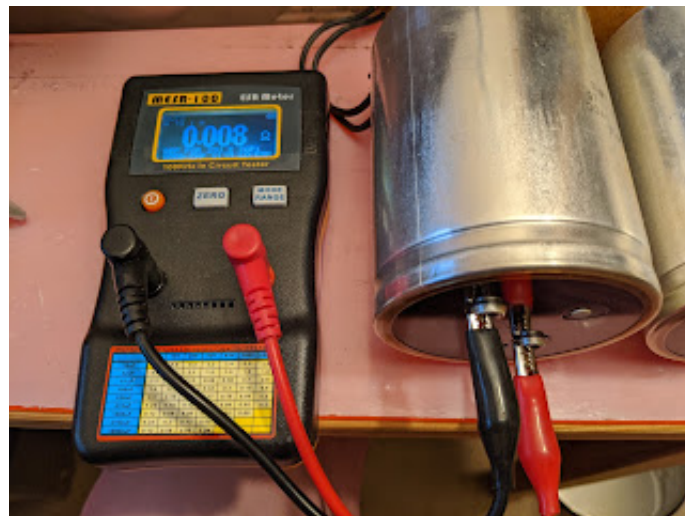
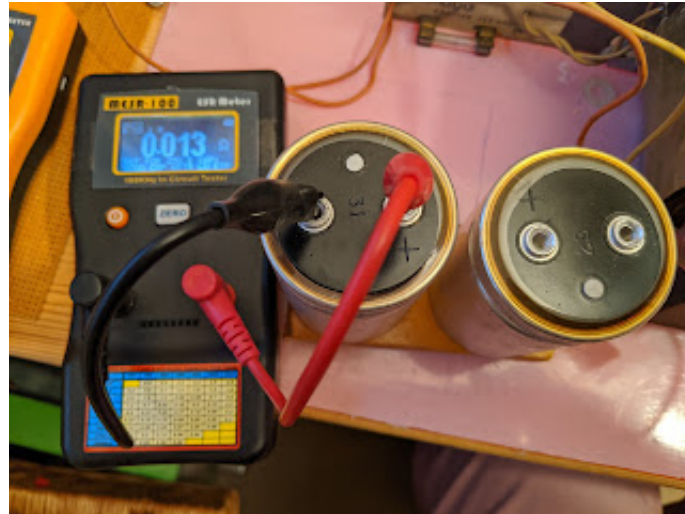
Now we can carry out initial tests on the large capacitors, using a Capacitance Meter and an ESR Meter:

The results can be summarised as follows:

(The tolerance on these large aluminium capacitors can often range from -20% to +80%)

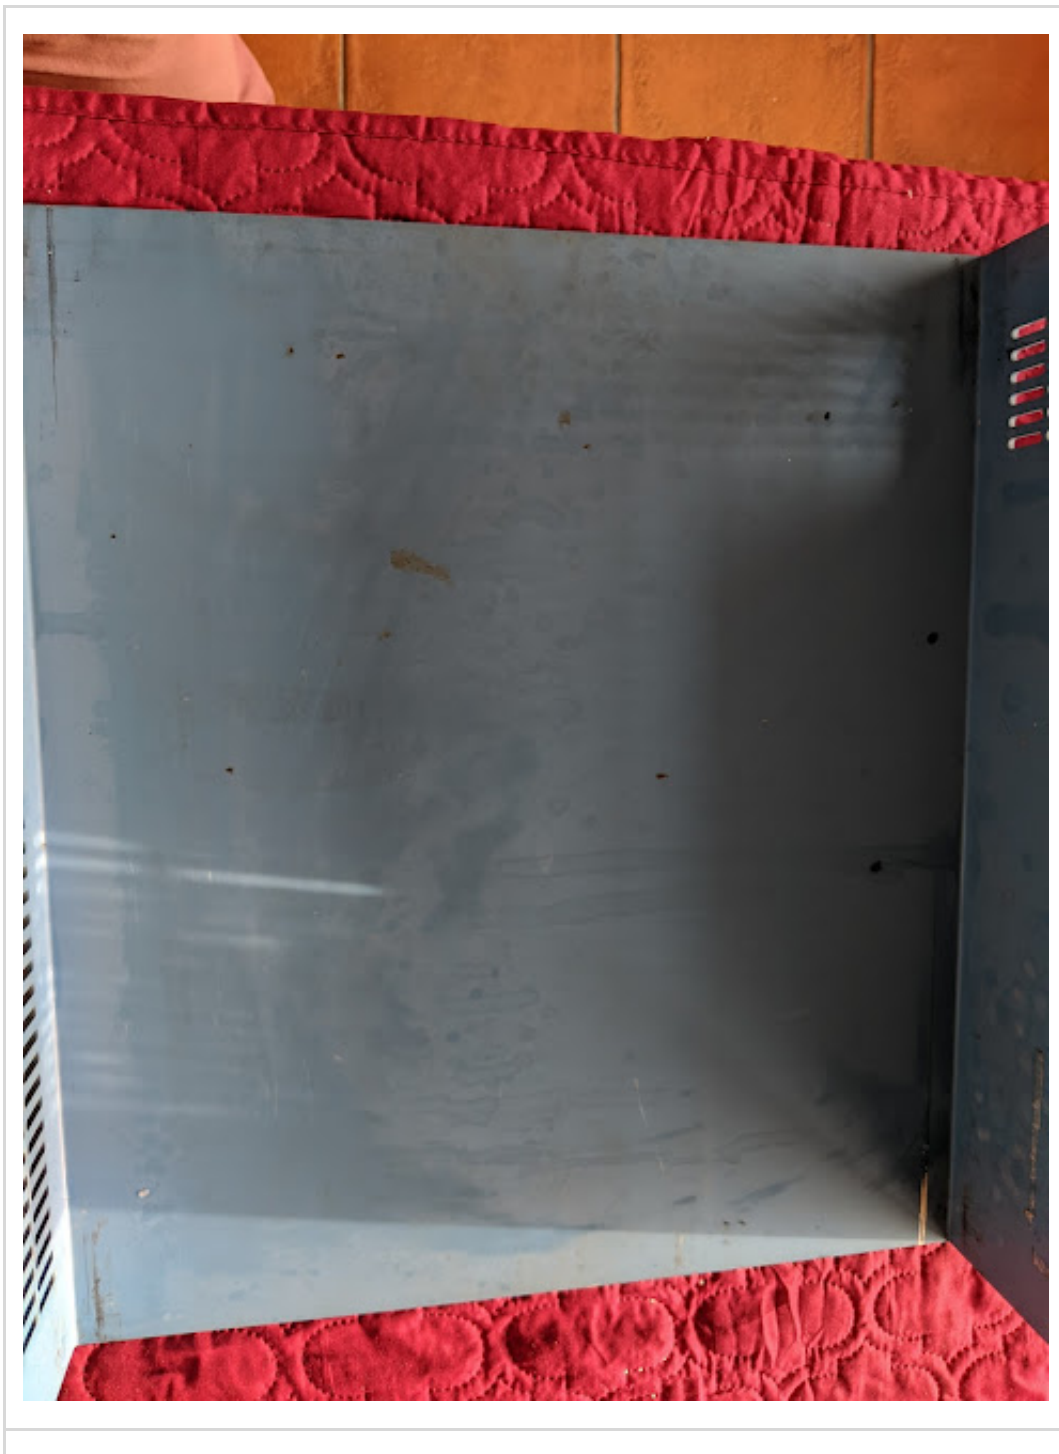
The lid was one of the worst I have come across, in terms of the grime on it, and the degree to which it seemed to be embedded into the paintwork. It looks like it was used in an industrial environment. There are nearly always small areas of markings which are stubborn to remove, and this one is no exception.

## The underside!

The process is a fairly standard one, where painted parts such as the lid are concerned.

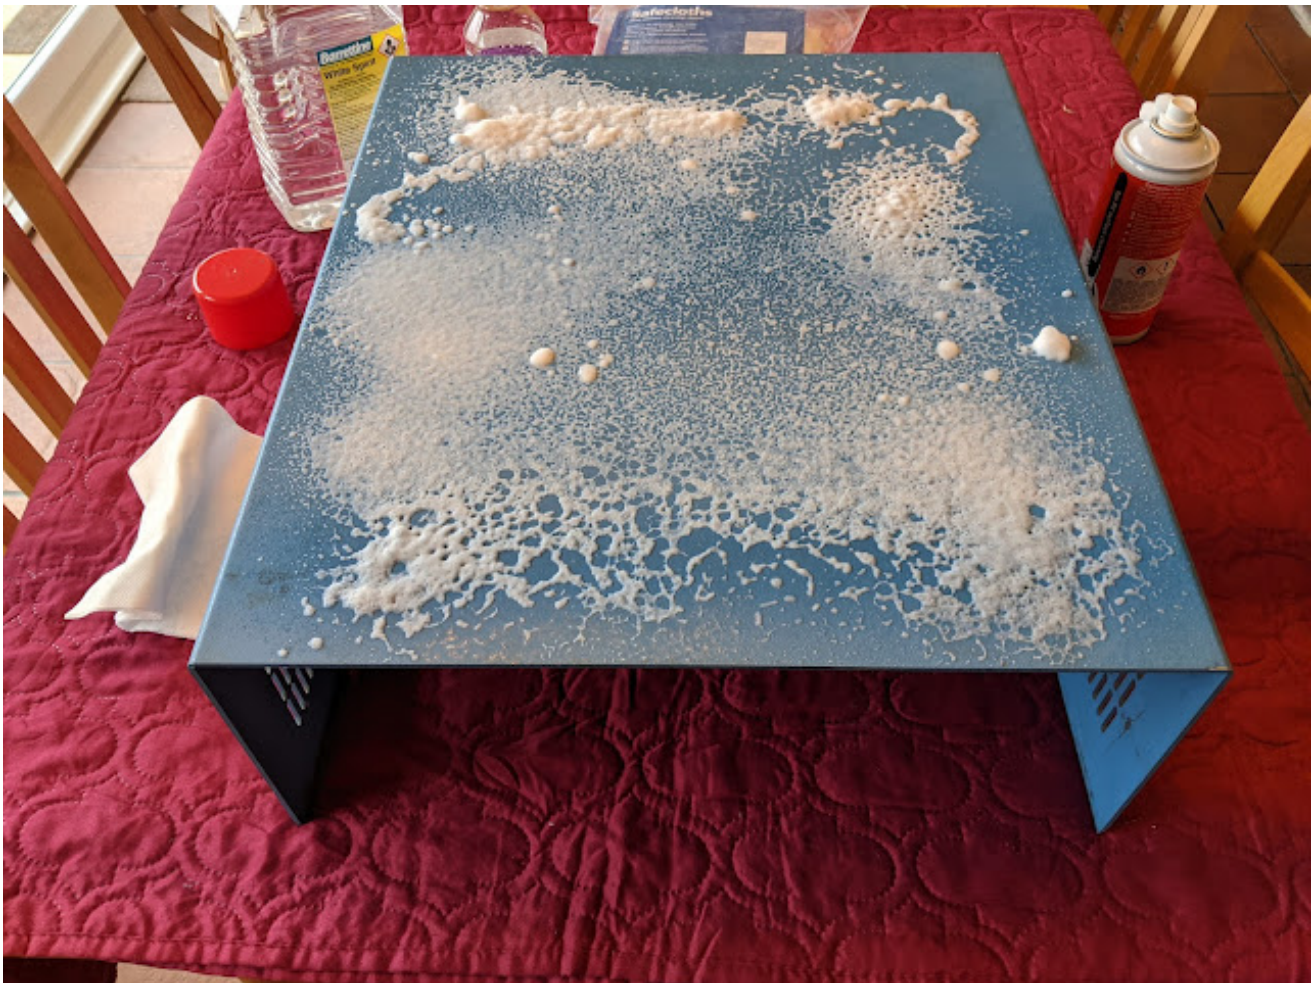
Foam Clean in action

A final light clean with Foam Cleaner and then White Spirit once more, and then a nice heavy coat of Pledge Beeswax Furniture Polish, makes everything look much better, without looking new. Leave the polish to almost dry, before buffing with a soft cloth.
