# IMSAI 8080 Restoration for The Centre For Computing History at Cambridge, UK.

## **BLOG PART 1: What Have We Actually Got?.**

09/11/2019 - Ross Milbourne.

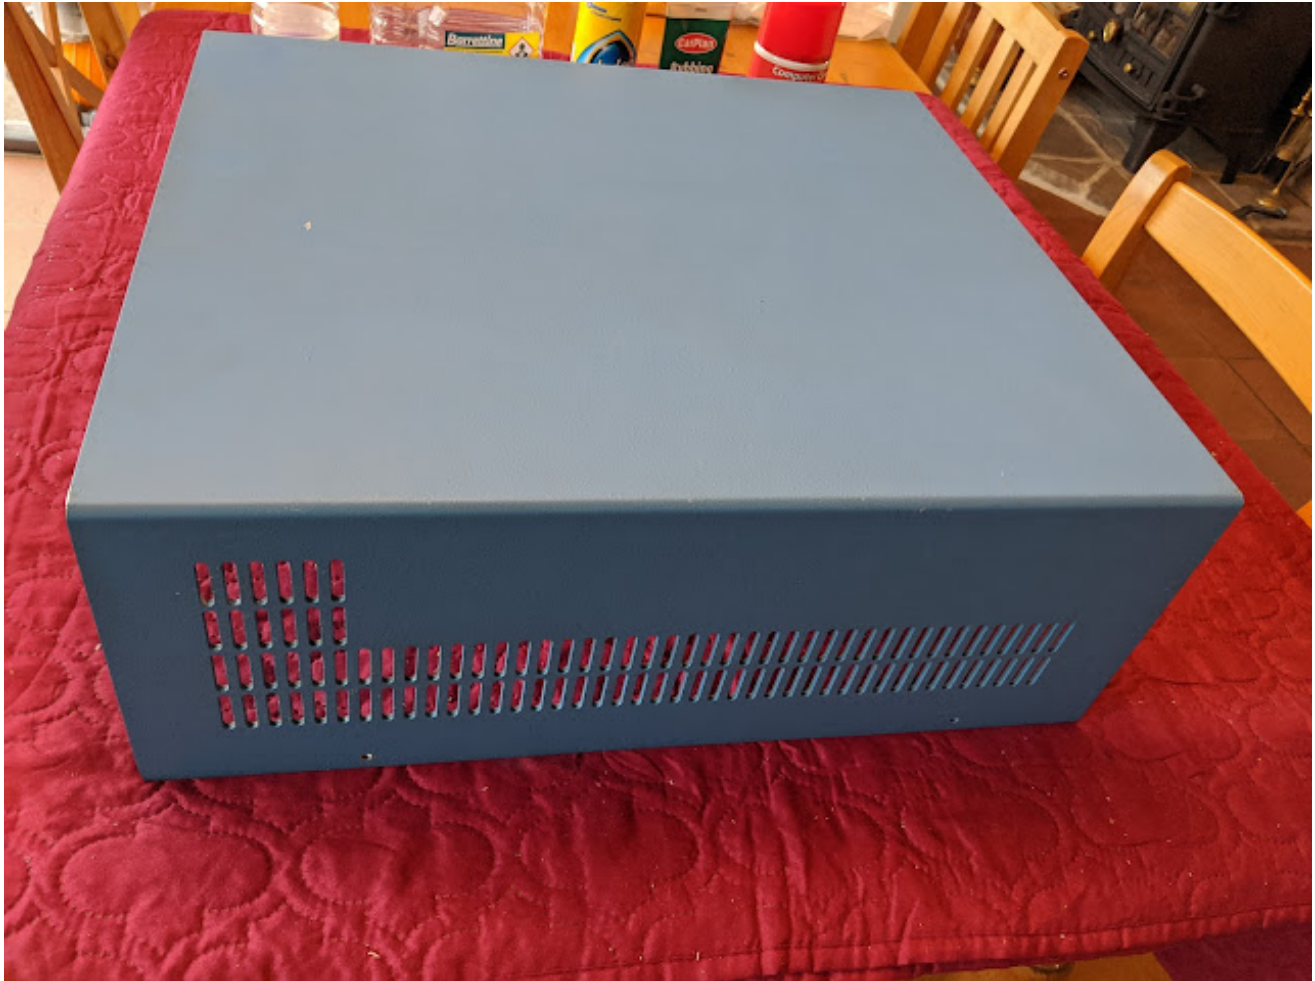
Just the small paint chip on the top left to do

We can buy generic 'Altair/IMSAI Blue' in small, touch-up pots, for bits where there has been paint loss. This will hardly ever be an exact match, as age has changed the hue of the paint in many different ways on different machines. Nevertheless, it can look a lot better than bare aluminium shining back at you.

To do this, we just need to use a very small amount of White Spirit, to clean off the Polish over the chip. We then apply a tiny amount of paint and spread it thinly, sticking within the area of the chip and just taking the paint up to the edge all around it. Leave it for 8 hours to dry and harden, then just apply a little Polish to protect it.

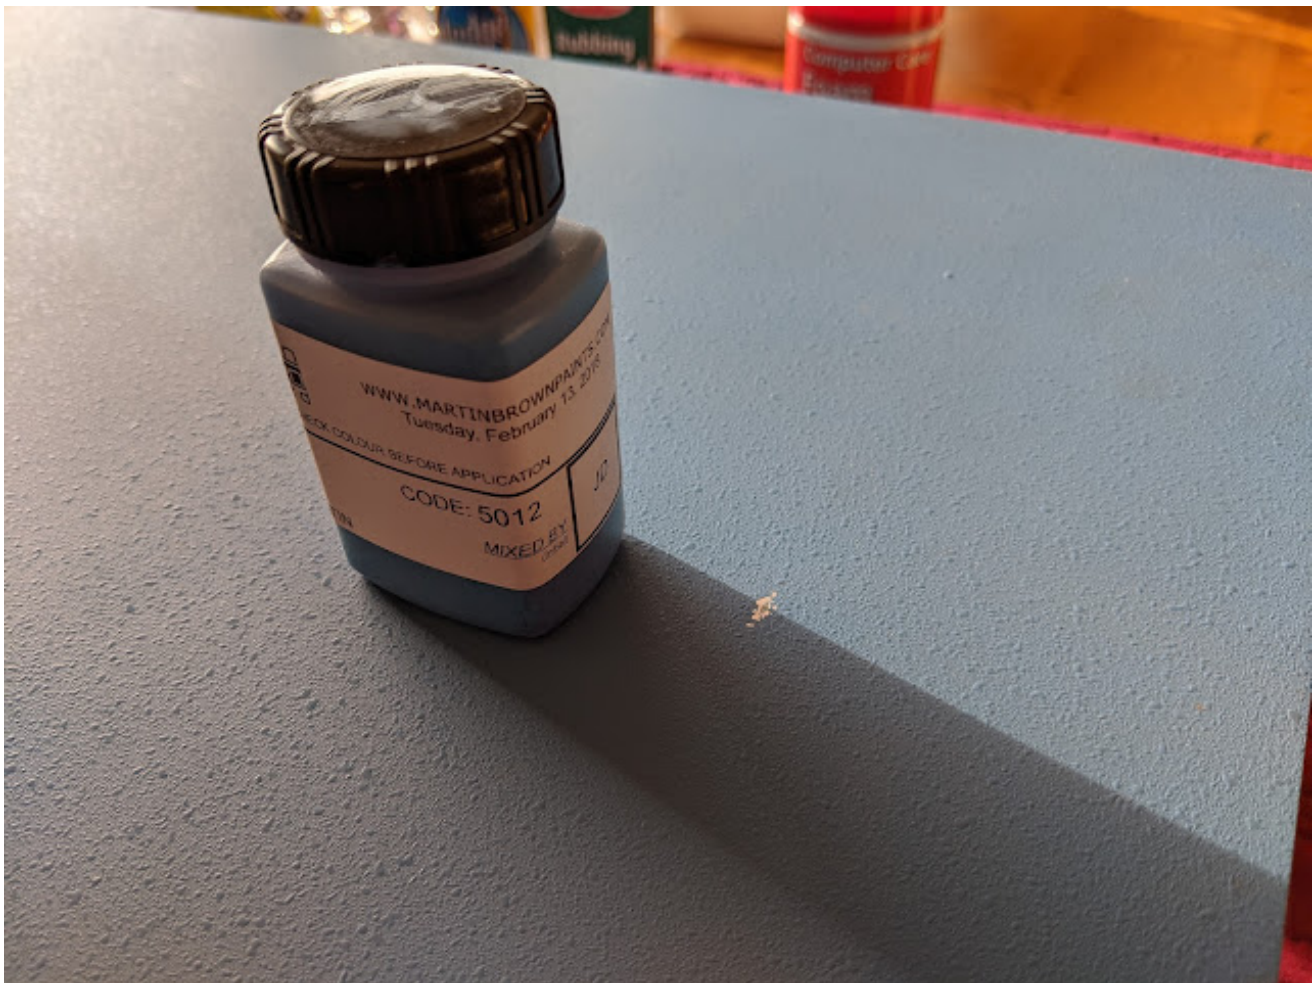
The before and after are shown below:

The original paint colour RAL 5012 [www.martinbrownpaints.com](http://www.martinbrownpaints.com)

An artists brush, a glass dish and some thinner help to get the right consistency to stipple the paint.

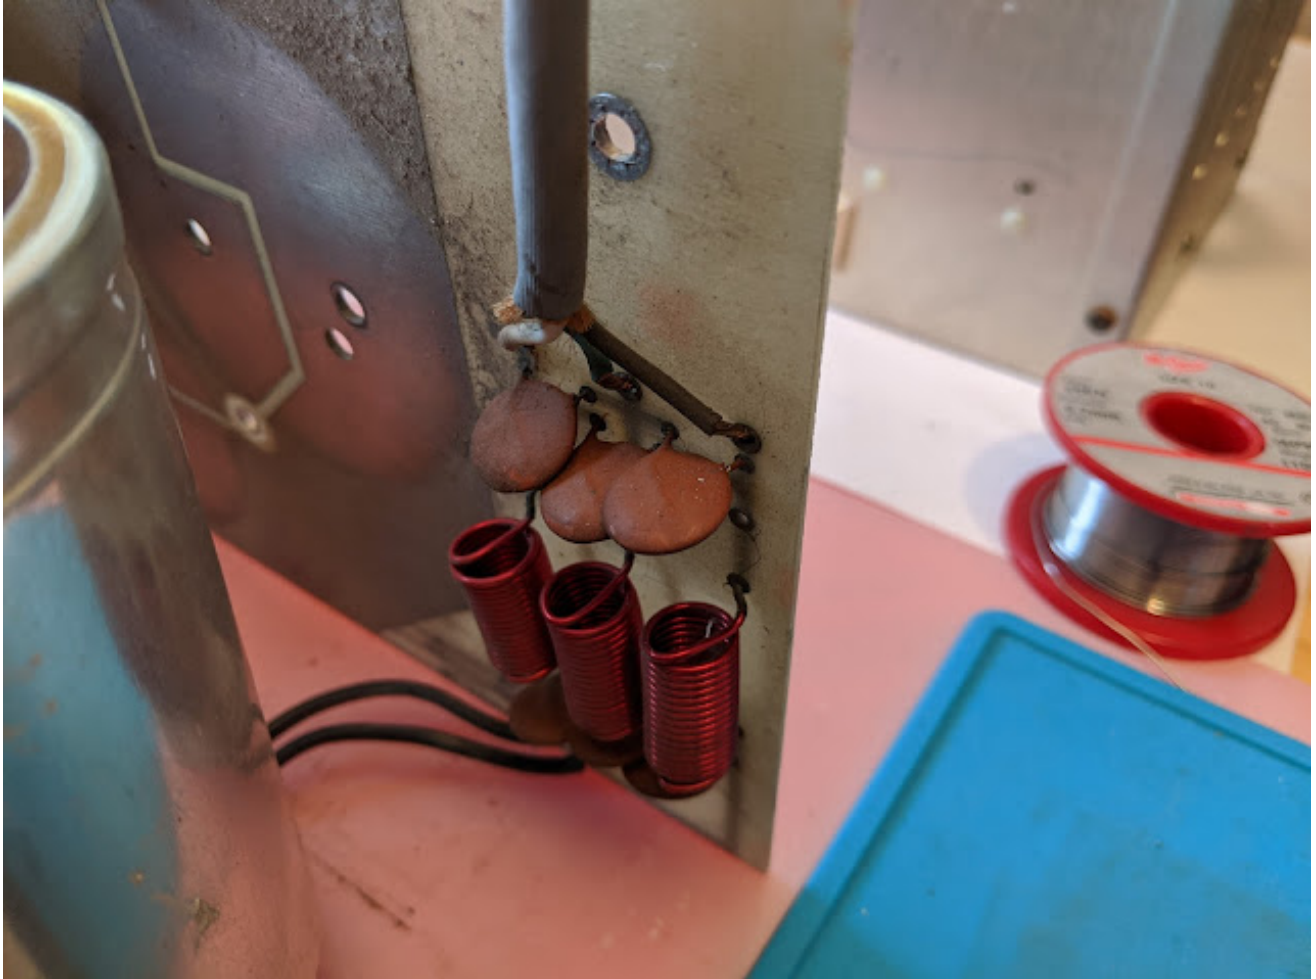
The incoming mains cable. The pcb has helpful colour code markers.

Firstly, we need to remove the mains cable, to detach the PSU from the Chassis.

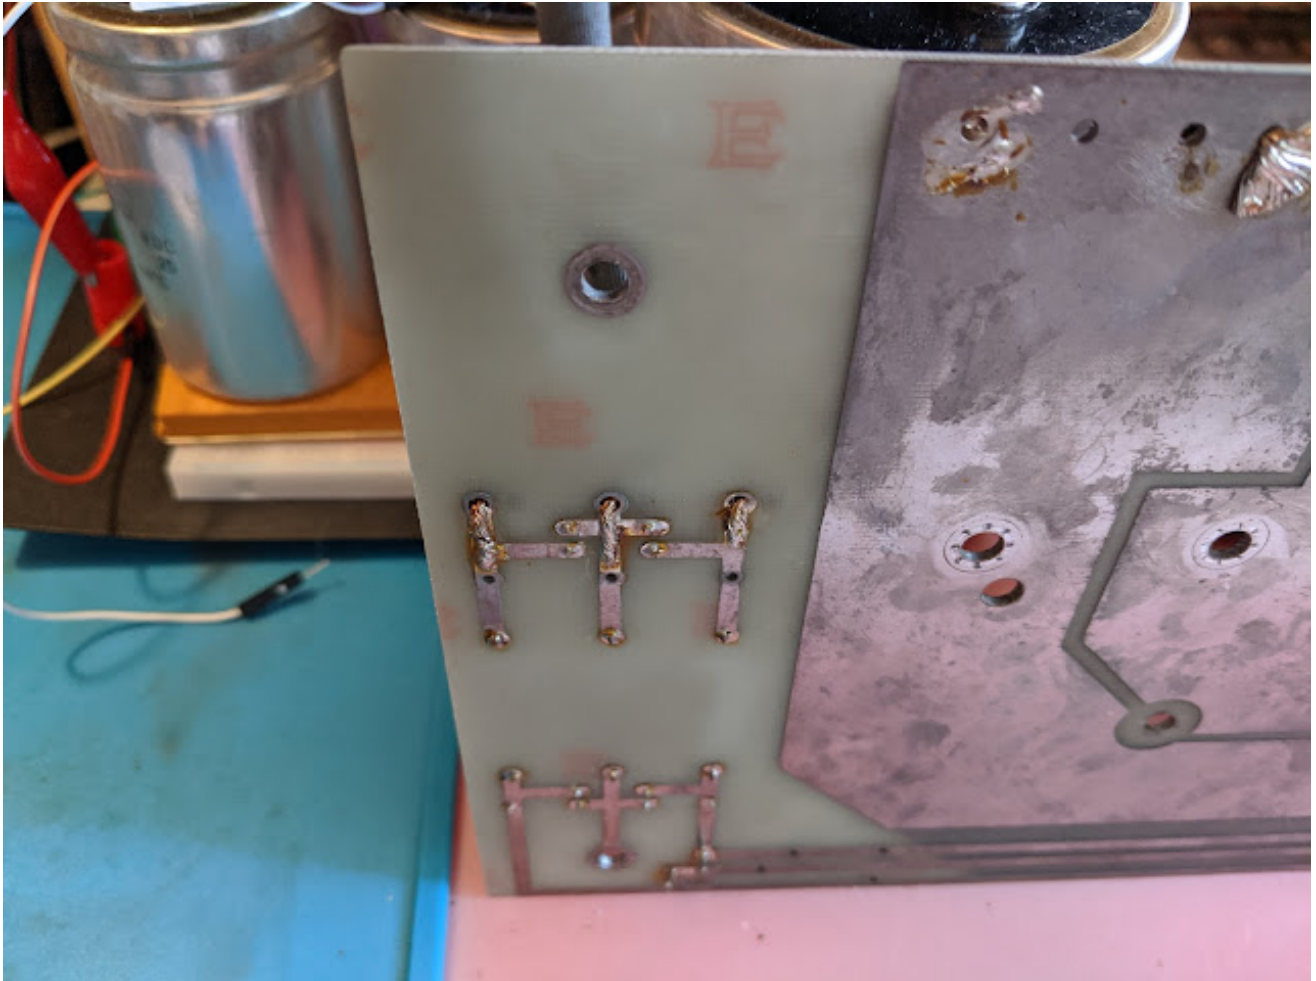
A 40W soldering iron is needed to desolder these 3 cables

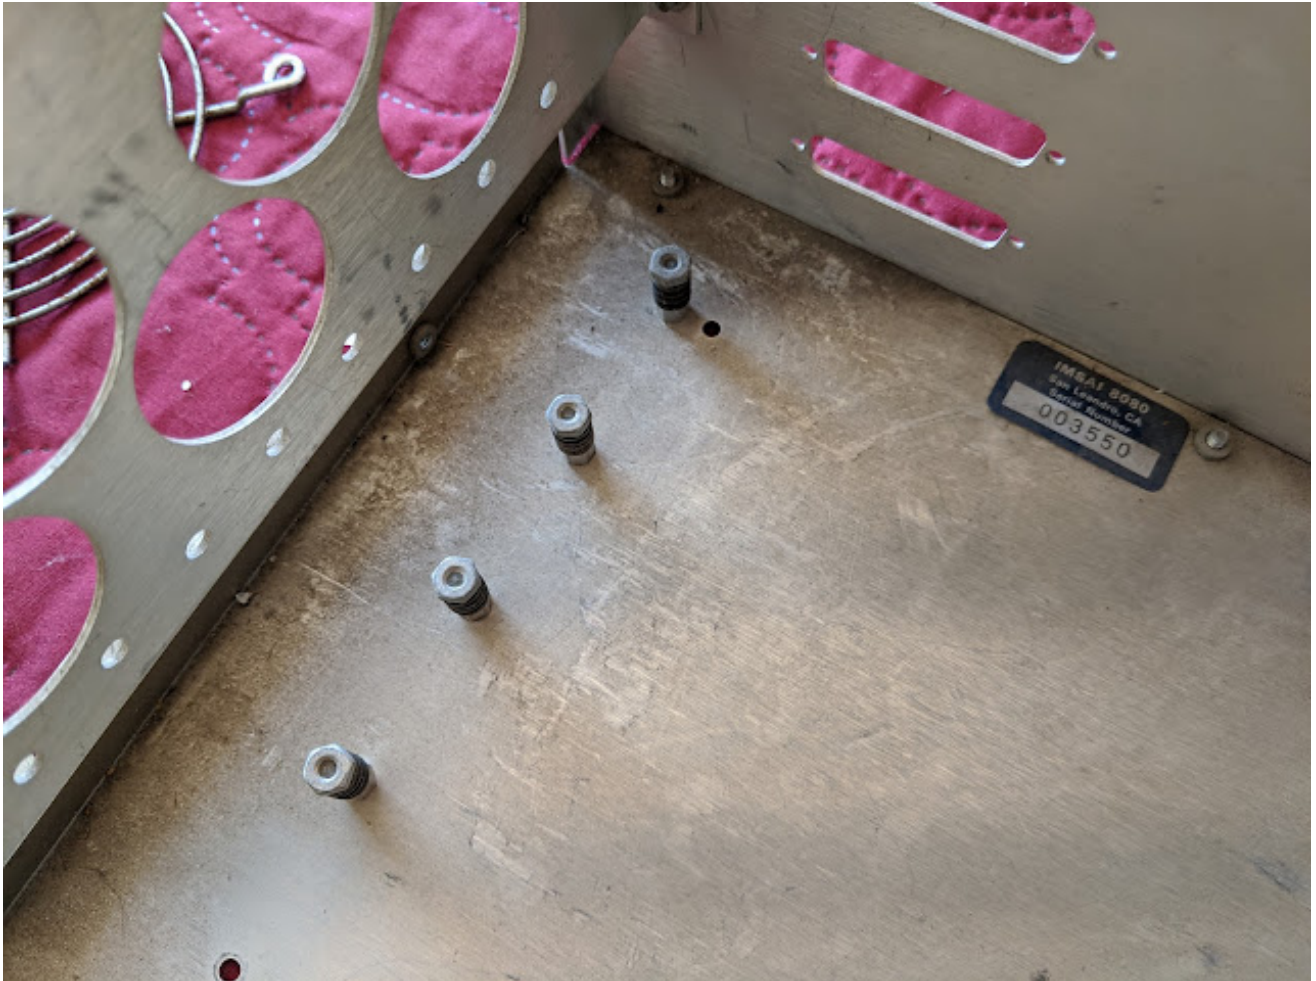
43 years worth of grime

Great care should be taken not to get any cleaner on the serial number label. This is an important and valuable part of the machine.

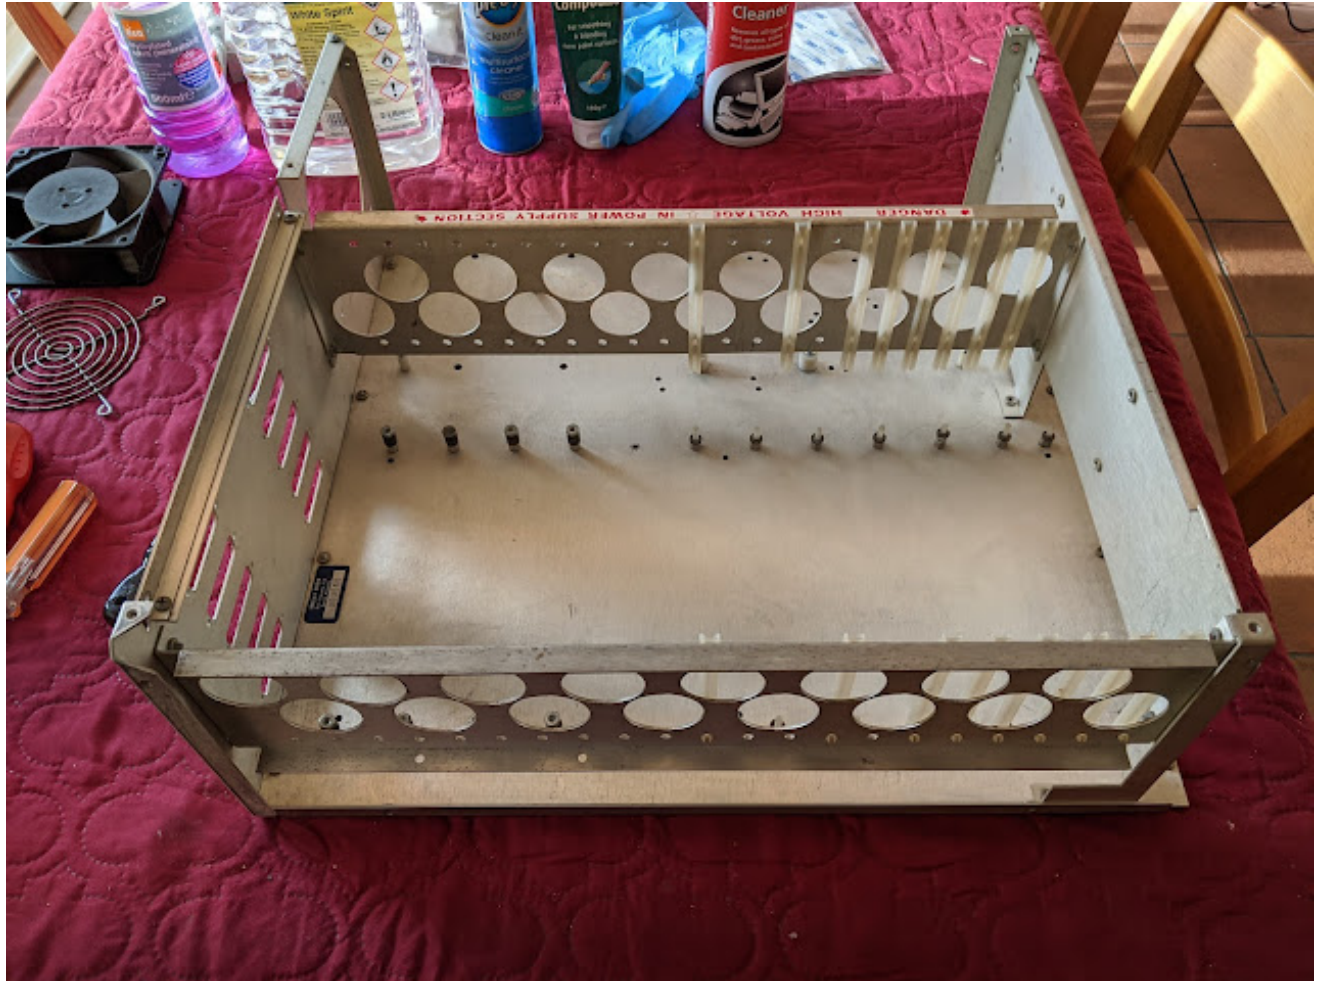
It is still easy enough to get in to clean. Here is the finished article. With it being aluminium, Foam Cleaner is all that was required. We were not trying to polish it like new, just get all the dirt and dust off, retaining the original patina.

Clean and tidy - side view

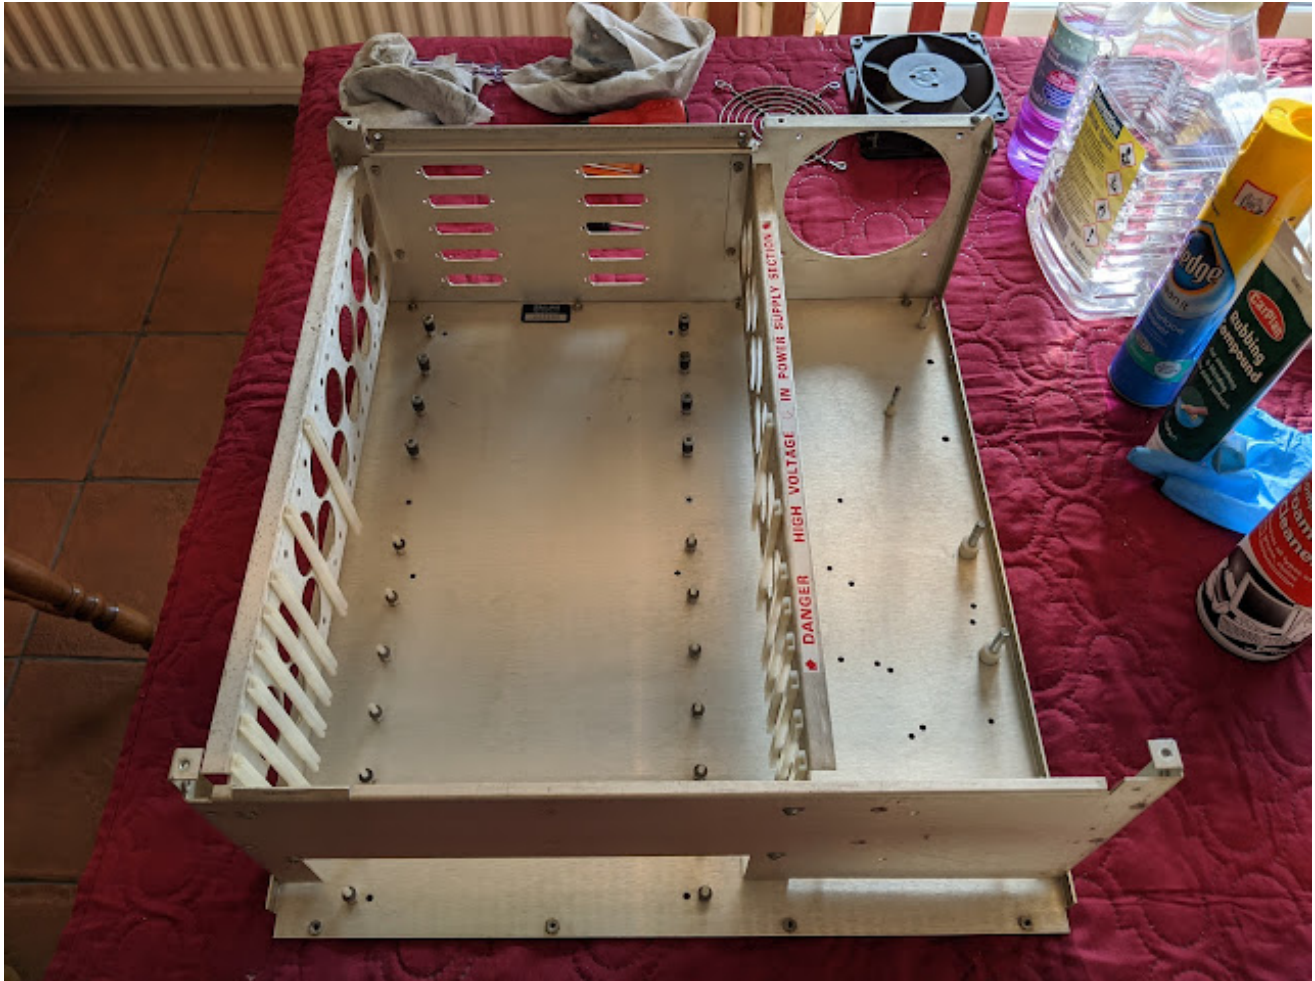
Clean and tidy - front view

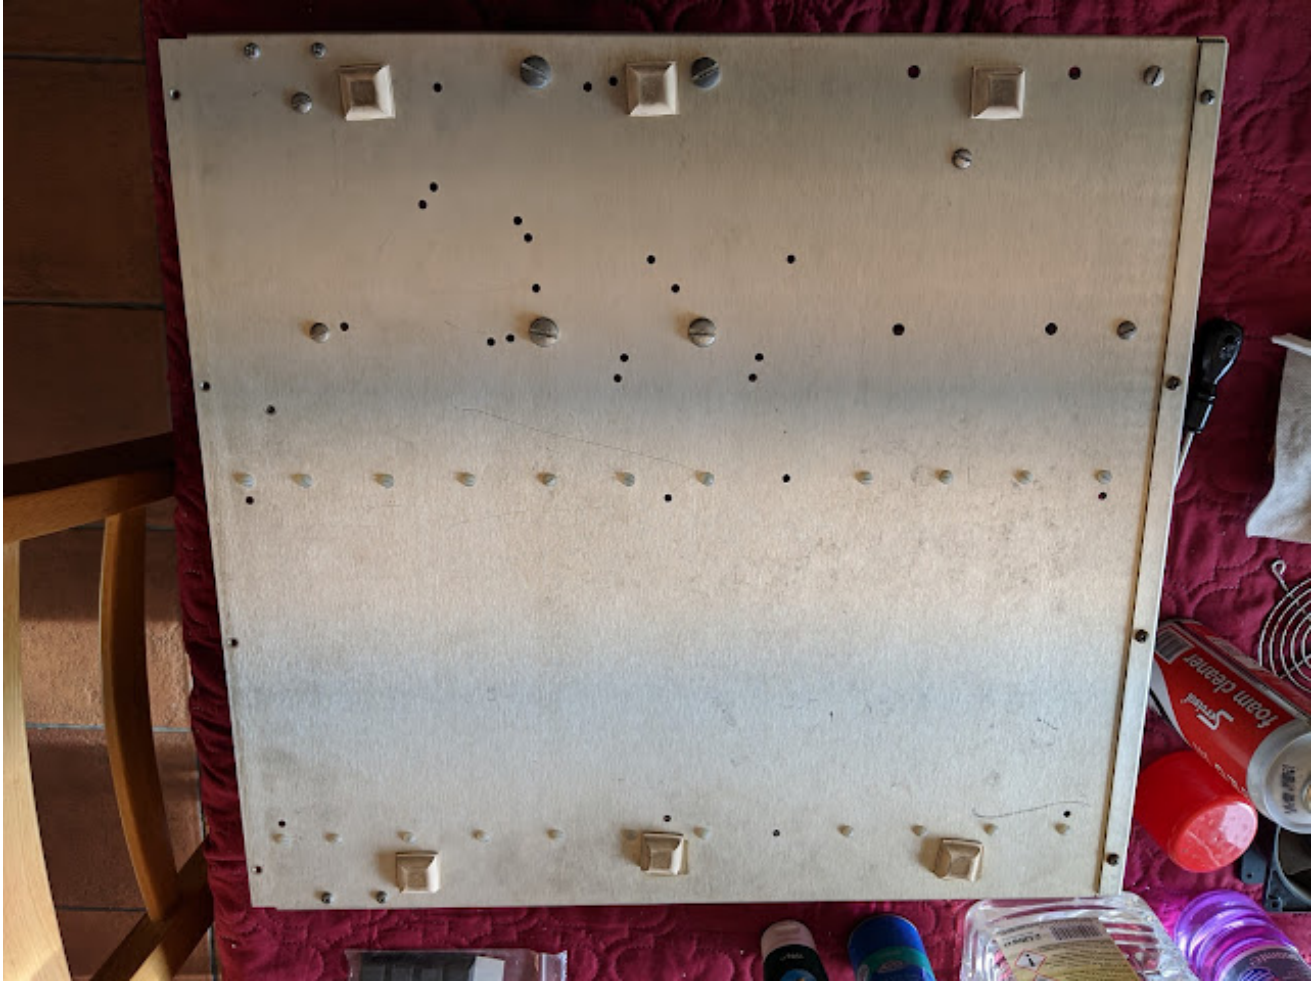
There are an insufficient number of original rubber feet to support the weight and distribute it evenly. This can lead to warping of the baseplate near the transformer, distorting the right-hand guide rail for the S-100 boards .

Underside View

We will fit a complete set of new, slightly higher feet, to avoid any weight on the originals, which are showing evidence of perishing.

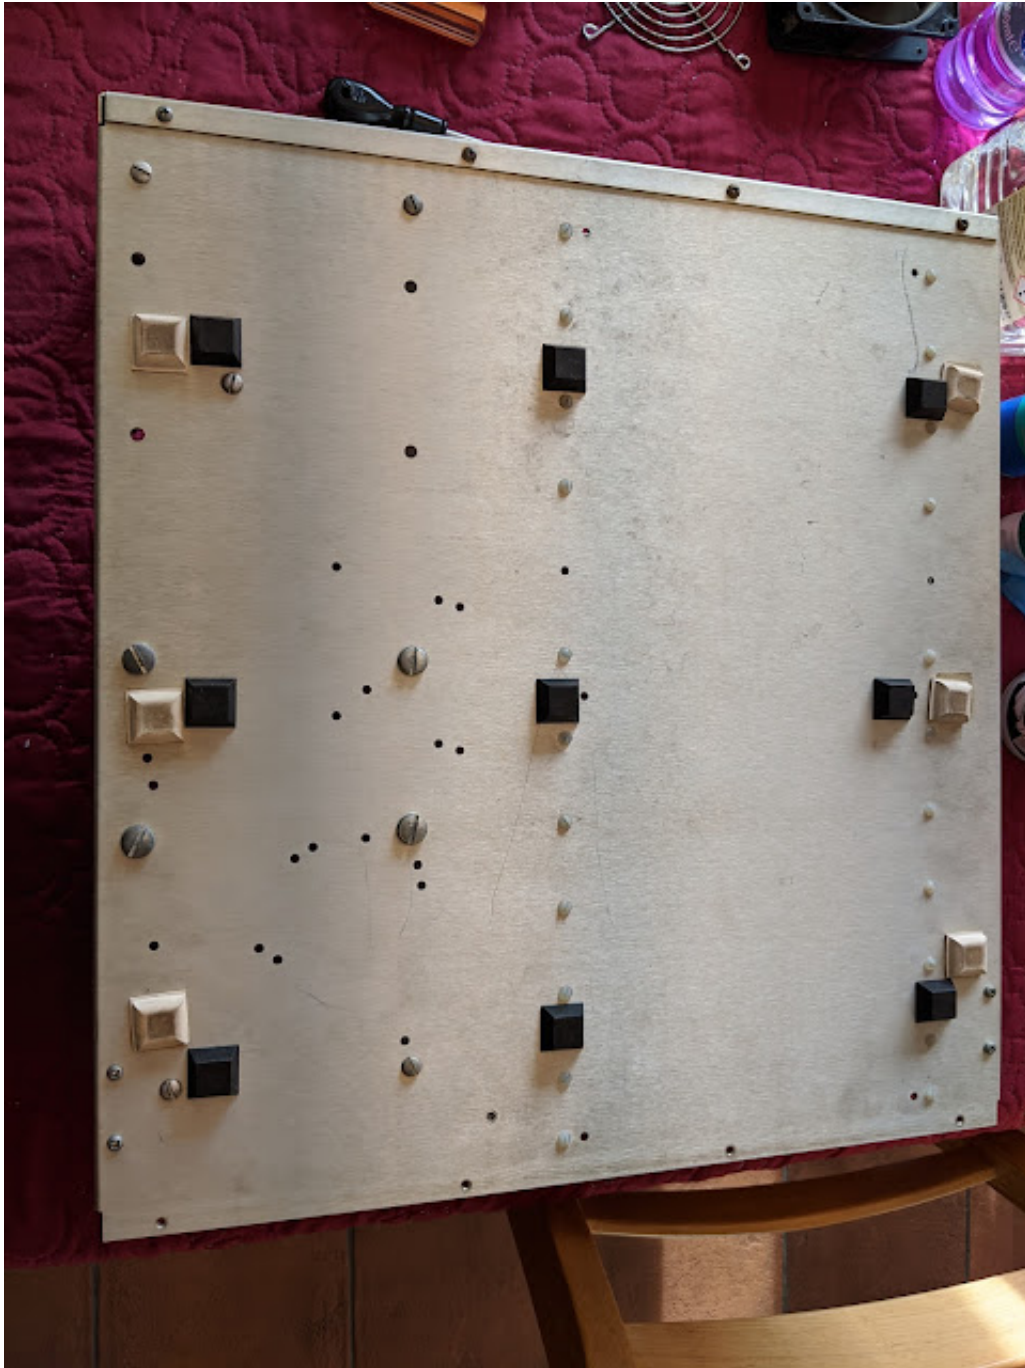
Full set of 3M Rubber Feet fitted

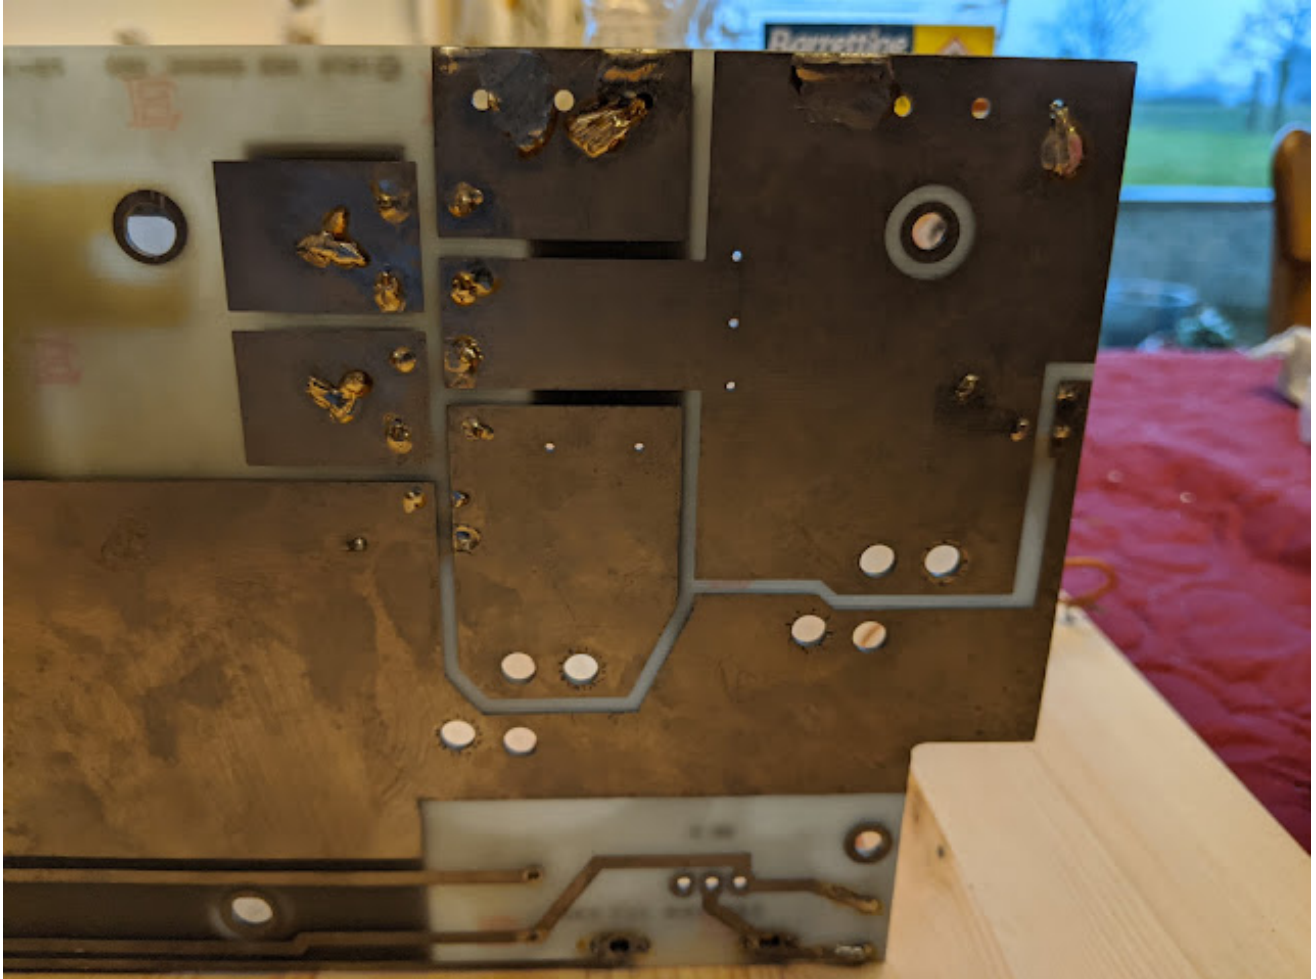
Examination of soldered joints

It is fairly apparent from this, that the original build was of a fairly amateur nature. This adds to the picture that this was a home kit-built machine, rather than having been assembled for a customer by a retail outlet. The contradiction being the sheer amount of dust and grime.

Fortunately, no joints appear to have failed, so we have no remedial work to perform.

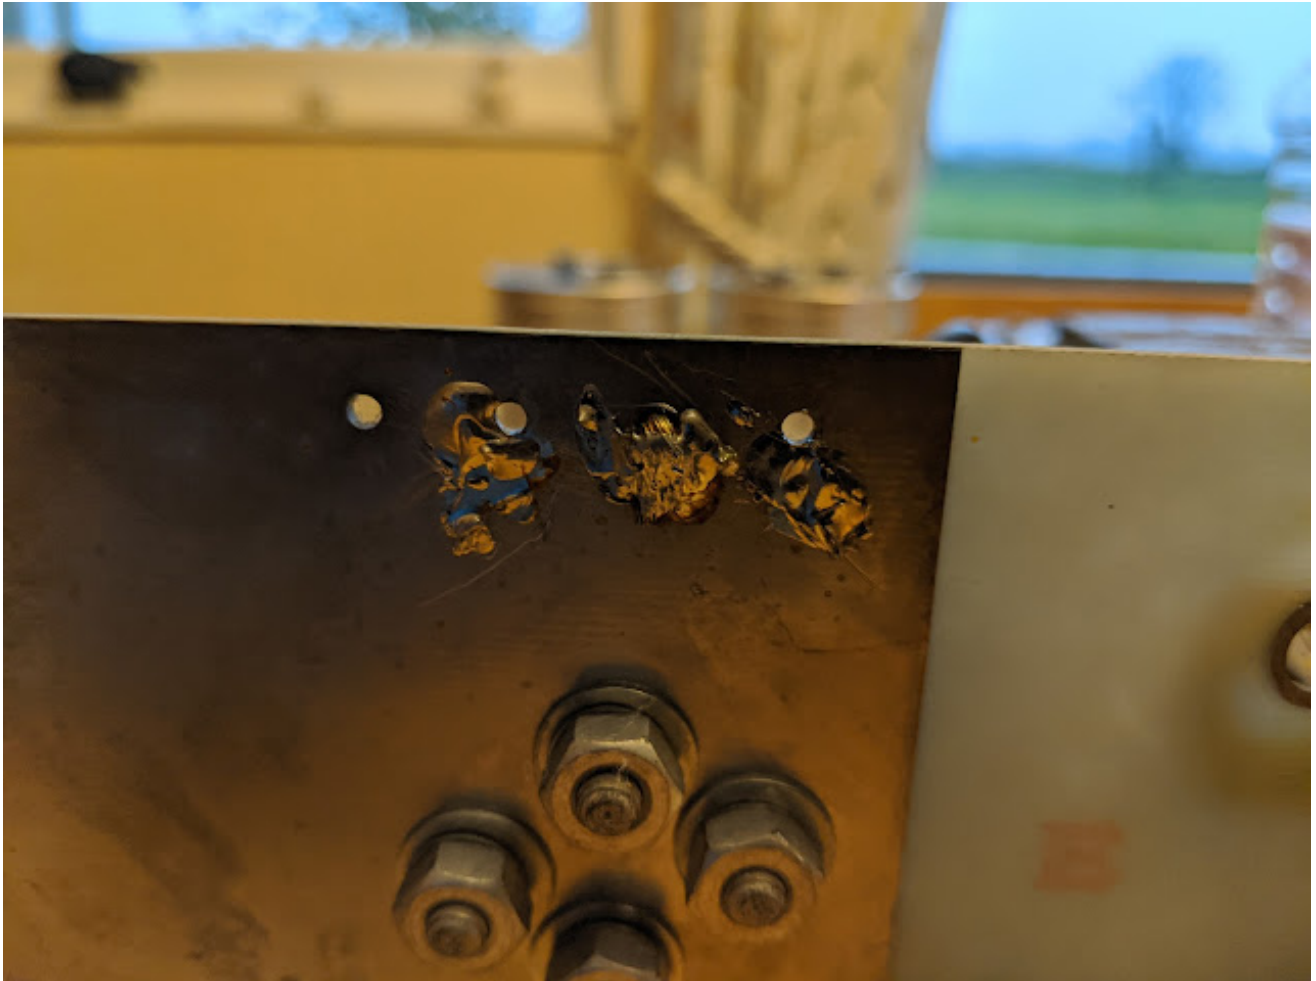
Examination of soldered joints

So far, so good though - all appears to be sound. The indentations around some holes helps to identify where the filter capacitors will need to be fixed back in place now that they have been tested.

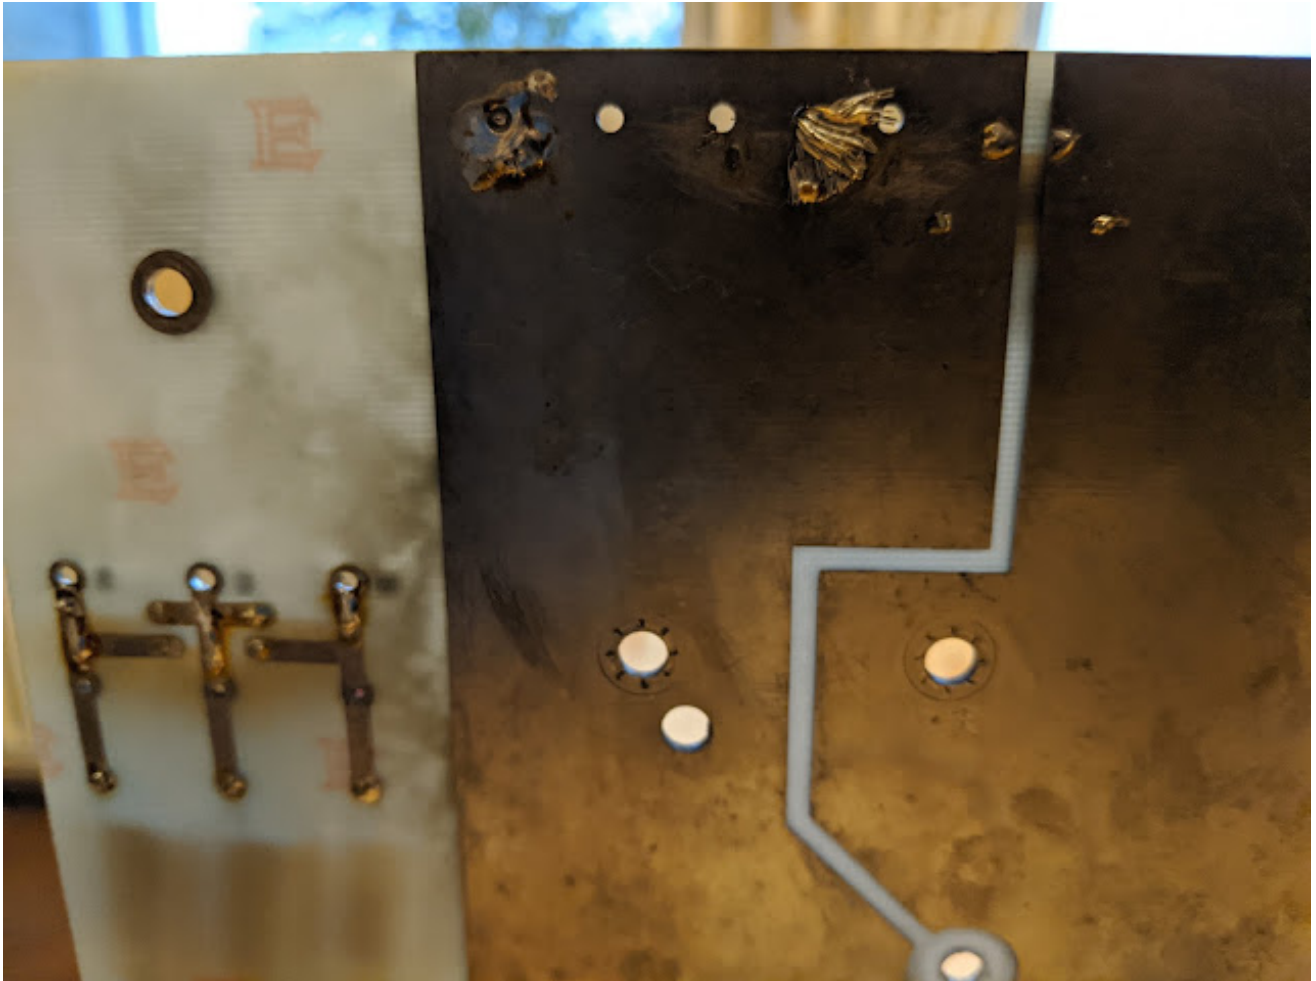
Examination of soldered joints

A grounding point. Clean this with a fibre pen.

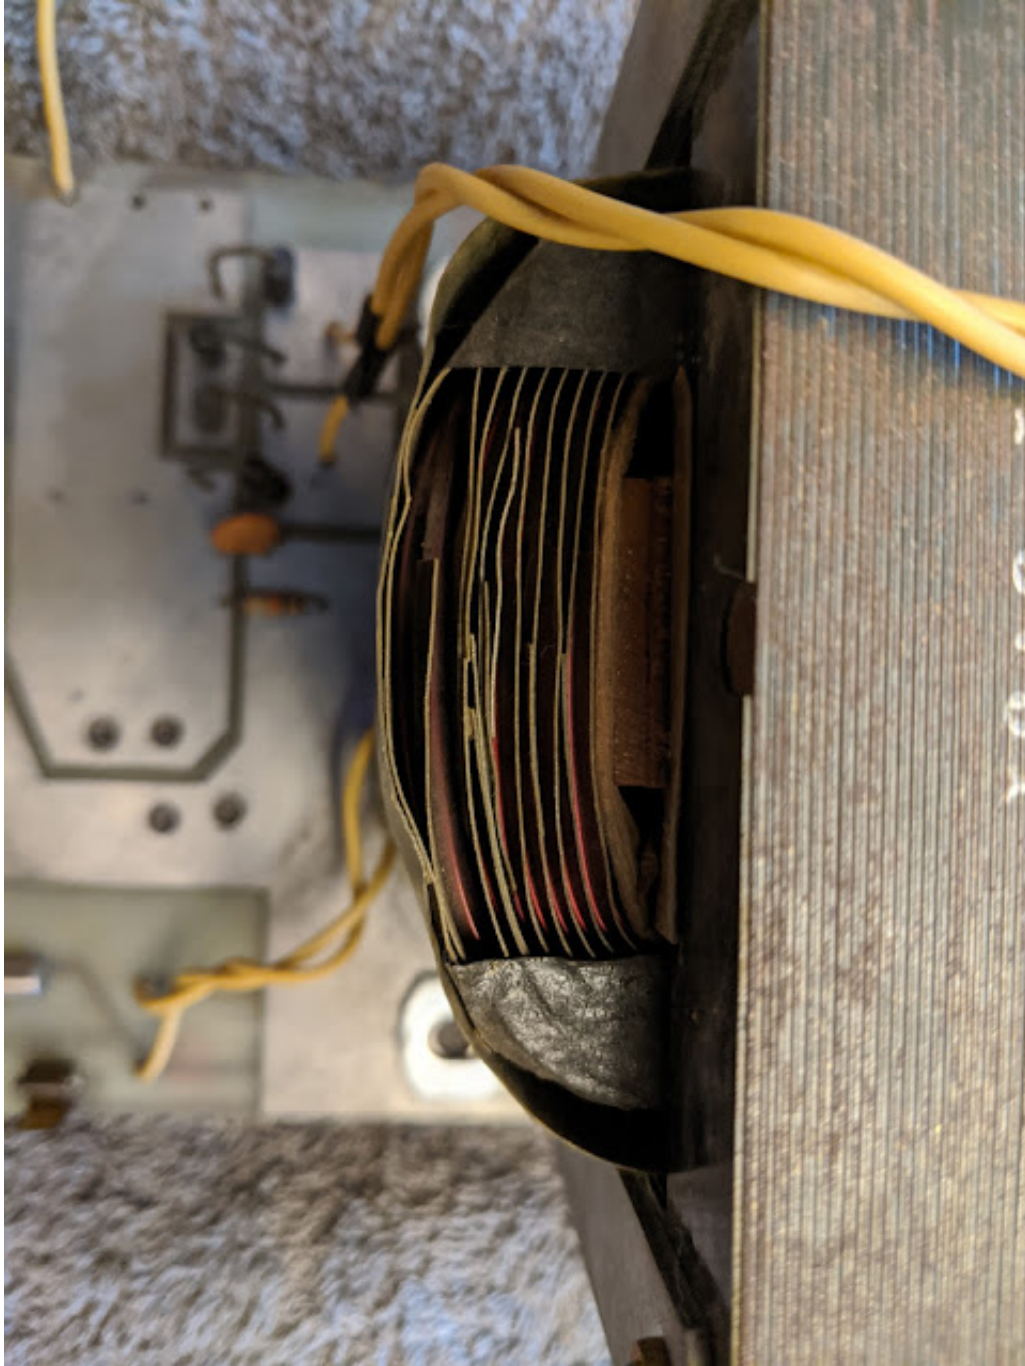
The top of the transformer coils are a dust trap. Do not be tempted to use anything other than an air duster to remove it, otherwise you may damage the insulation.

The top of the transformer coils.

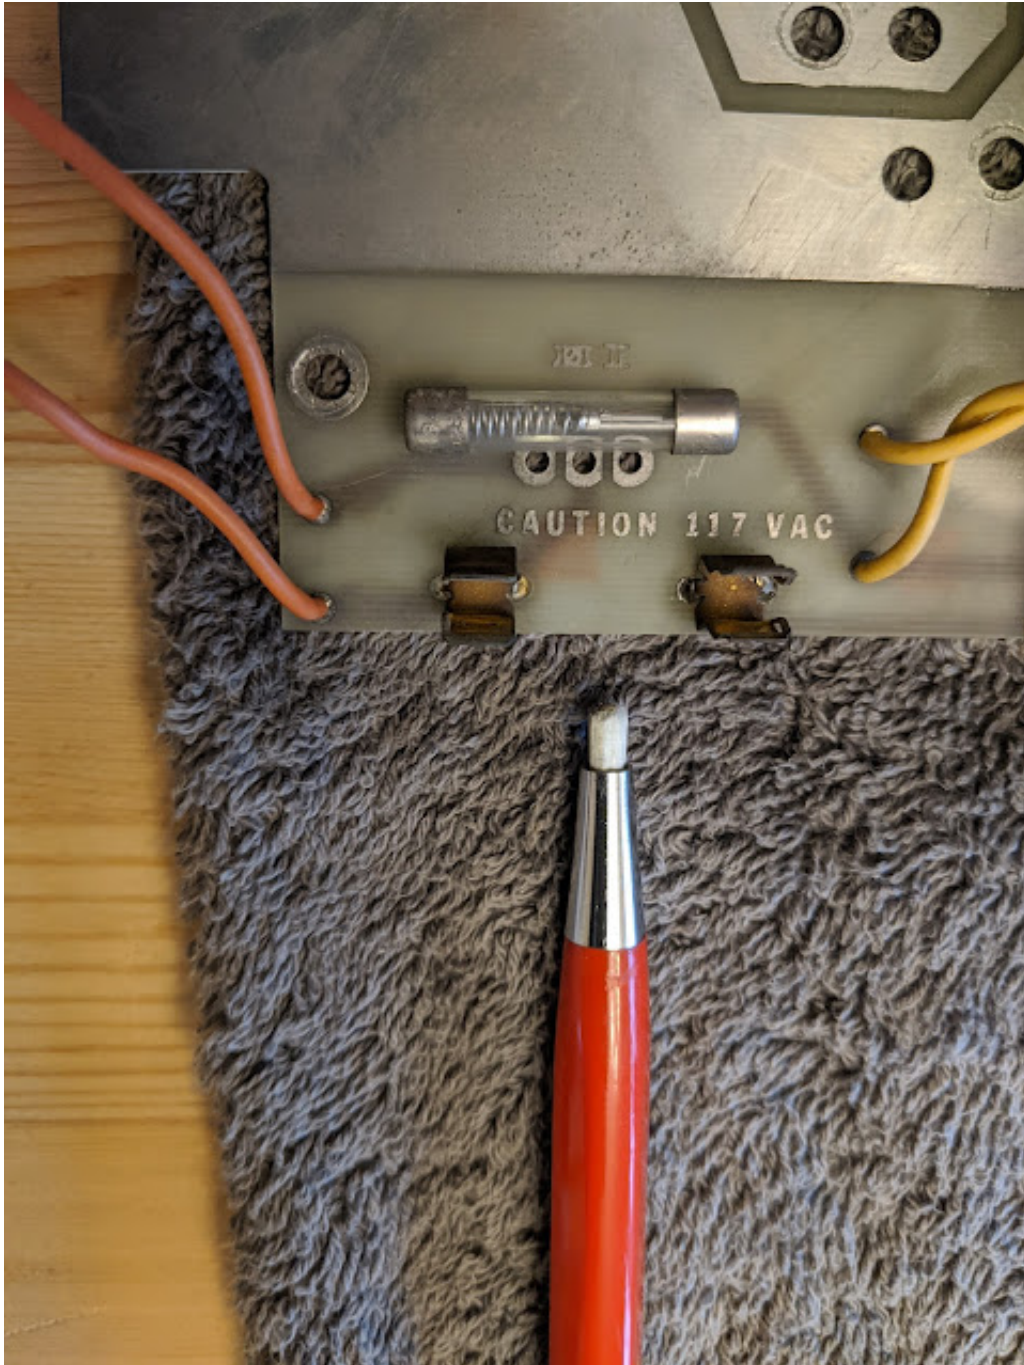
A mains fuse and holder, with a fibre pen for cleaning

The fuse turns out to be 5A, 125vac, slow-blow, which is typical for a USA machine. We will extrapolate later, when stress testing the PSU, whether that is going to be enough to cope with the 28 amp +8vdc supply when in

If fitted to the pcb, as in our case, the mains fuse should be removed and it, and the metal surfaces of the fuse holder, should be thoroughly cleaned with a fibreglass pen.

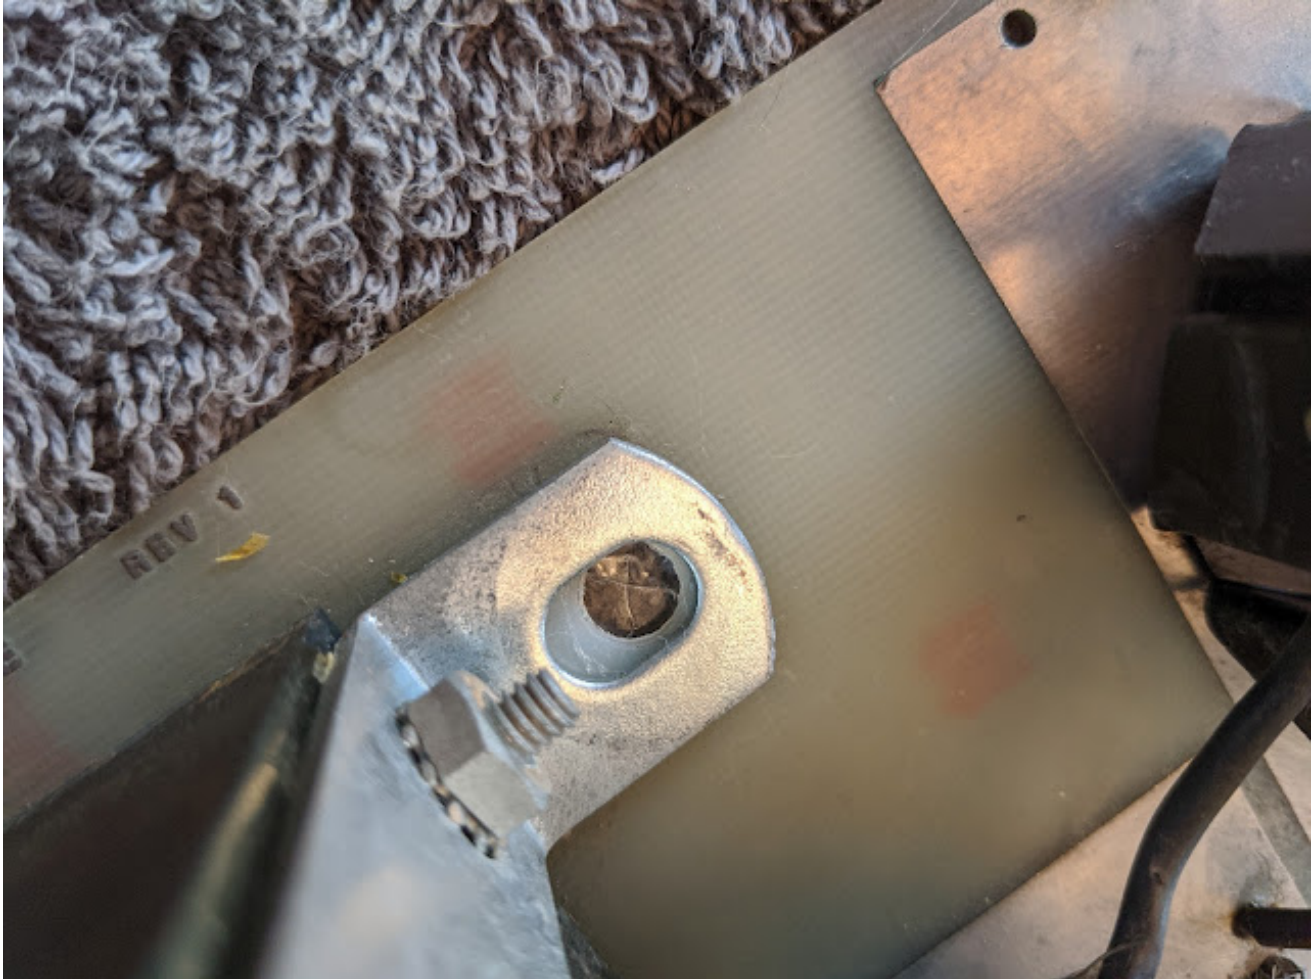
The washer is now fixed in place on the pcb, and the slits cut in the tape will allow the bolts to pass through.

Plastic washer fixed in place on the pcb.

When trying to put the PSU back into the chassis, we will potentially have a problem with the four plastic washers that sit between the pcb and the transformer falling out of position. An easy way to tackle that is to put double-sided tape onto one side of the washer cut around it with scissors and then cut an X in the middle with a Stanley knife.

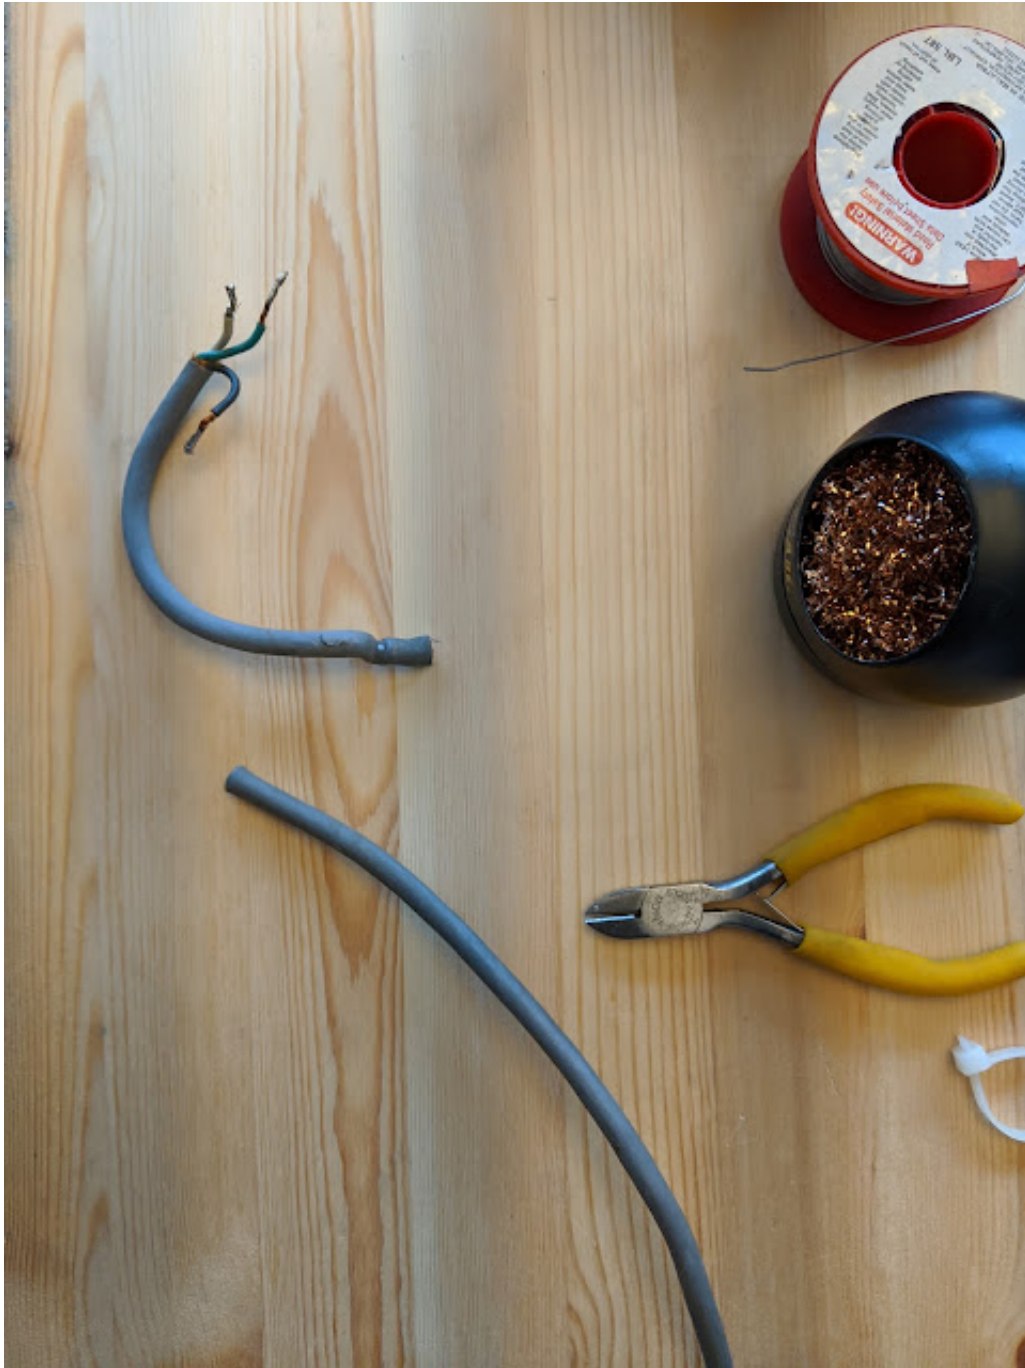
A schoolboy error is well demonstrated here. The mains lead has not been soldered to the bottom of the PSU pcb before lowering it onto the bolts. So, off it comes again to do the job properly this time.....

We do not know if the mains cable has been damaged after years of holding the cable in place, so we simply remove that small section.

Piece of cable that had the strain relief on it.
