# IMSAI 8080 Restoration for The Centre For Computing History at Cambridge, UK.

## **BLOG PART 1: What Have We Actually Got?.**

09/11/2019 - Ross Milbourne.

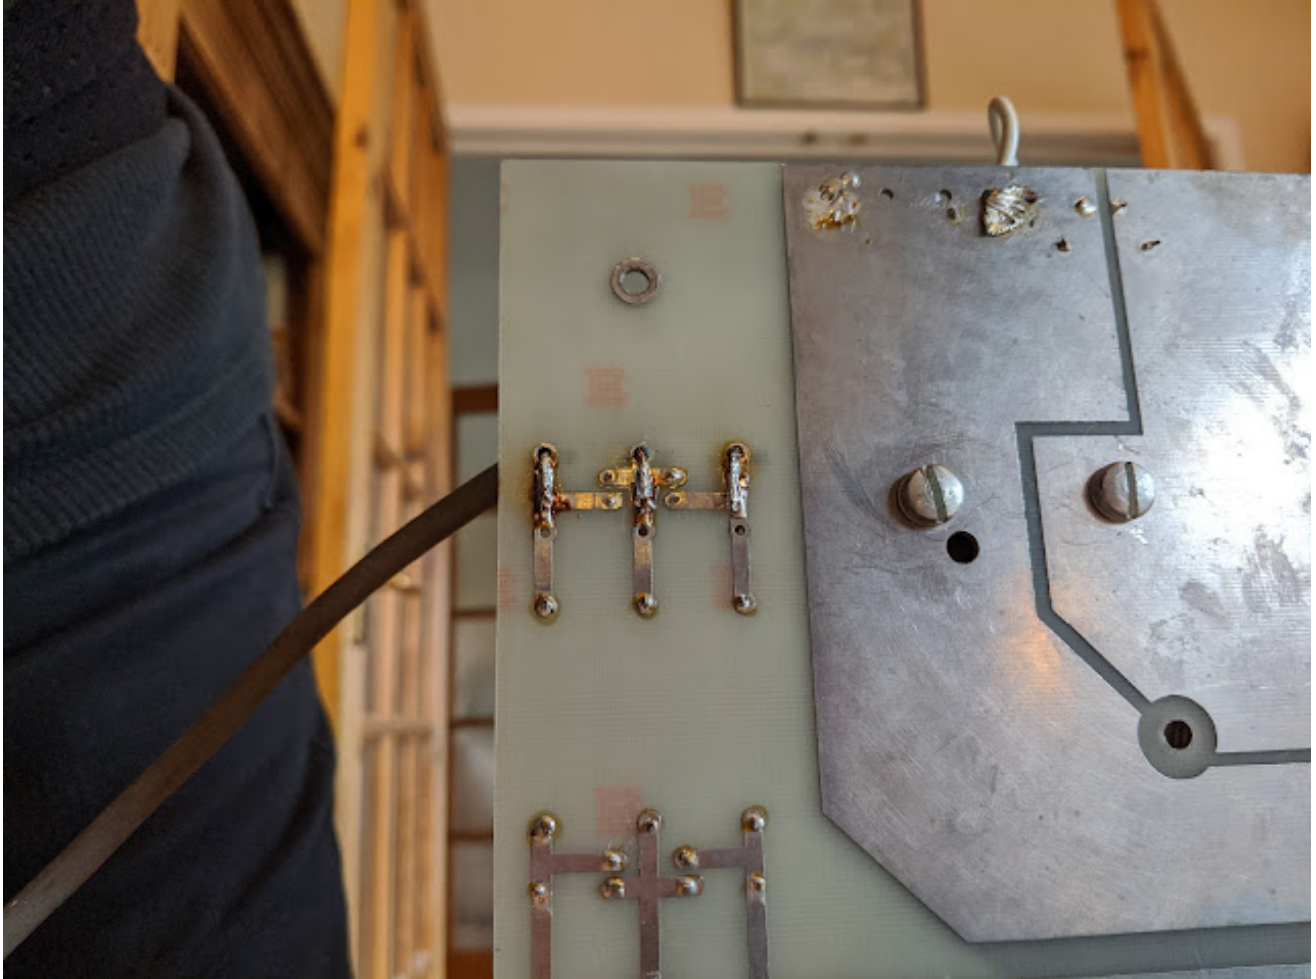
Mains cable soldered onto pcb.

Tin and solder the mains cable into place, observing the colour code printed onto the pcb. A minimum 40 watt soldering iron is required to get a good joint.

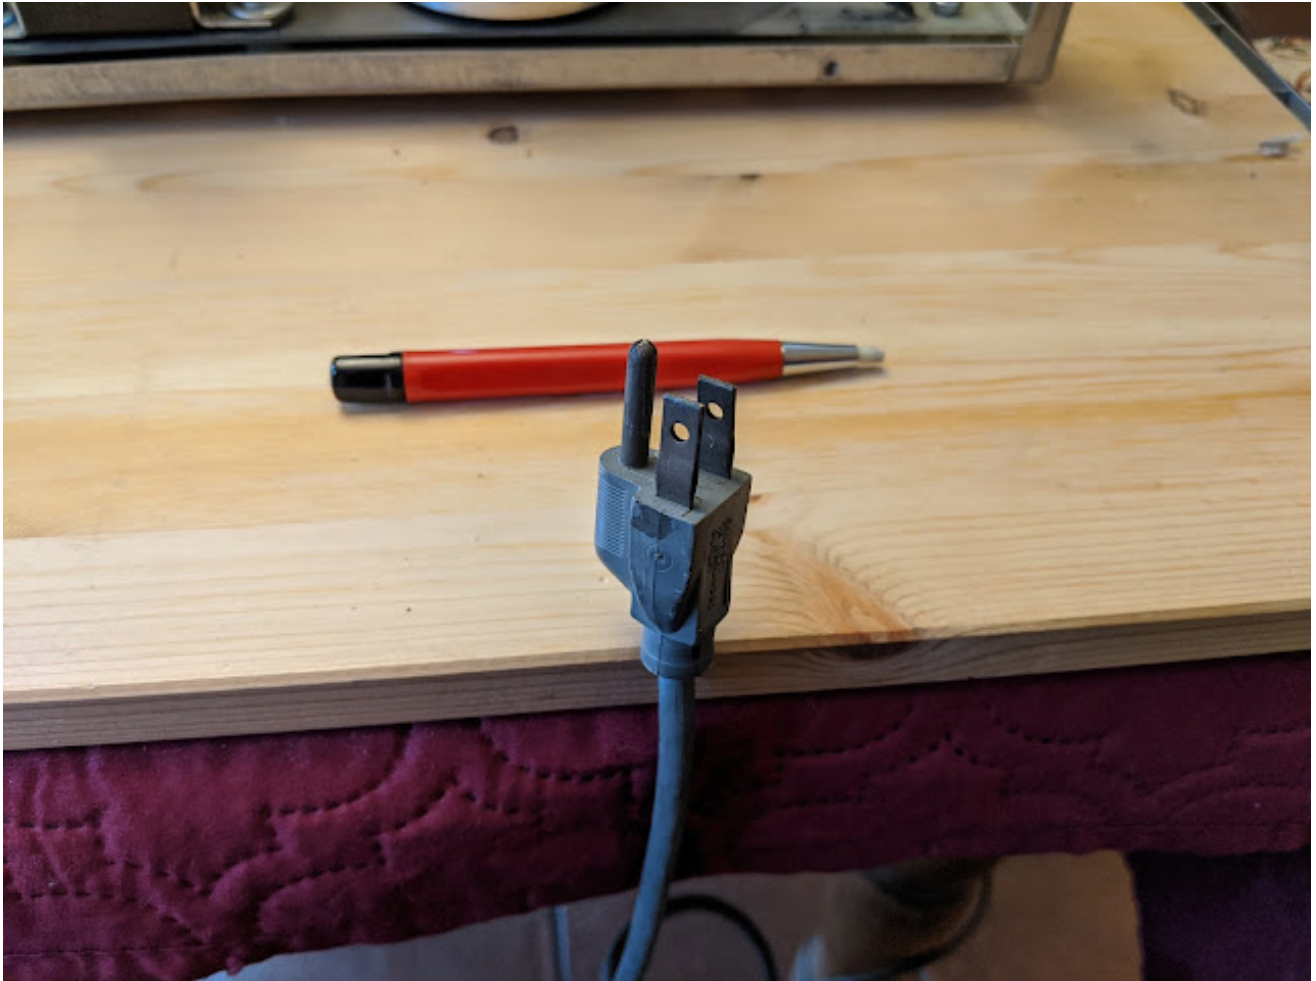
USA mains plug.

The mains plug itself should not be neglected. As can be seen, there is a significant film of corrosion on the pins.

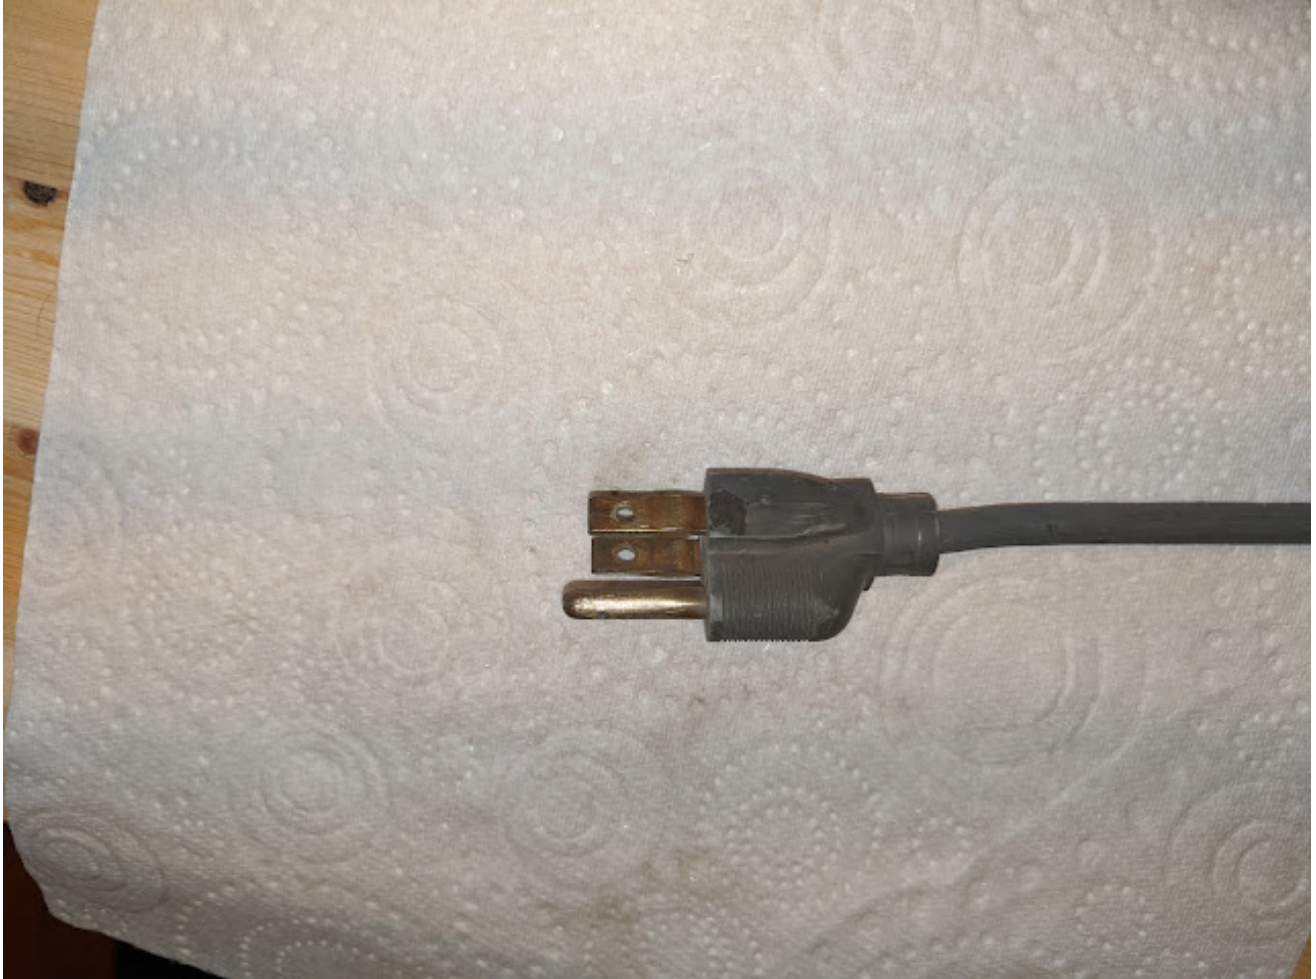
Cleaned mains plug contact pins.

As usual, a fibre pen is used to clean up the contacts. When using a fibre pen, you should place a sheet of paper towel under the area being worked on, to catch the broken fibres and dispose of them safely. You should wear vinyl gloves to avoid the fibres getting into your skin. You should wear a face mask, to avoid breathing in the dust and fibres when carrying out the work.

We will get much less heat building up in the plug now, due to the decrease in resistance.

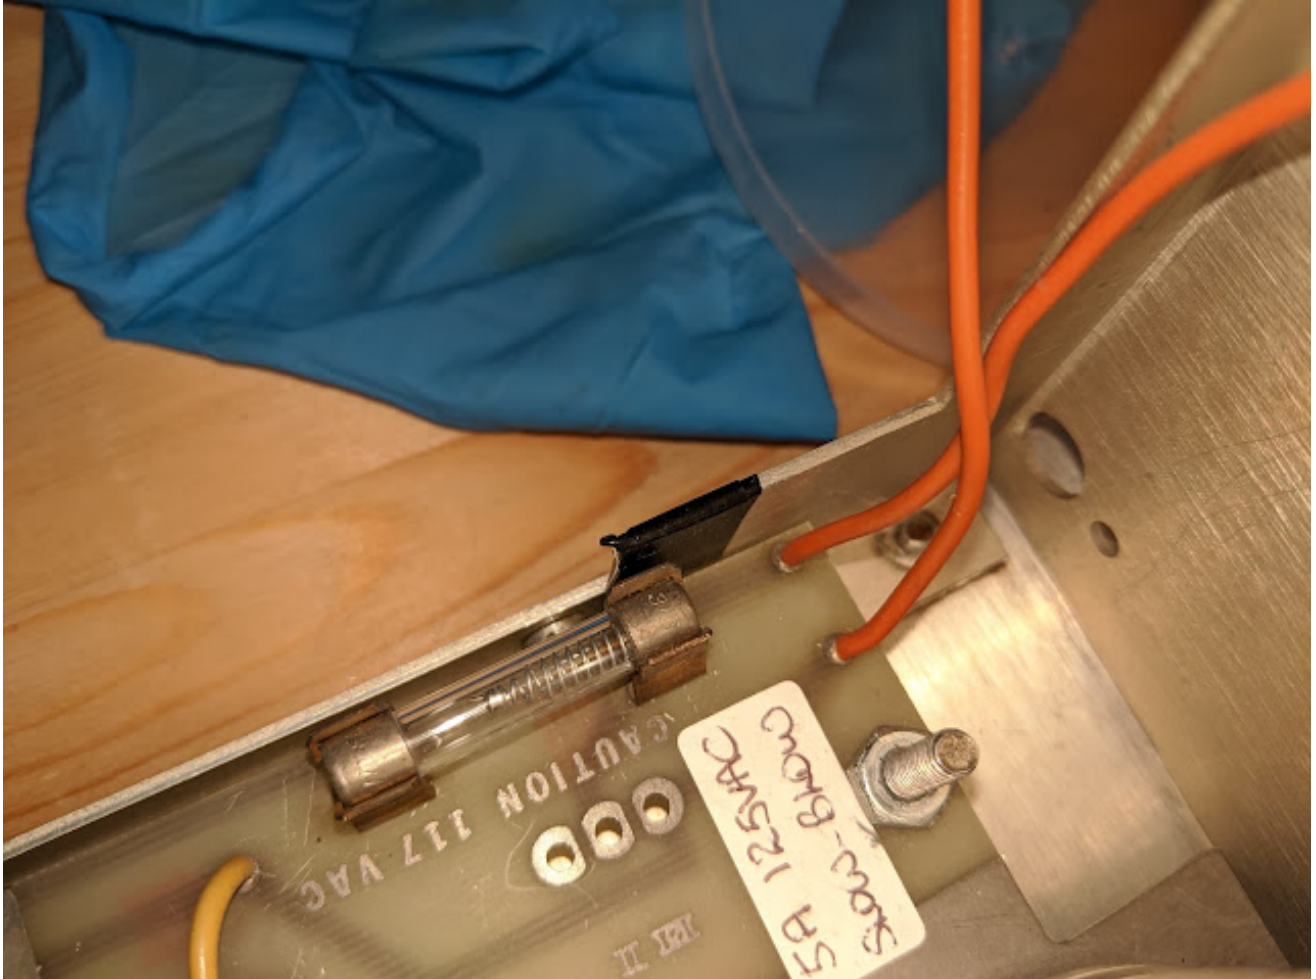
If your pcb is fitted with a mains fuse, check it is not too close to the chassis. This is a design flaw and a potential safety hazard.

As can be seen, ours is not good.

Vinyl tape applied to chassis.

Cut tape to create a good fit that is wrapped around the edge of the chassis.

This addresses the potential safety concern.

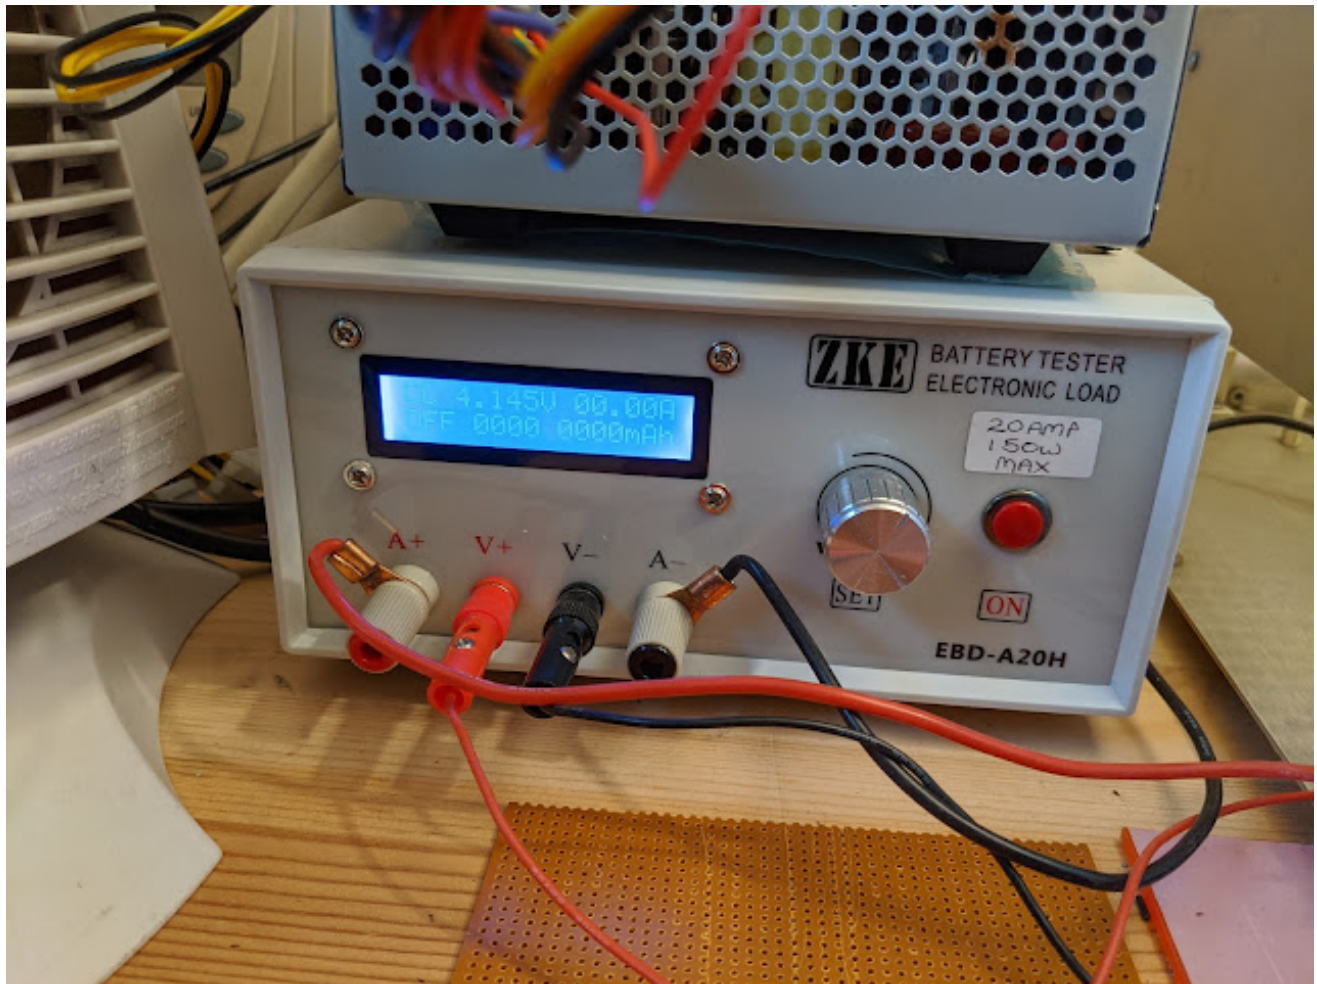
So far, all had gone well. However, when the Variac was wound down and the supply turned off, we would expect the bleed resistors for each DC output to slowly but surely reduce the voltage in the large capacitors to zero, over a period of a few minutes, rendering them safe.

What we saw, was a problem. The +8vdc output voltage had dropped to about half, in a couple of minutes. The -16vdc output voltage had also halved. However, the +16vdc output voltage was not moving.....

+8vdc line.

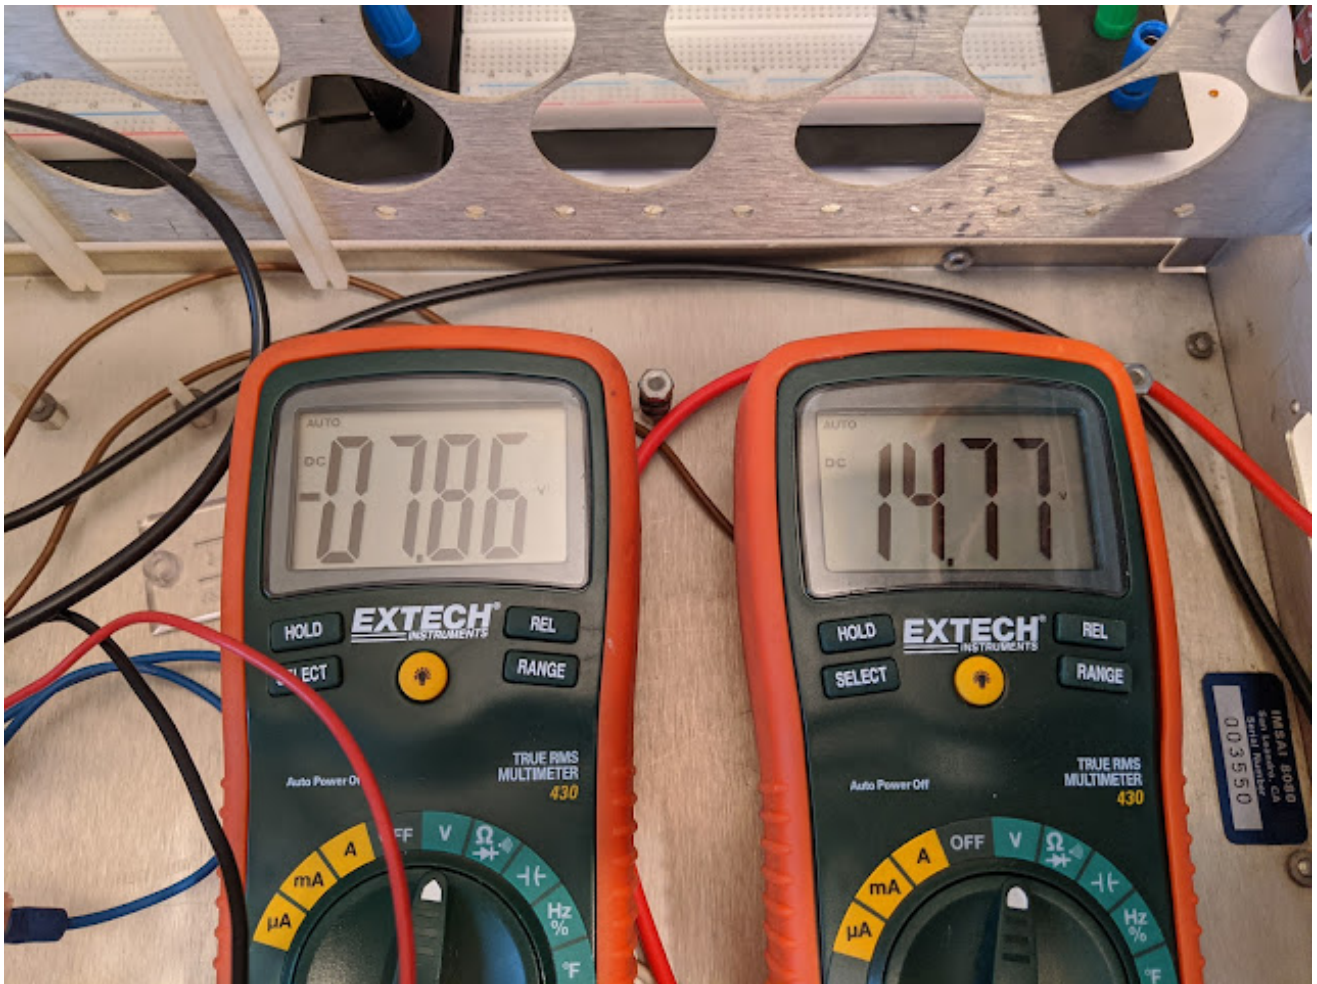
The +16vdc line was still sitting at nearly 15vdc.

-16vdc and +16vdc lines.

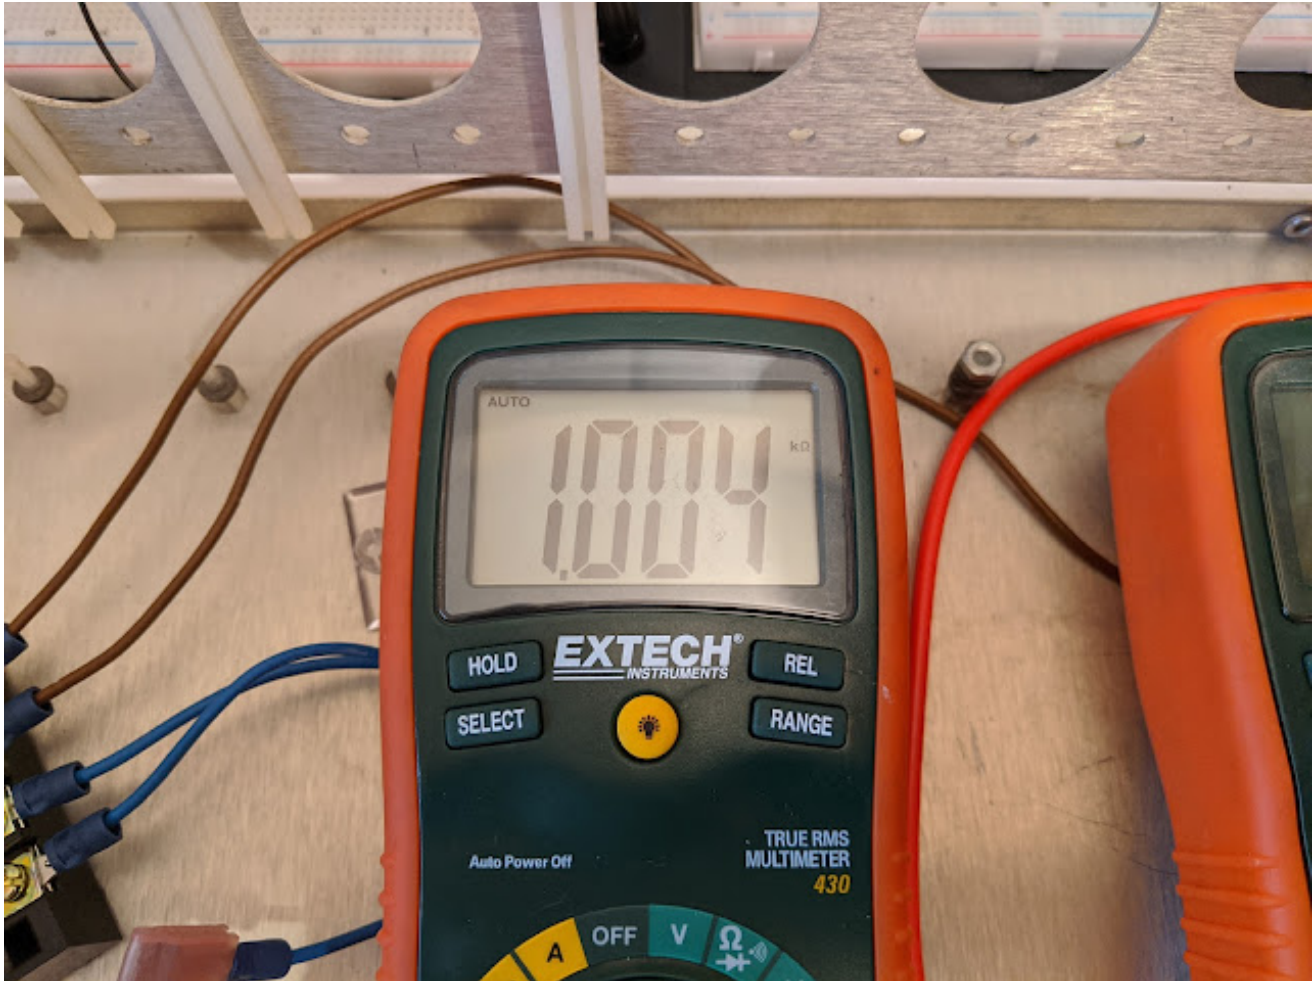
+16vdc line 1k Ohm Bleed Resistor measurement.

Success! The connection was formed and now the Bleed Resistor could do its job at last.

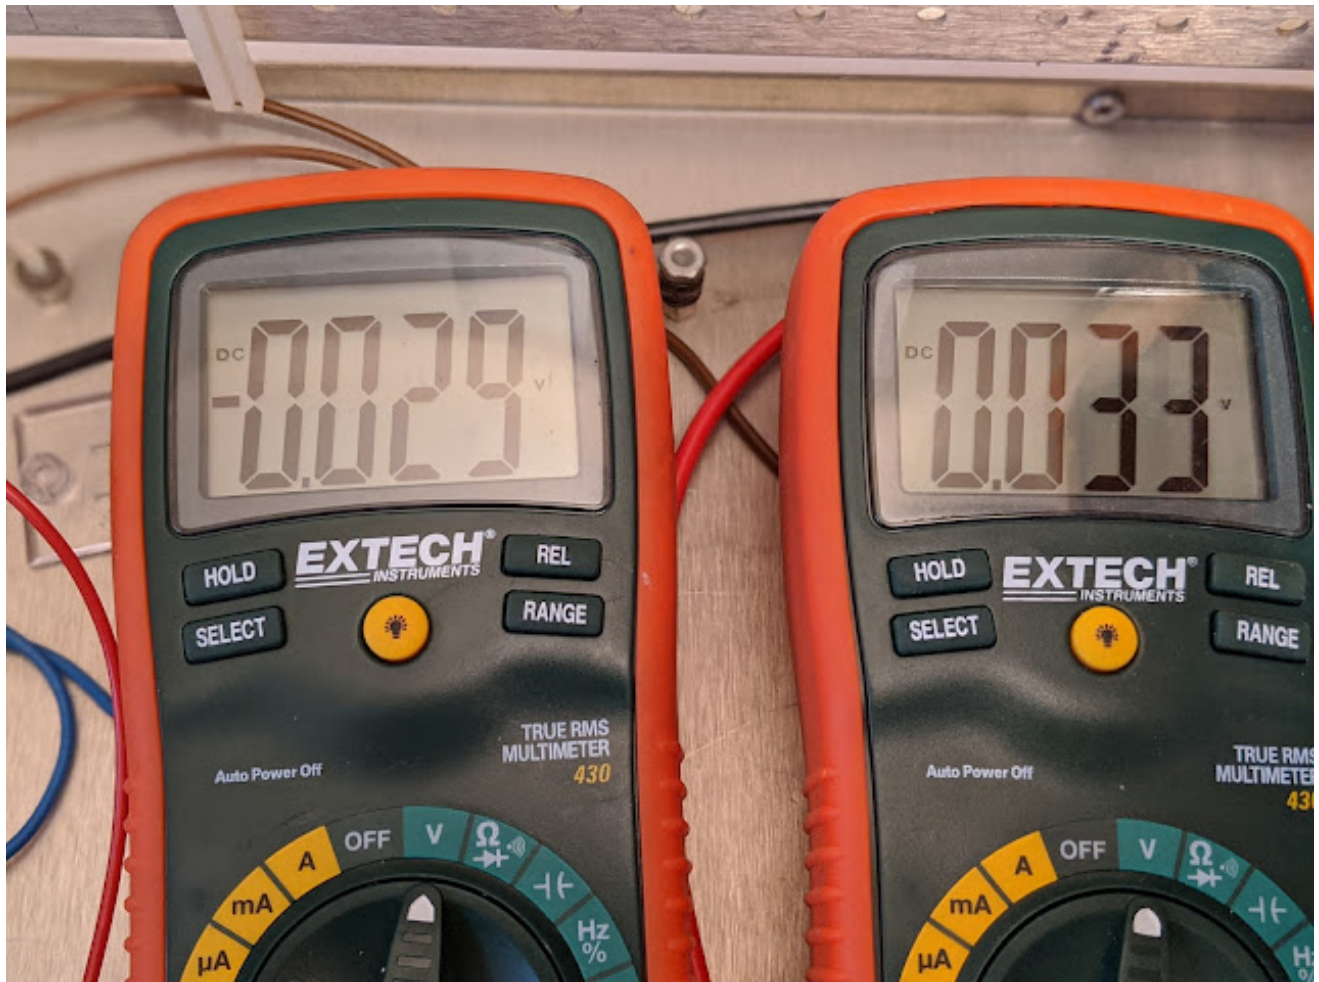
+16vdc and -16vdc voltage readings after 1 minute.

Problem solved, and a safer PSU for future users.

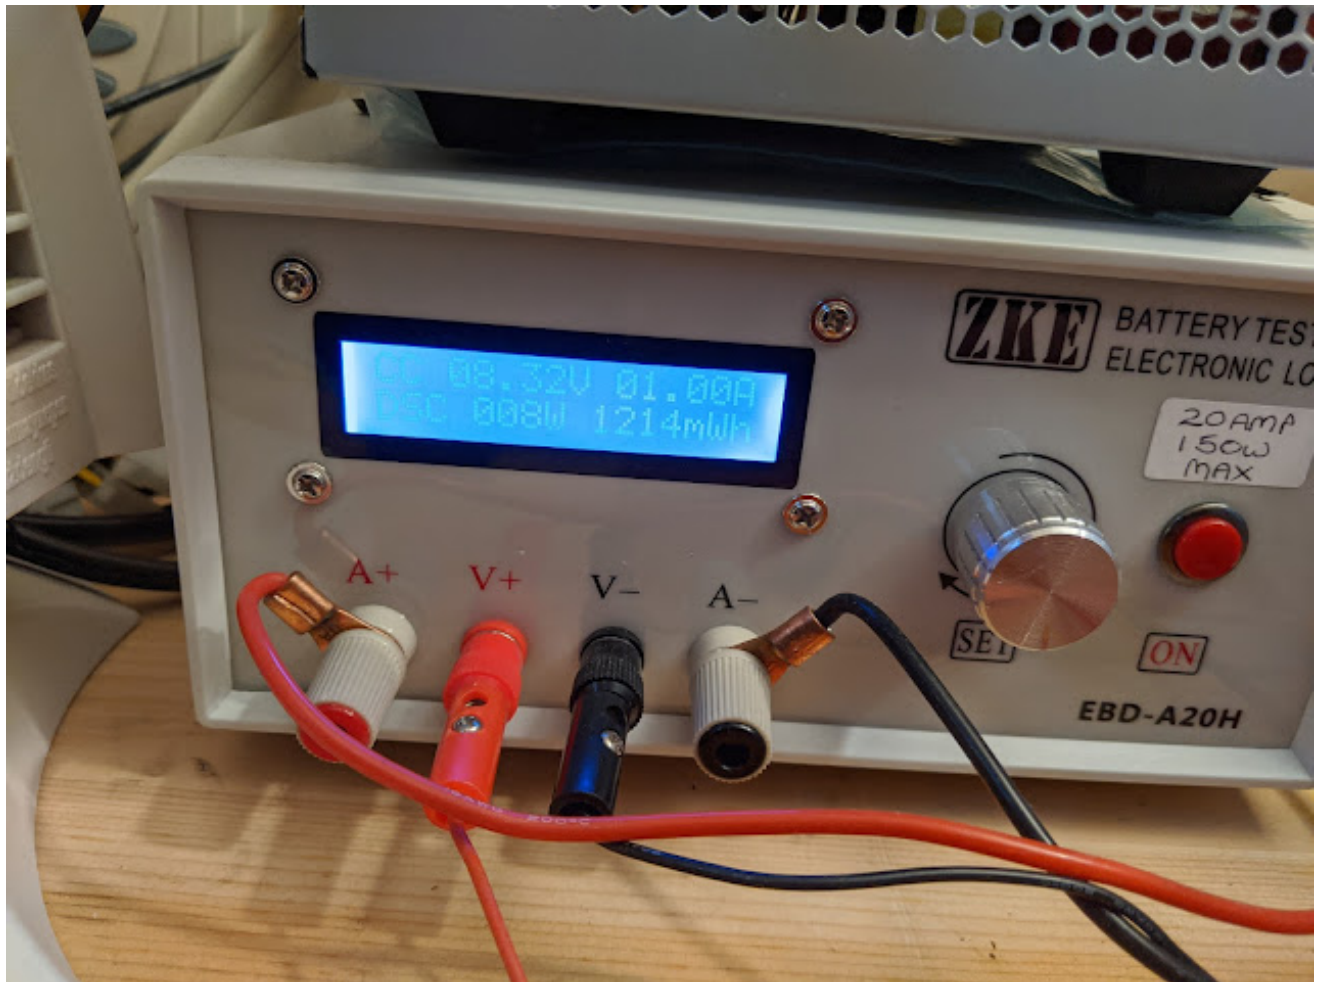
Next, we run a nominal 1 amp load on the main +8vdc rail for 5 minutes, and check there are no unexpected issues.

1.0 Amp test load on the +8vdc line.

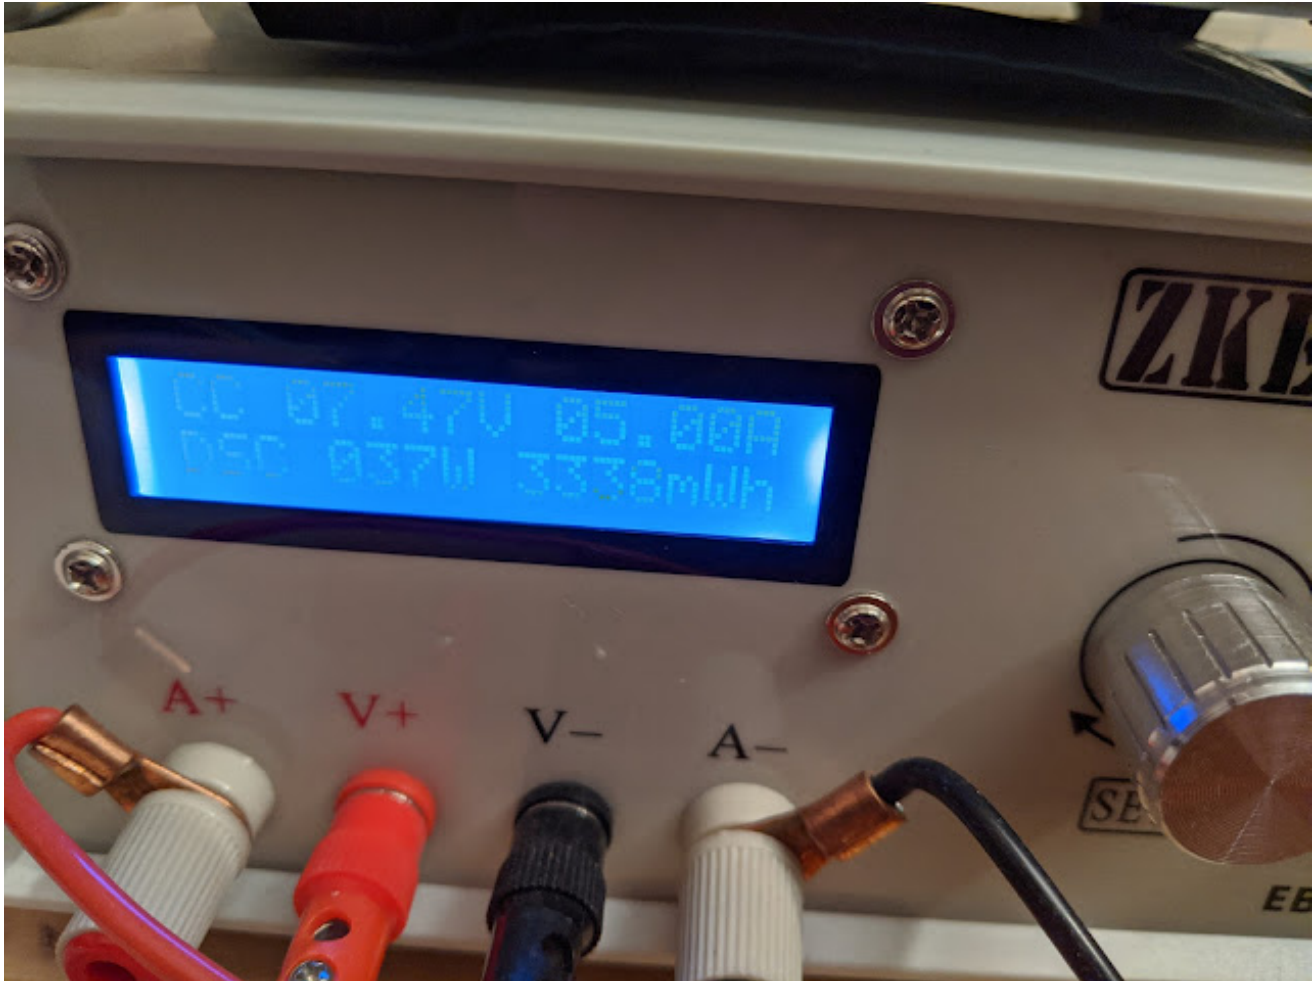
The voltage has dropped to 7.47vdc at 5.0 Amps, which is well within the specification of 7.0vdc at 28 Amps. The S-100 boards all have onboard 7805, 5vdc voltage regulators fitted, to take the +8vdc raw supply and provide the regulated +5vdc need for their circuits. The 7805 will work from +7vdc to +30vdc, so 7.47vdc is fine.

5.0 Amp test load on the +8vdc line.

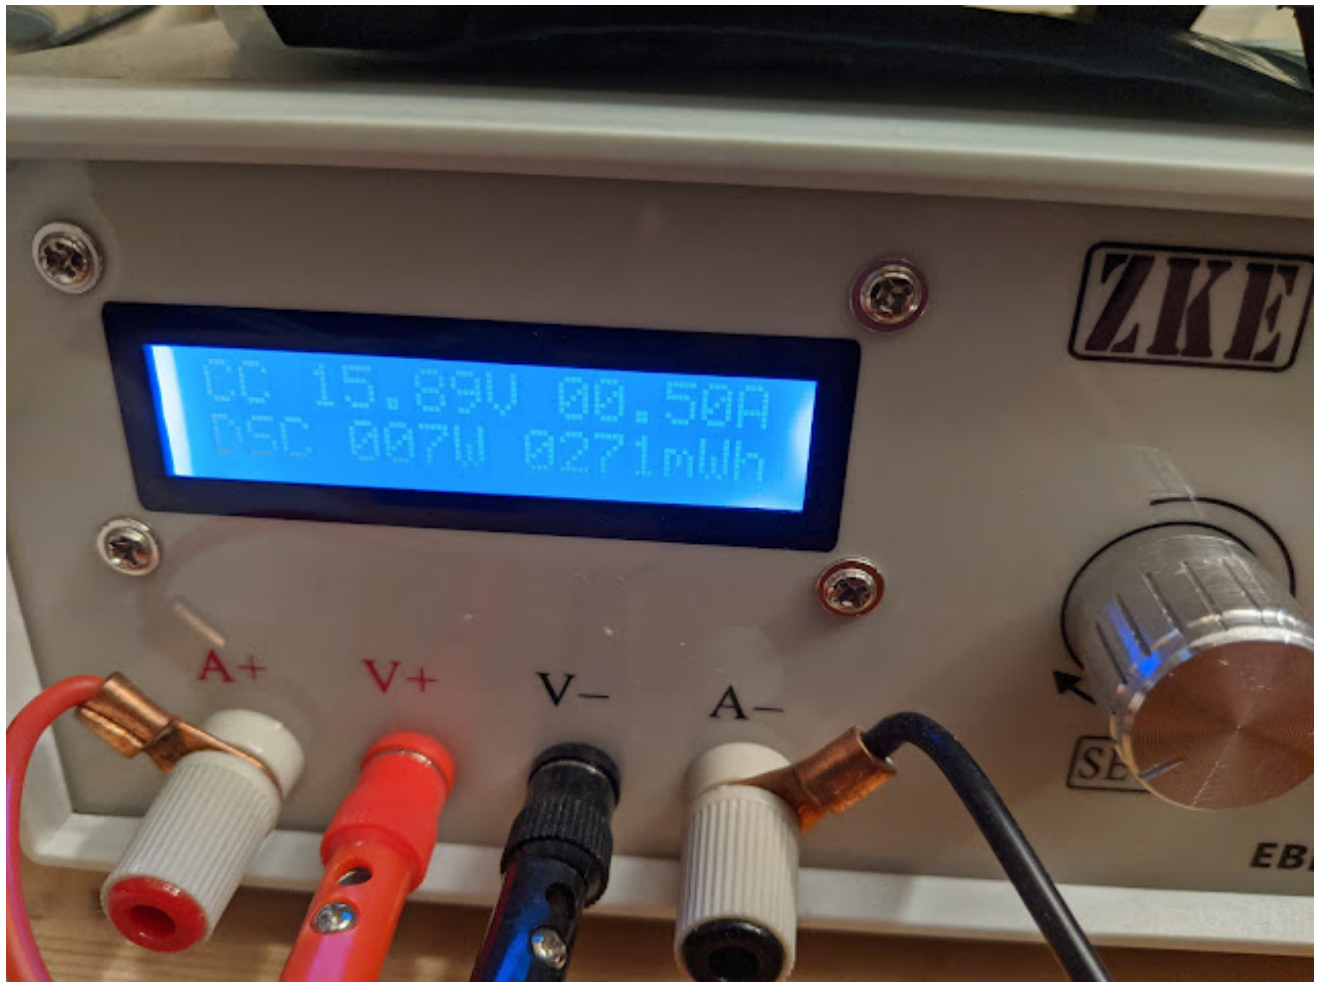
0.5 Amps is run through it for 5 minutes with no problems.

0.5 Amp test load on the +16vdc line.

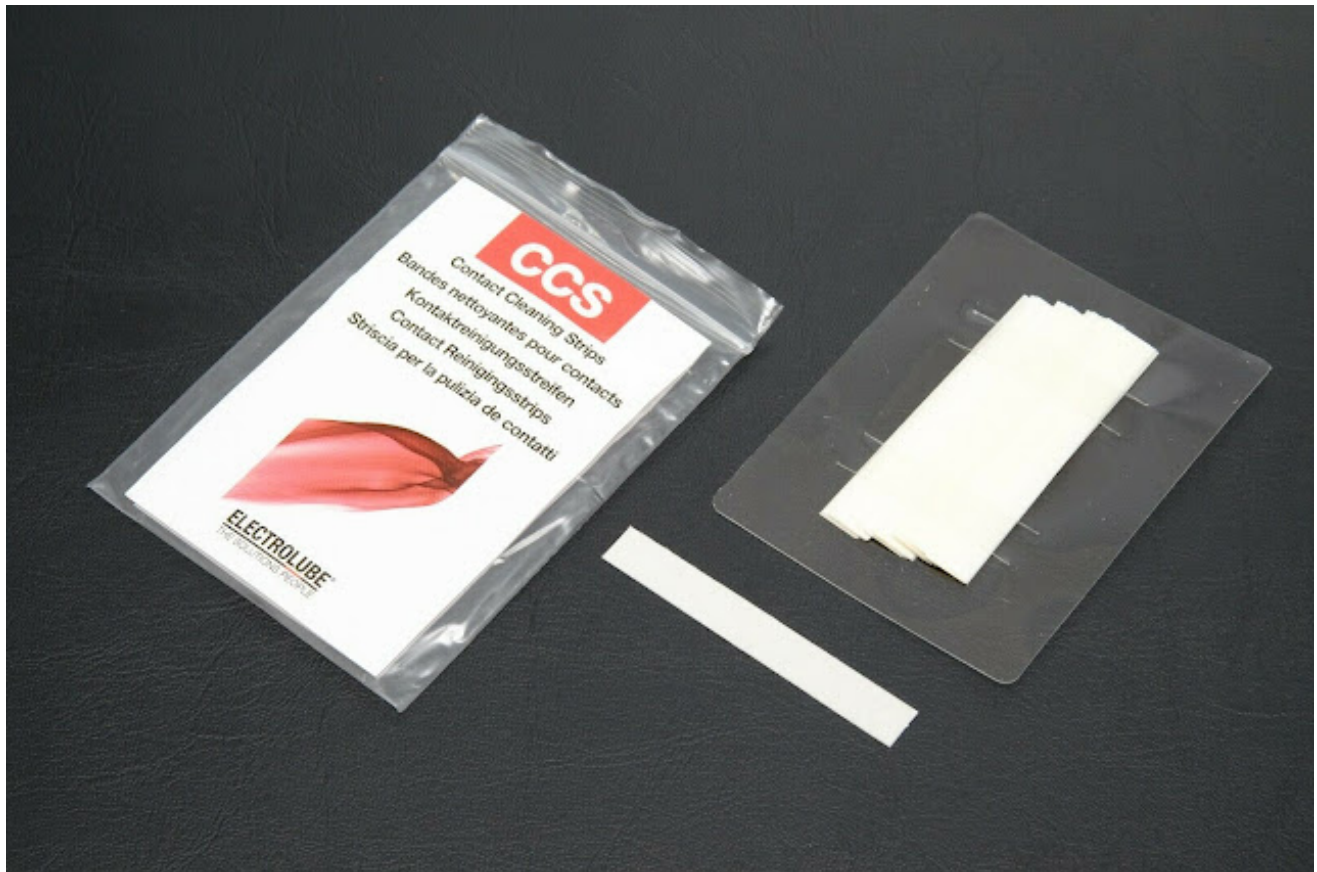
Contact Cleaner Strips.

The cleaner is sprayed into a slot and then contact cleaner strips are used vertically, working along the slot a little at a time. The strip has to be folded into four, so that it is thick enough to push on the contacts at each side of the S-100 connector. A short up-down motion, pushing slightly toward each side in turn, will do a good job.

It will cover 3 pairs of contacts at a time. After 24 pairs have been done,

turn the strip upside down to get to fresh cleaner surface. After 48, open the strip up and reverse it, to give access to another two areas that can cover another 48 pairs. Finish the last 4 pairs off and move to the next connector. You will now be able to find the other 50% of the cleaner strip to use on that connector.

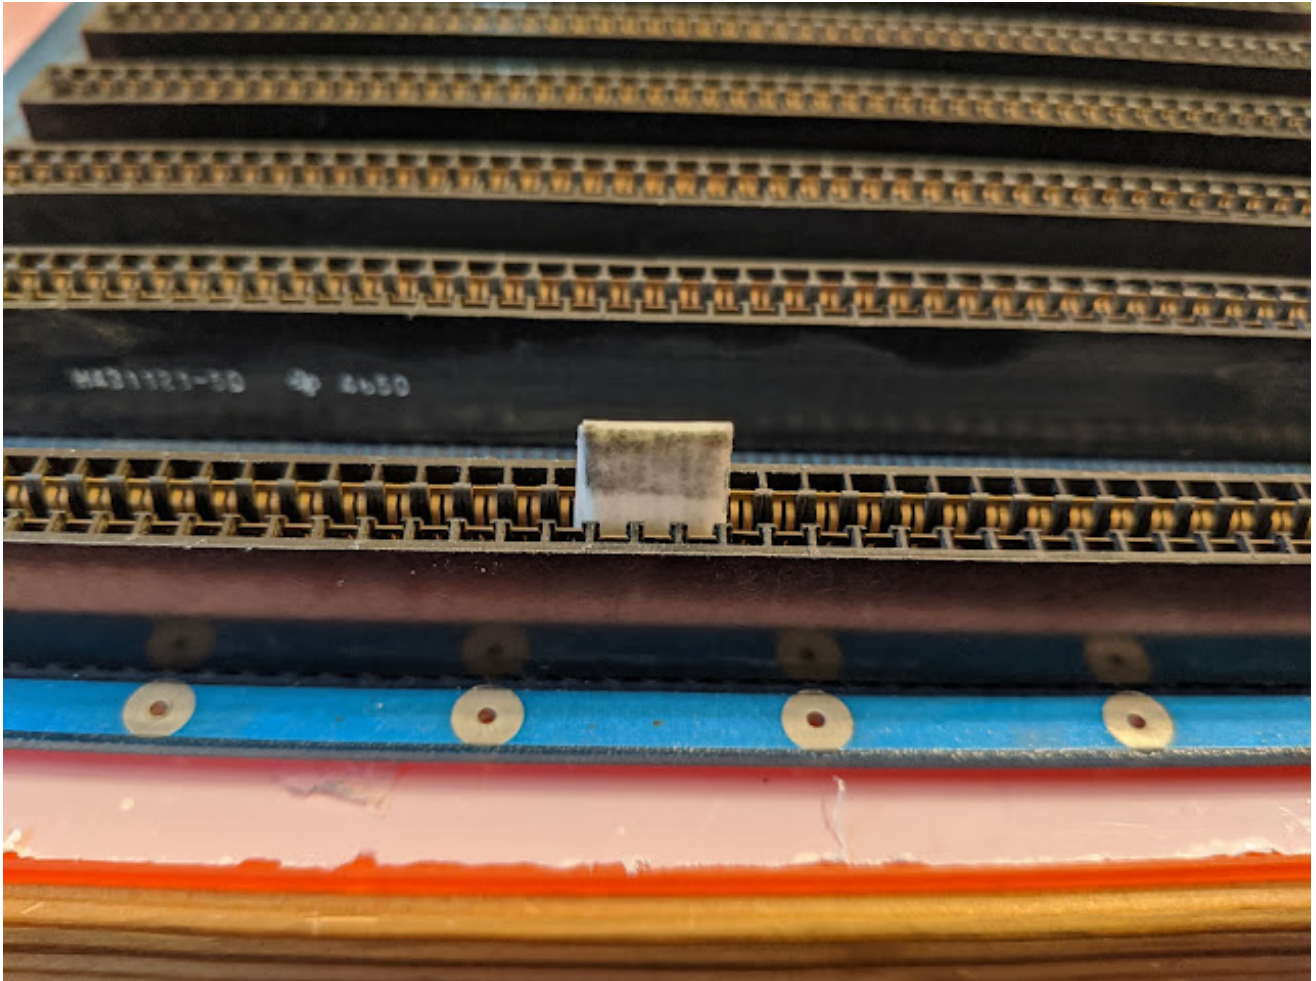
Carefully fold the strip over on itself twice, making it four layers thick. This is needed in order to push the contact apart and apply enough pressure to clean them effectively.

Cleaner Strip folded to 4 layers thick. It is now about 2cm long.

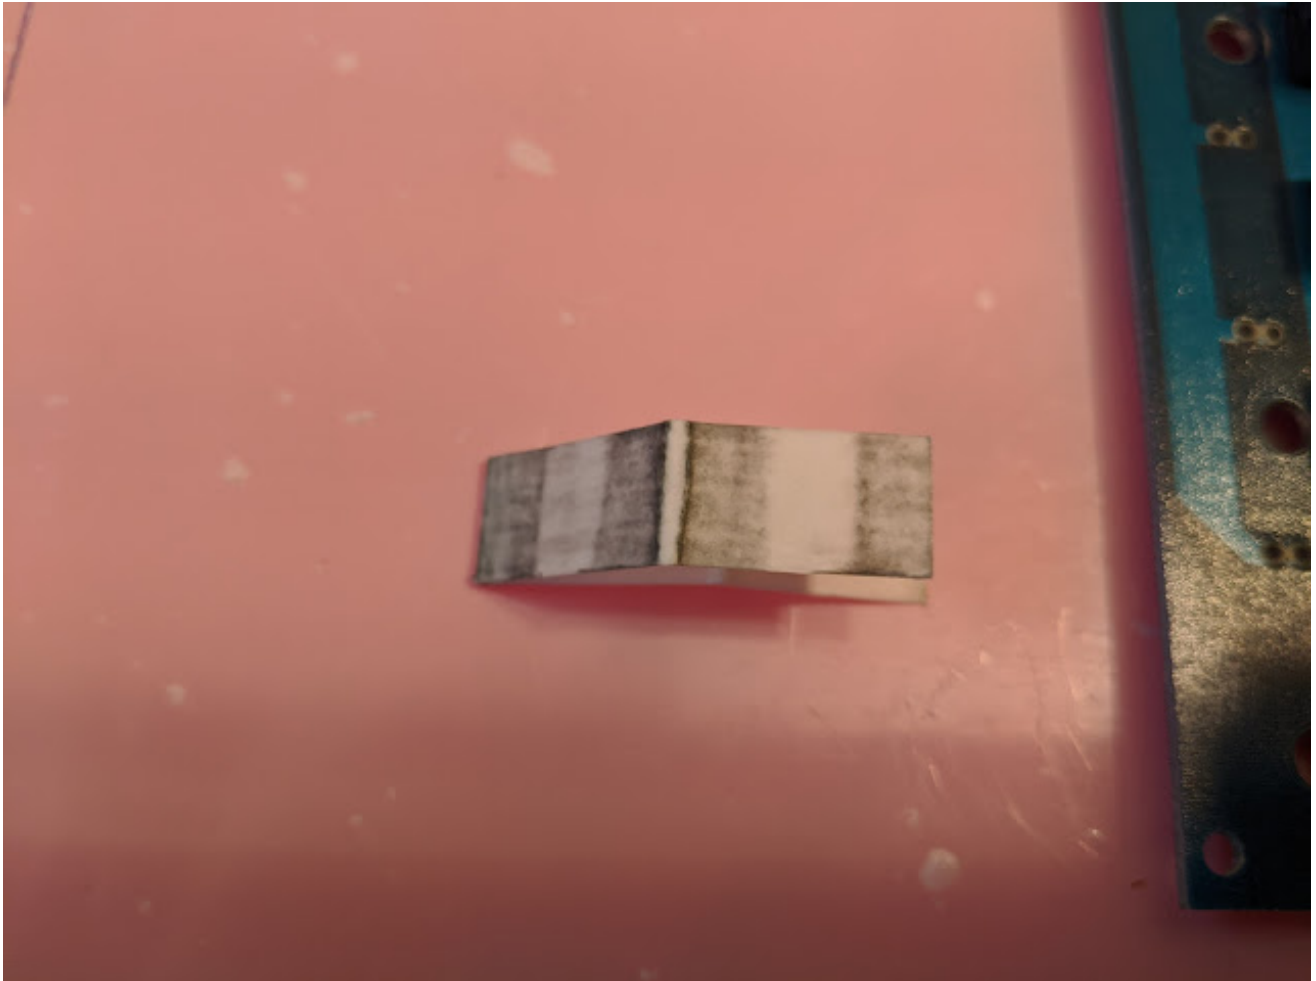
It is a fairly time-consuming job, but well worth doing, as can be seen by the amount of grime that is removed.

After 24 contact pairs have been cleaned.

Now turn the strip over, and do the next 24 pairs. After that, repeat to finish the connector.

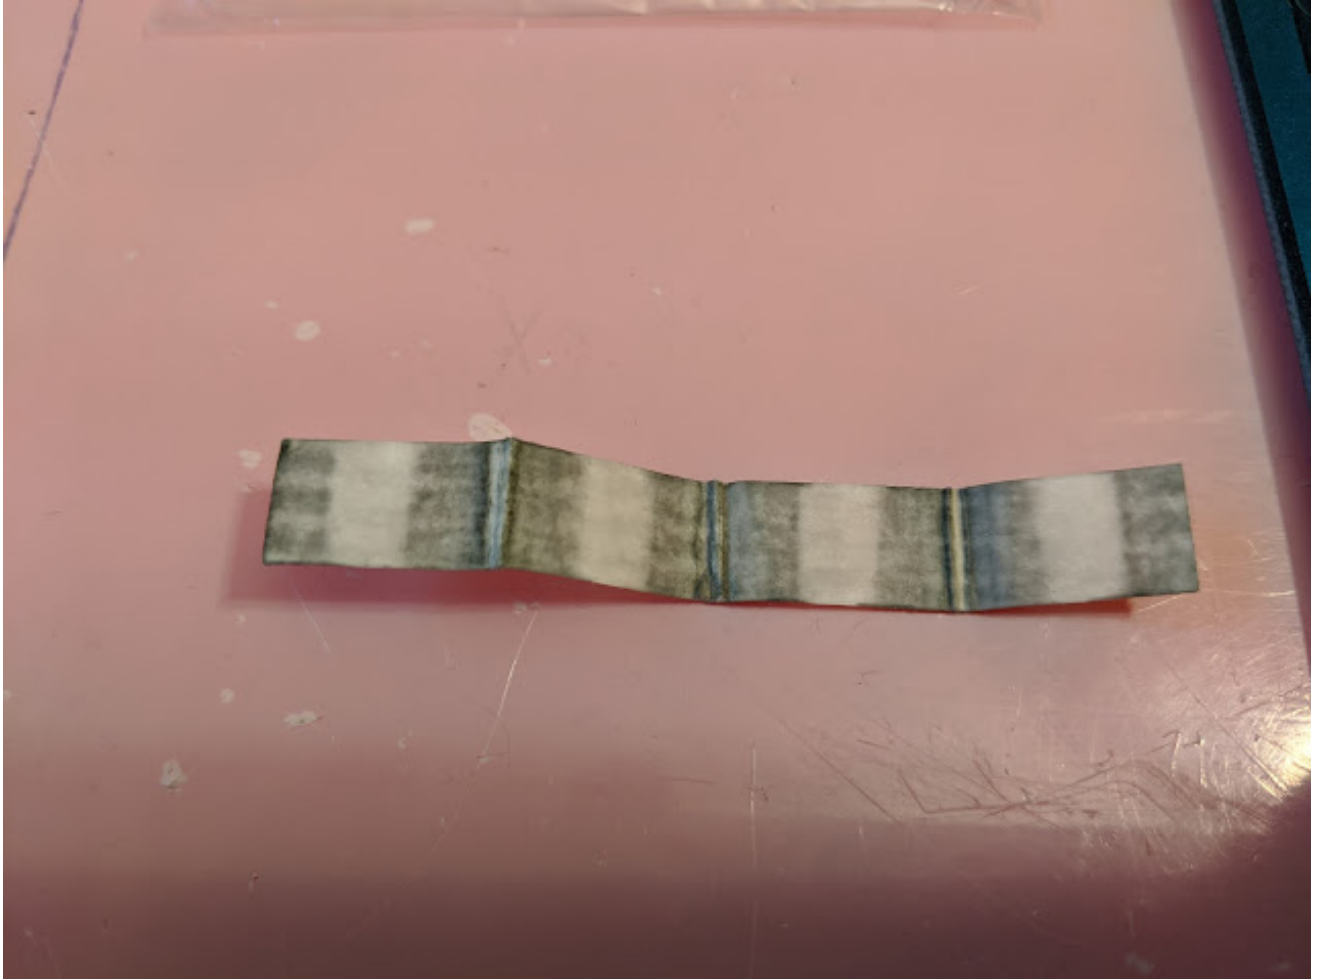
This is what it looks like after one S-100 connector has been done. The strip can now be turned over to do another connector. In this way, a pack of 20 strips can do a couple of 22-slot Backplanes.

One side used up on a single S-100 Connector.

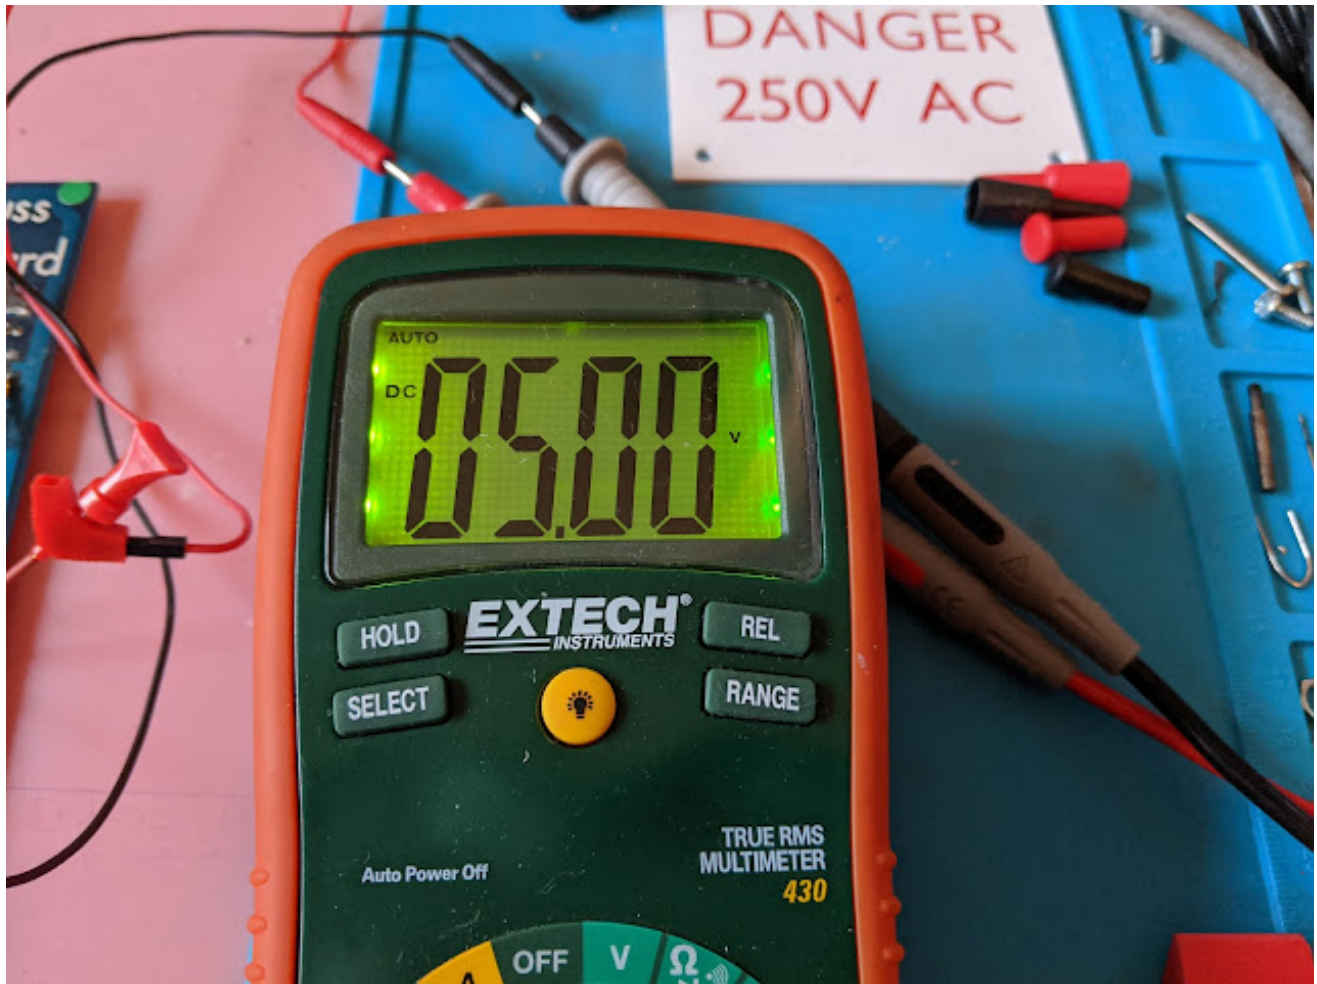
Output voltage is right on target.

Output from 7805 Regulator.

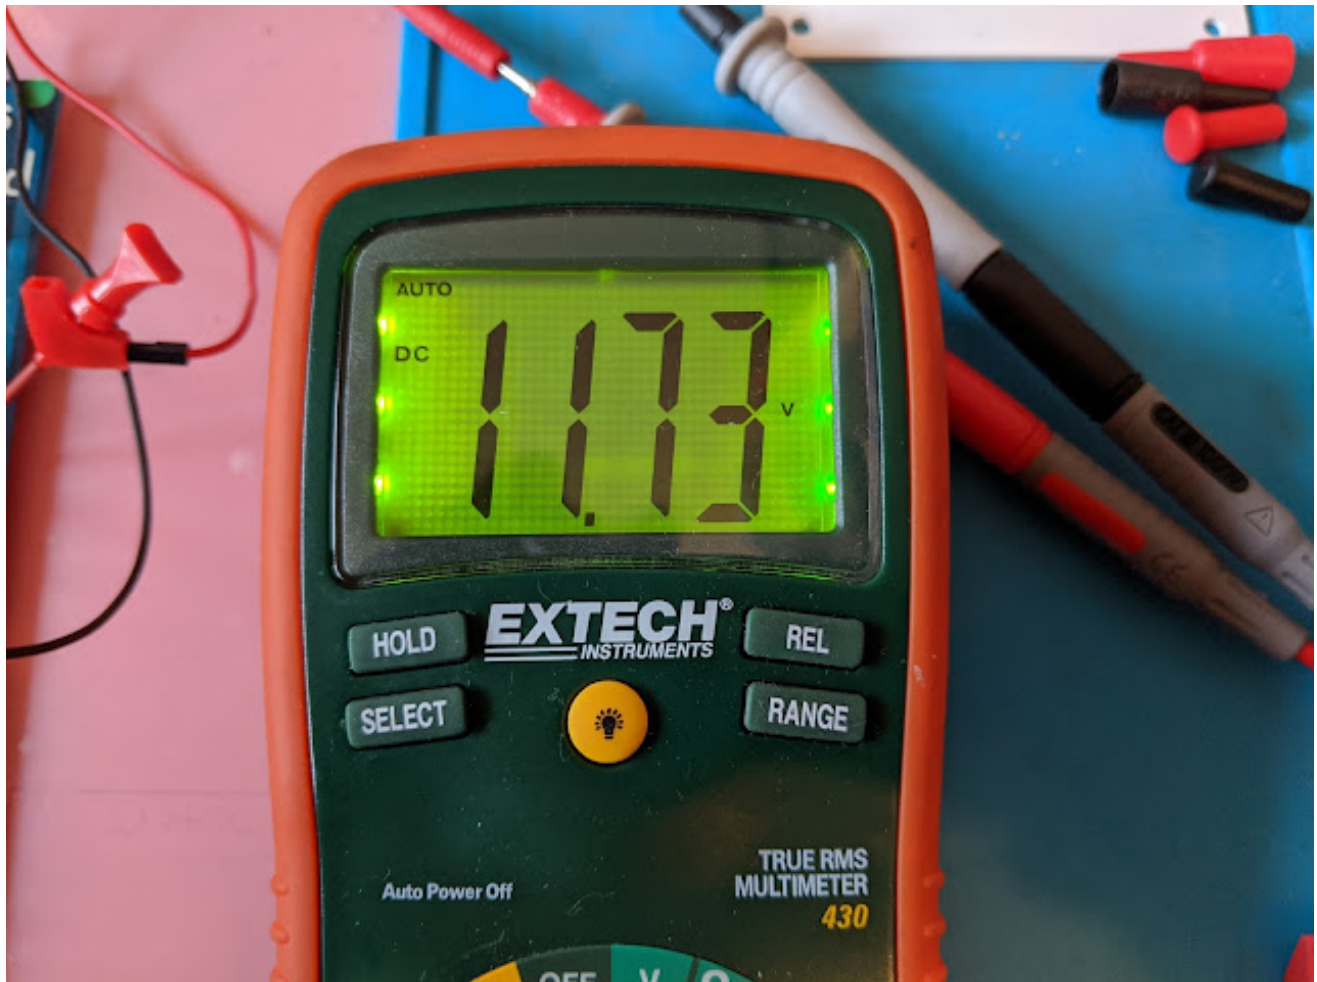
Output voltage is 2.25% below target.

Output from 7812 Regulator.
