# IMSAI 8080 Restoration for The Centre For Computing History at Cambridge, UK.

## **BLOG PART 1: What Have We Actually Got?.**

09/11/2019 - Ross Milbourne.

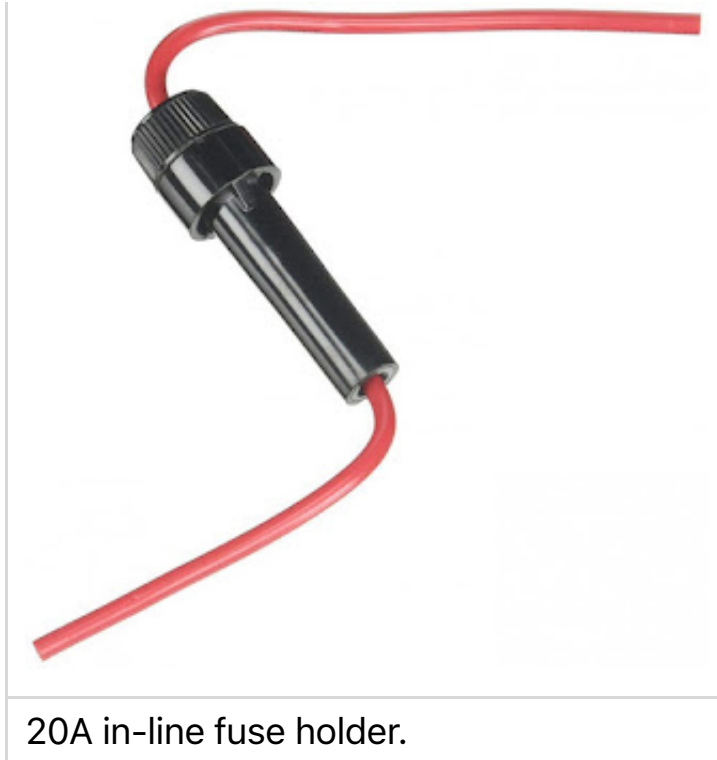
20A in-line fuse holder.

In addition, in-line Fuse Holders will be added to each of the DC lines, with fast-blow fuses fitted that closely match the measured current draw with the boards we will be running in the machine. This will serve to further protect matters in the event of faults developing.

It also means that we can control the maximum current that we ever want to allow on each of the lines. In our case, that would be 20 amps on the +8vdc line and 3 amps on each of the +/- 16vdc lines. In reality, however, it is likely to be fused at 3 amps and 0.5 amps respectively, with the minimal number of boards we plan to run.

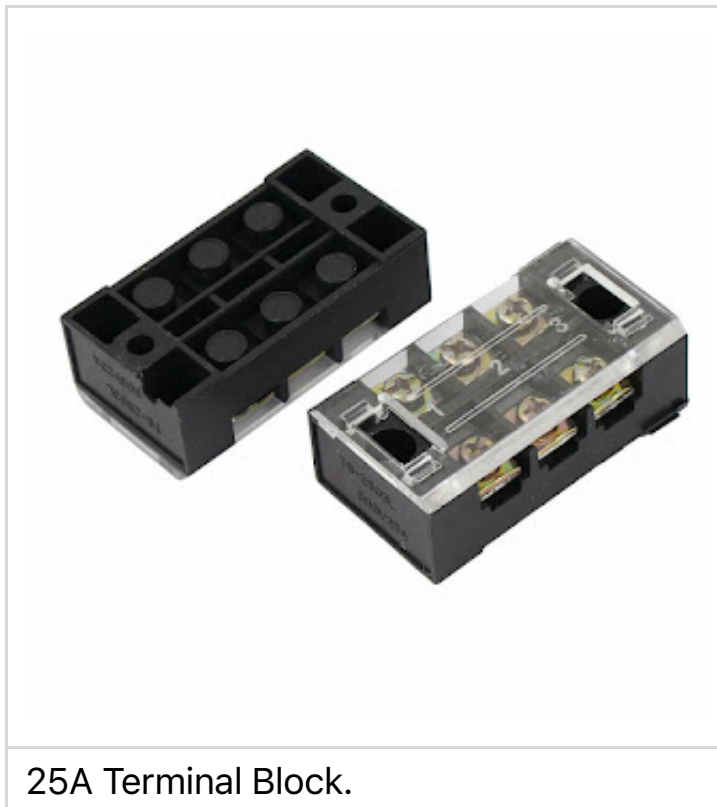
Connections will be to a 25A Terminal Block, using crimped and soldered ring connectors, to allow for easy future disconnection of the backplane from the PSU.

25A Terminal Block.

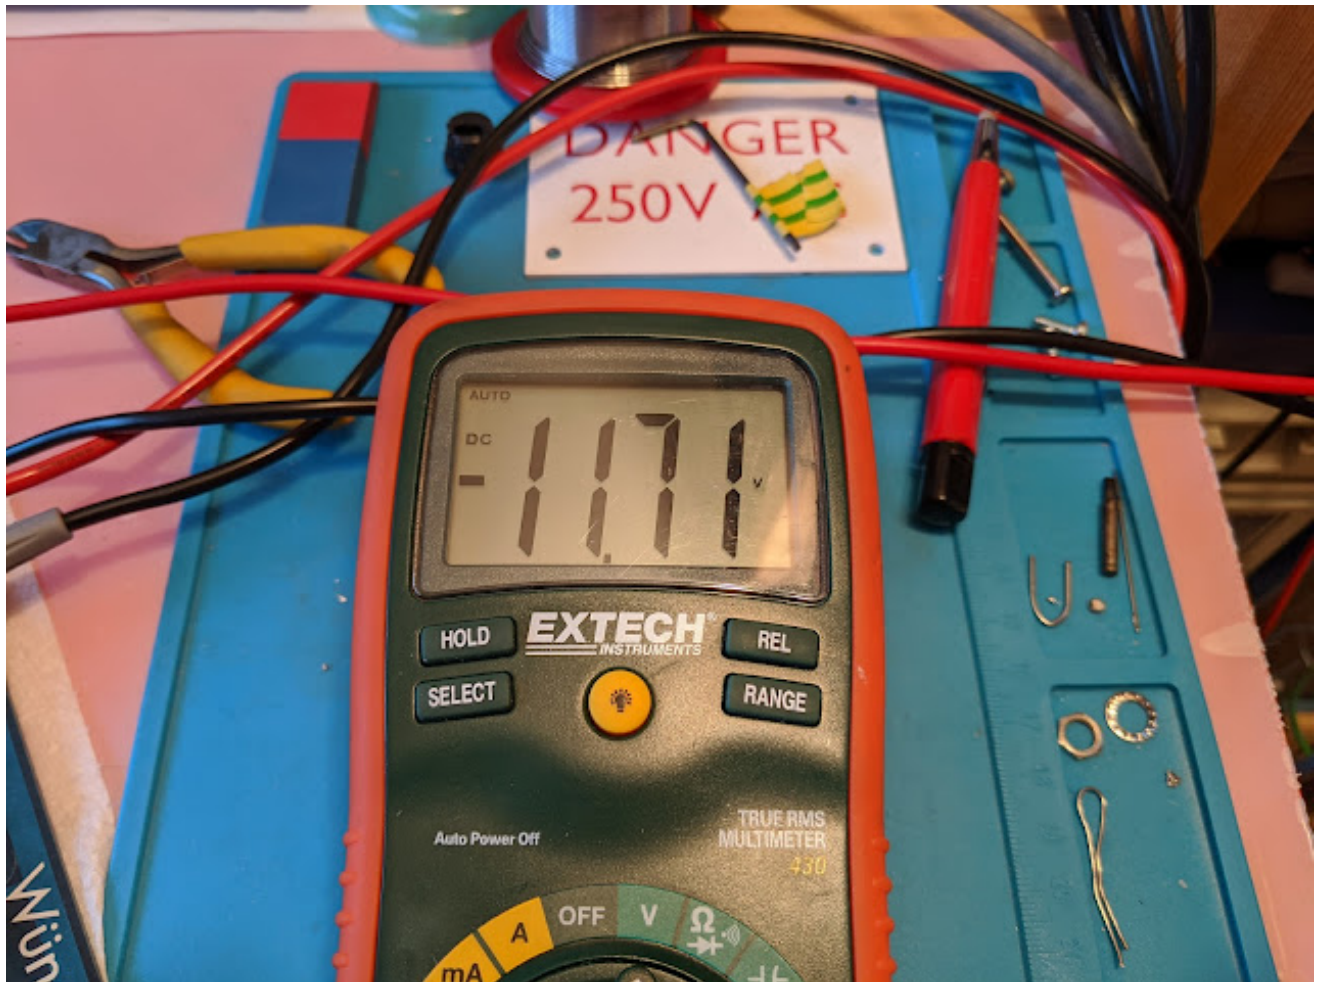
Ground is the left leg on a 7912 and output is on the right.

The output voltage is 2.4% low, but acceptable.

Output voltage from the 7912, -12vdc regulator.

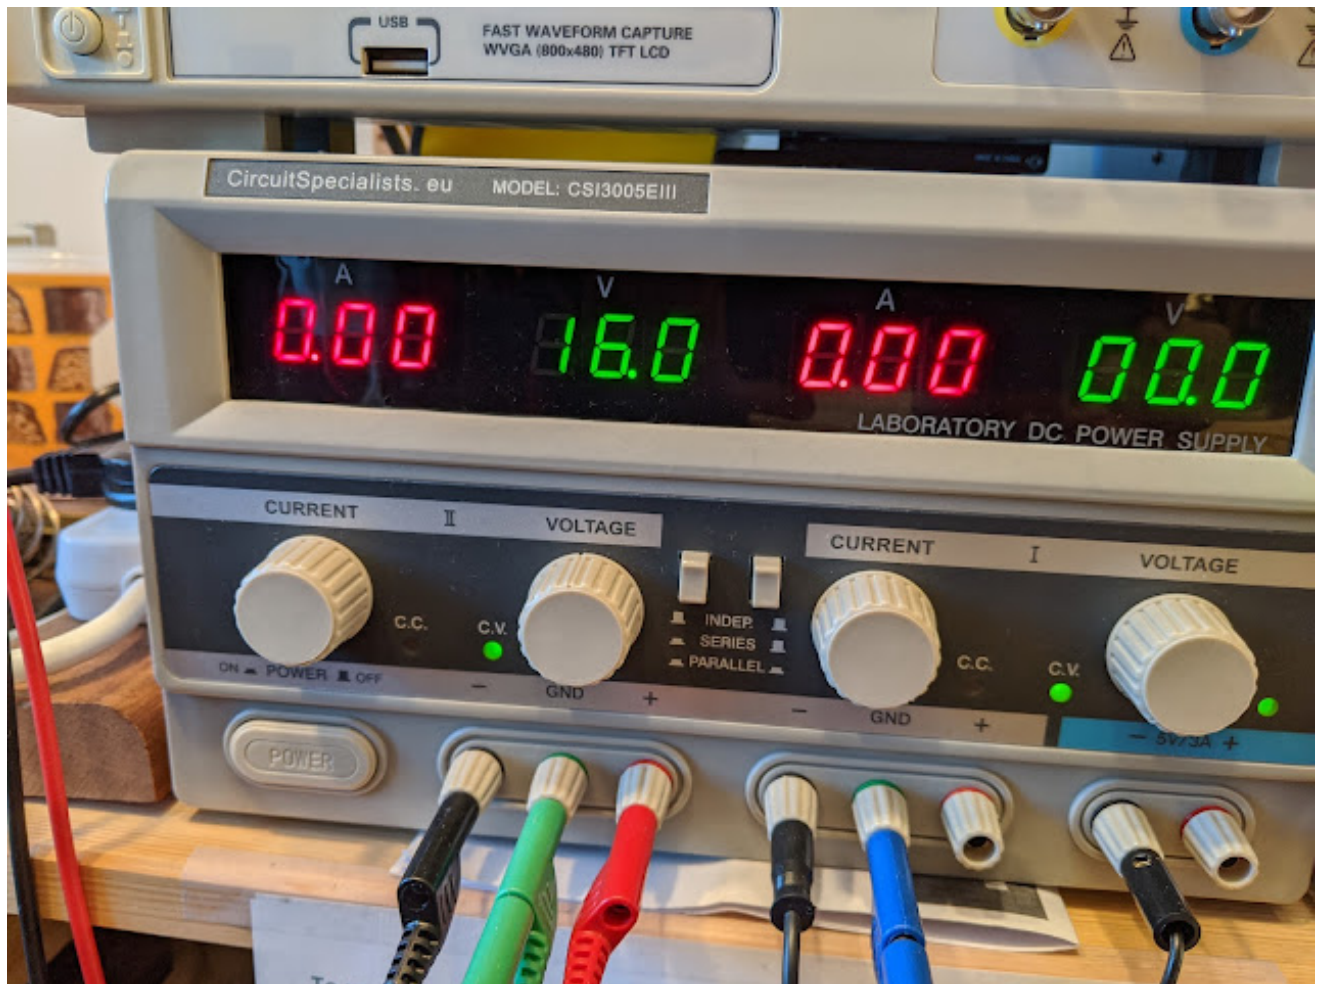
The Bench Supply provides -16vdc just by reversing the polarity at the Wunderbuss.

Input voltage set at -16vdc.

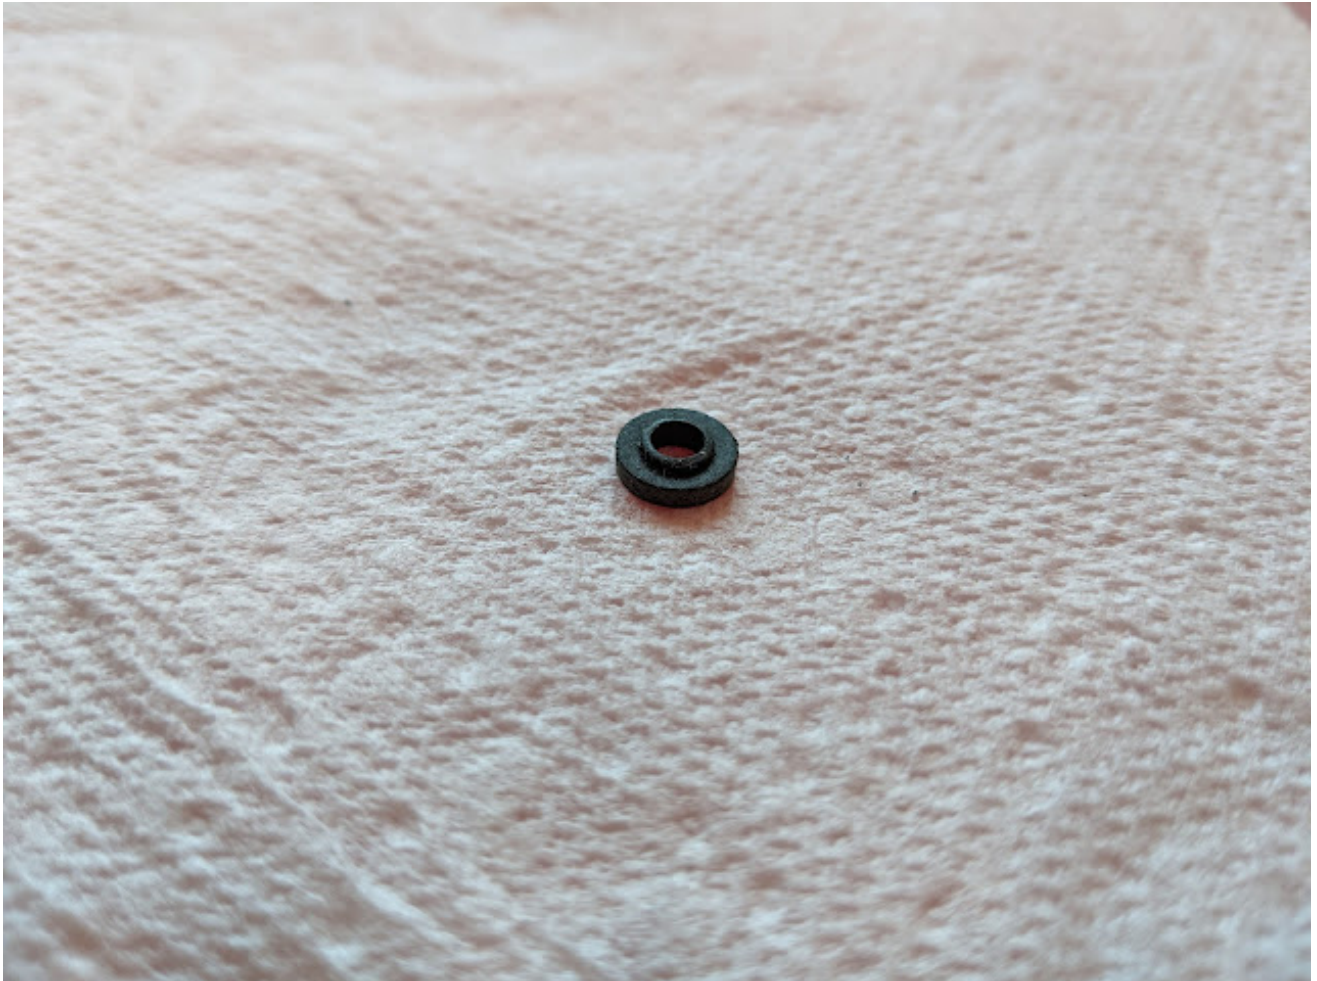
It is important to note that the washer underneath the Backplane, and above it, both need to have the ridge pointing into the hole. Many that we took off were installed incorrectly.

Ridge on washers.

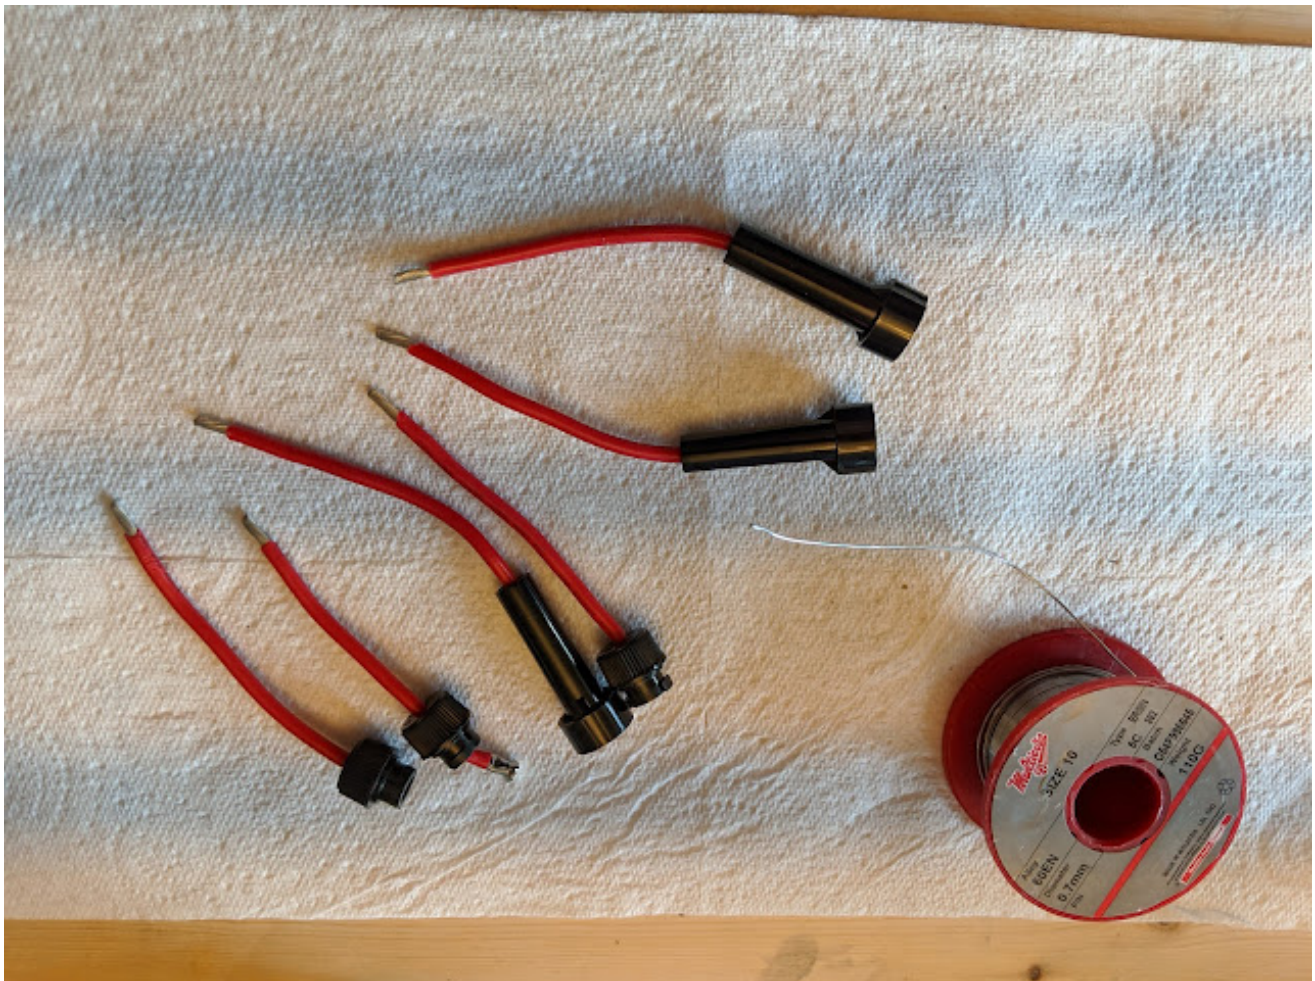
Cable ends ready to be tinned.

To make this up, the cable ends are tinned with a 40 watt Soldering Iron, then crimped, before finally being soldered to the connectors. We are unlikely to be able to achieve a connection capable of supporting 20 Amps with a normal crimper, so soldering is essential.

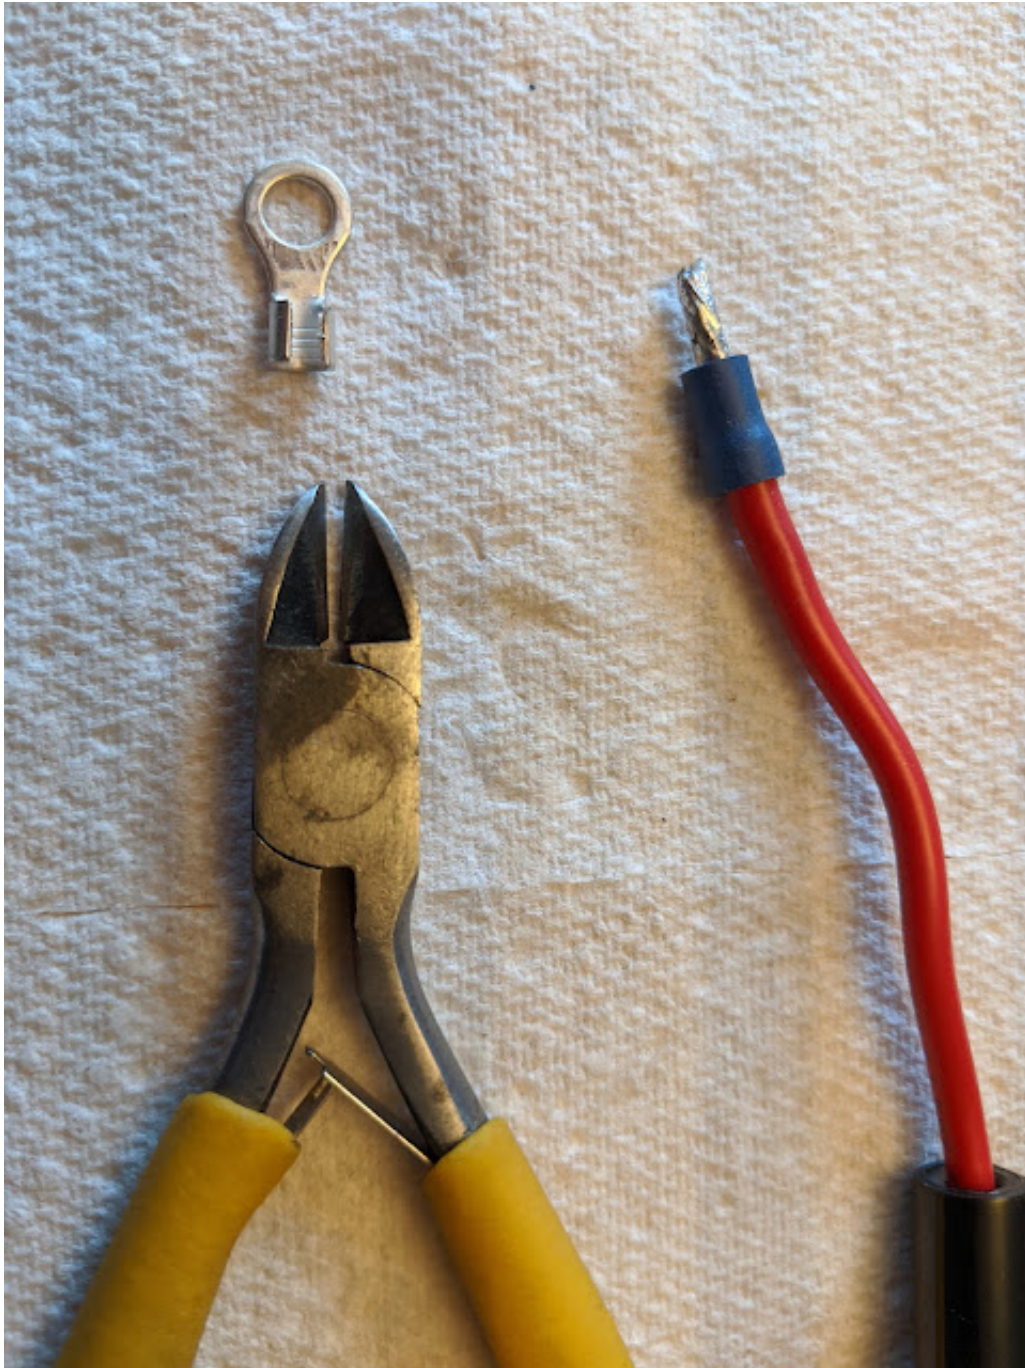
The crimp connector is easily opened up with a pair of wire cutters.

Crimp connector opened up.

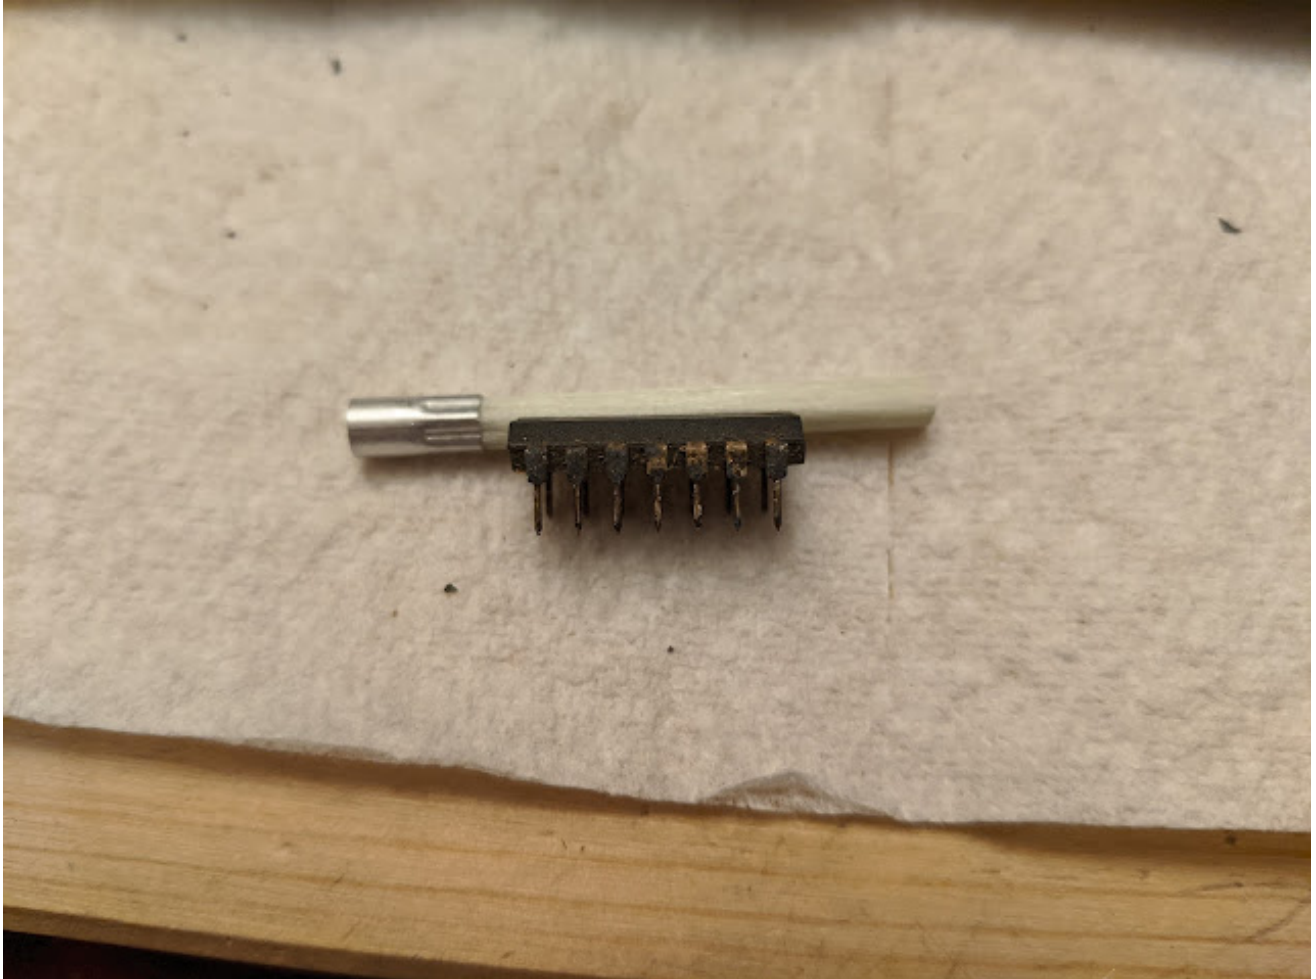
Some of the ICs are badly clogged with the 'gunk' of ages.....

Fibre pen used for cleaning legs of ICs.

After using a fibre pen to carefully clean the pins, we need to test the functionality of each.

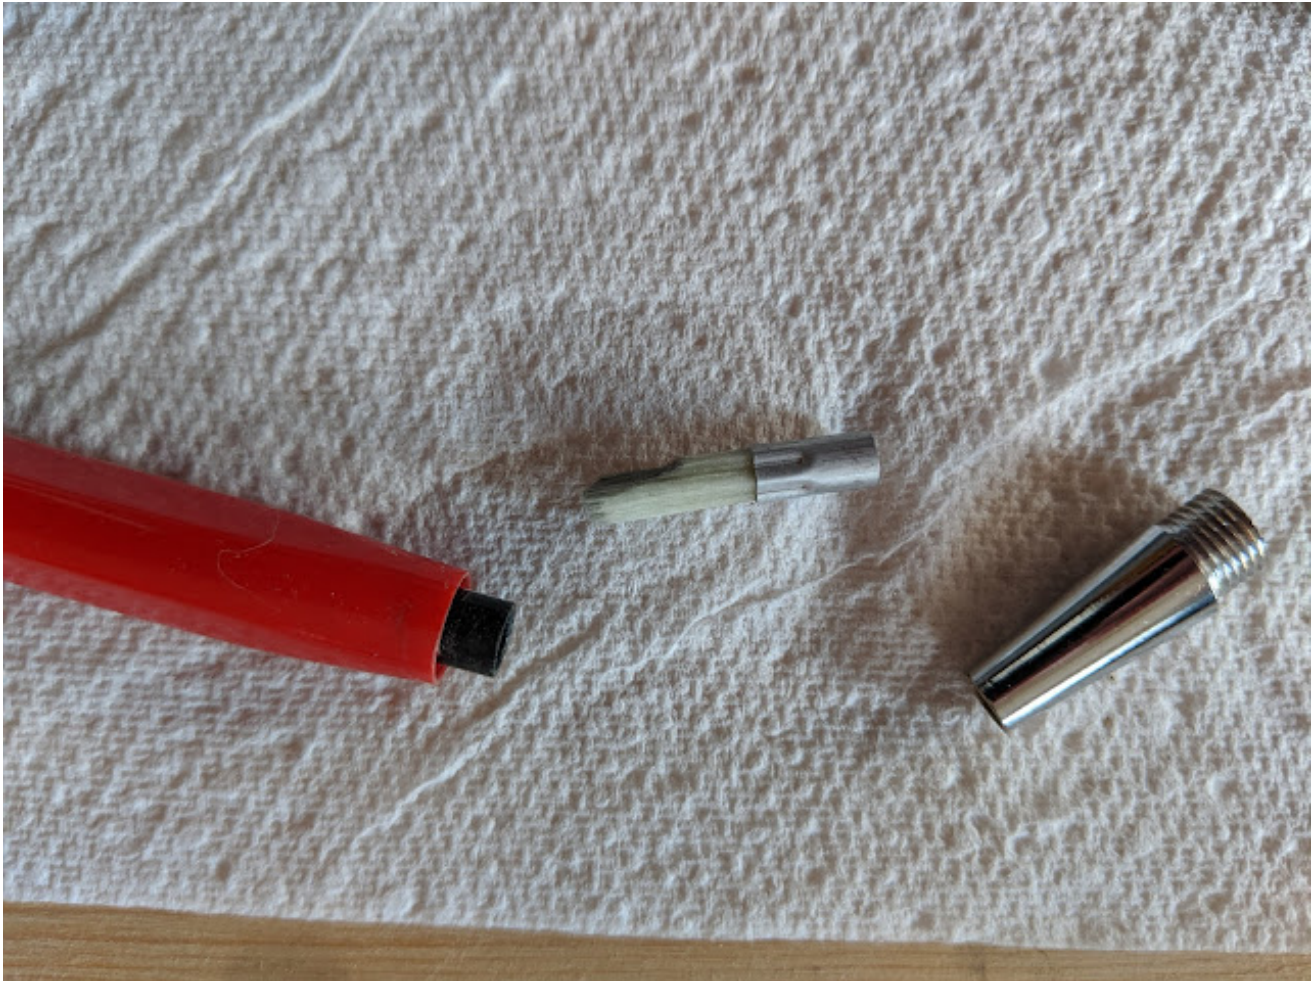
The best approach is to extended the Fibre Pen tip and rub it sideways along the contacts, slowly.

Effect of rubbing tip sideways along contacts.

Now to find out what difference it had made. The unit was put back in the Test Rig and the results looked much better! All functions were now operational and all LEDs were working.

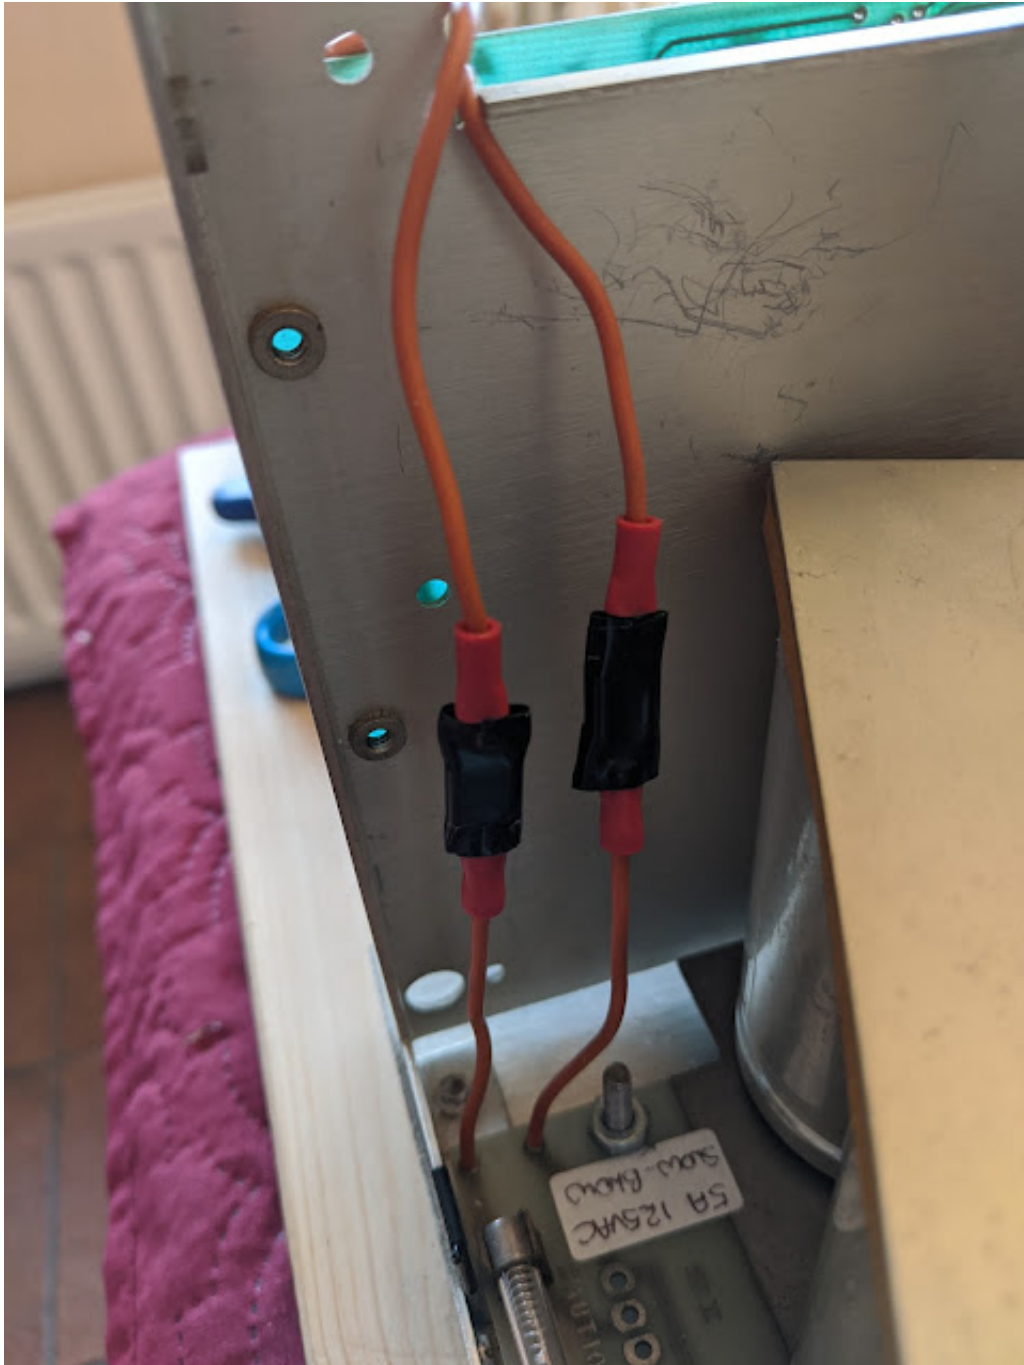
The cables are cut, tinned, crimped and then soldered to the crimp connectors. This will allow for quick and easy removal of the Front Panel in the future, where required.

Mains supply to ON/OFF switch cut and crimped.

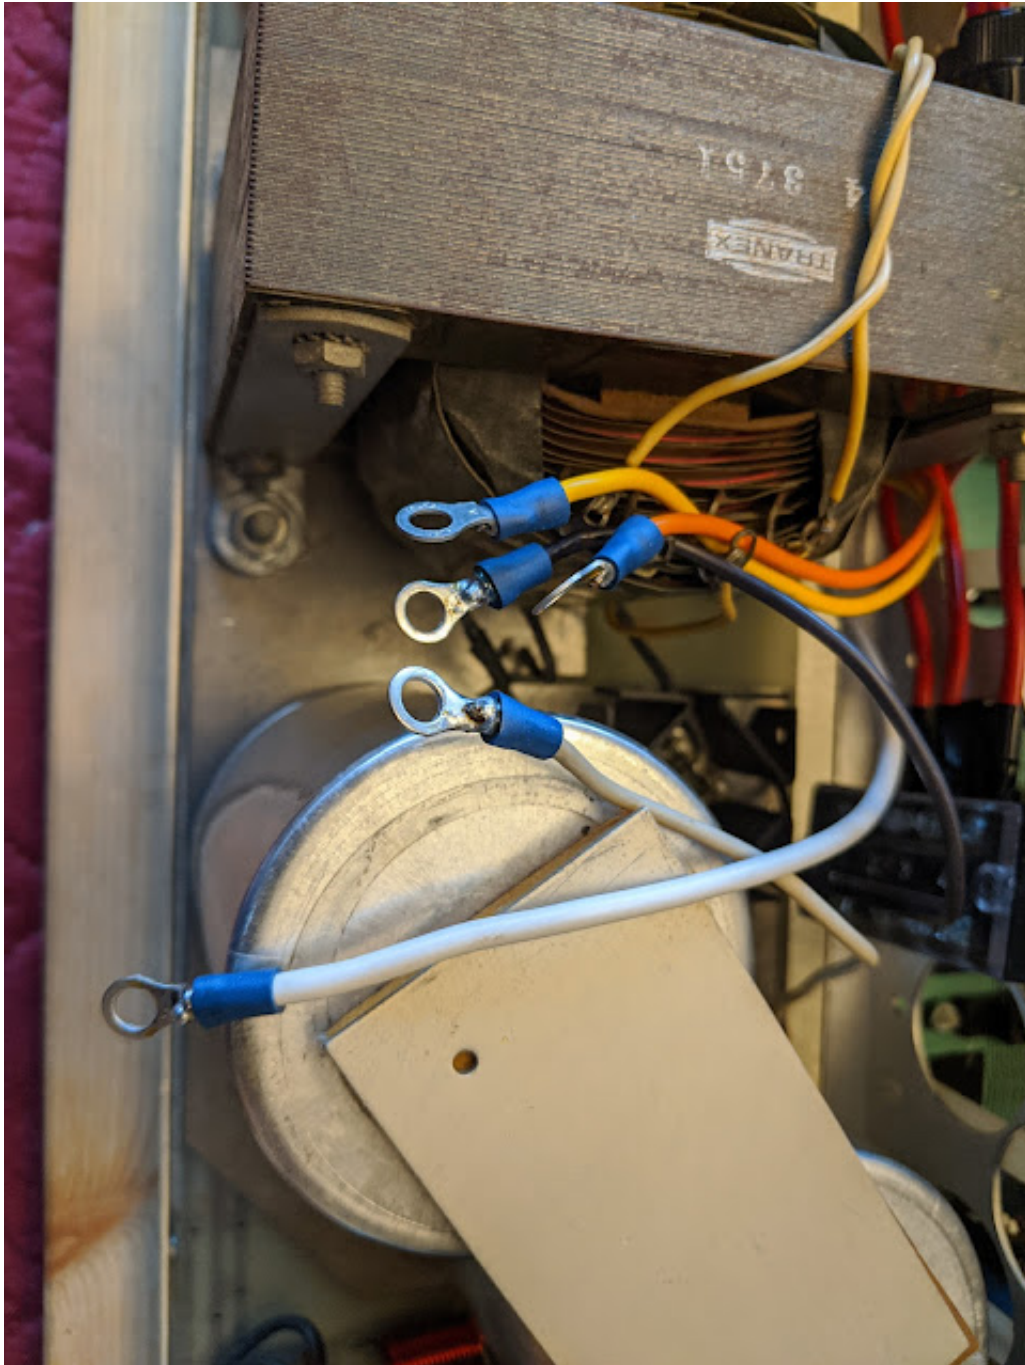
The next item is the DC supply cables from the PSU to the Backplane, carrying +8vdc, +16vdc, -16vdc and the Ground. The cable ends are tinned, before round connectors are crimped then soldered to each.

DC cables crimped and soldered.

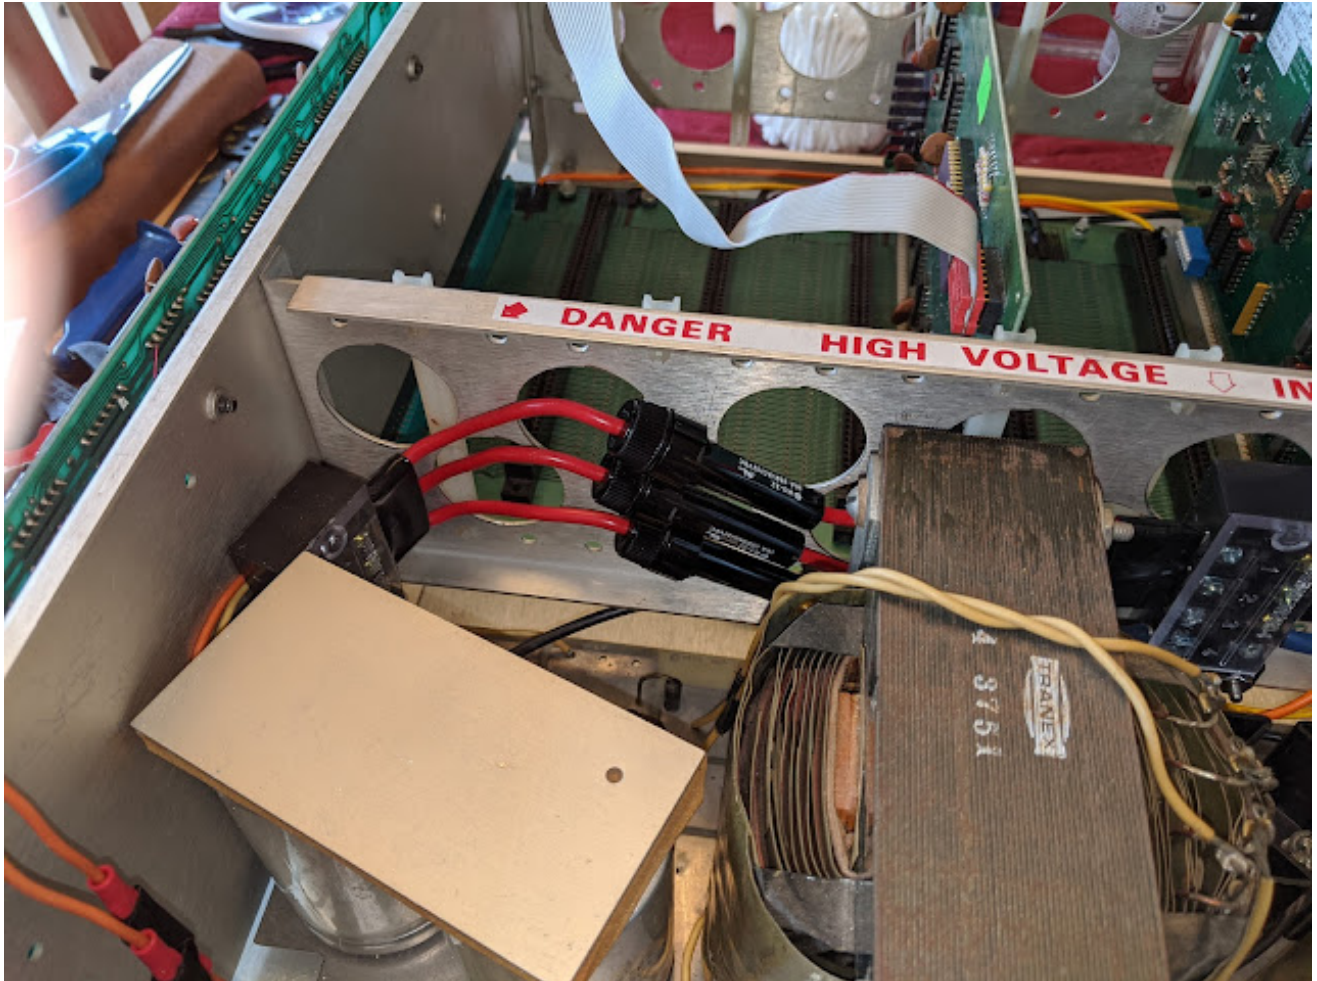
The other end is tucked away behind the +16vdc/-16vdc, 10,000uf, 25vdc capacitors. This allows us to easily access the fuses, while keeping the harness reasonably inconspicuous.

The other end is tucked away.

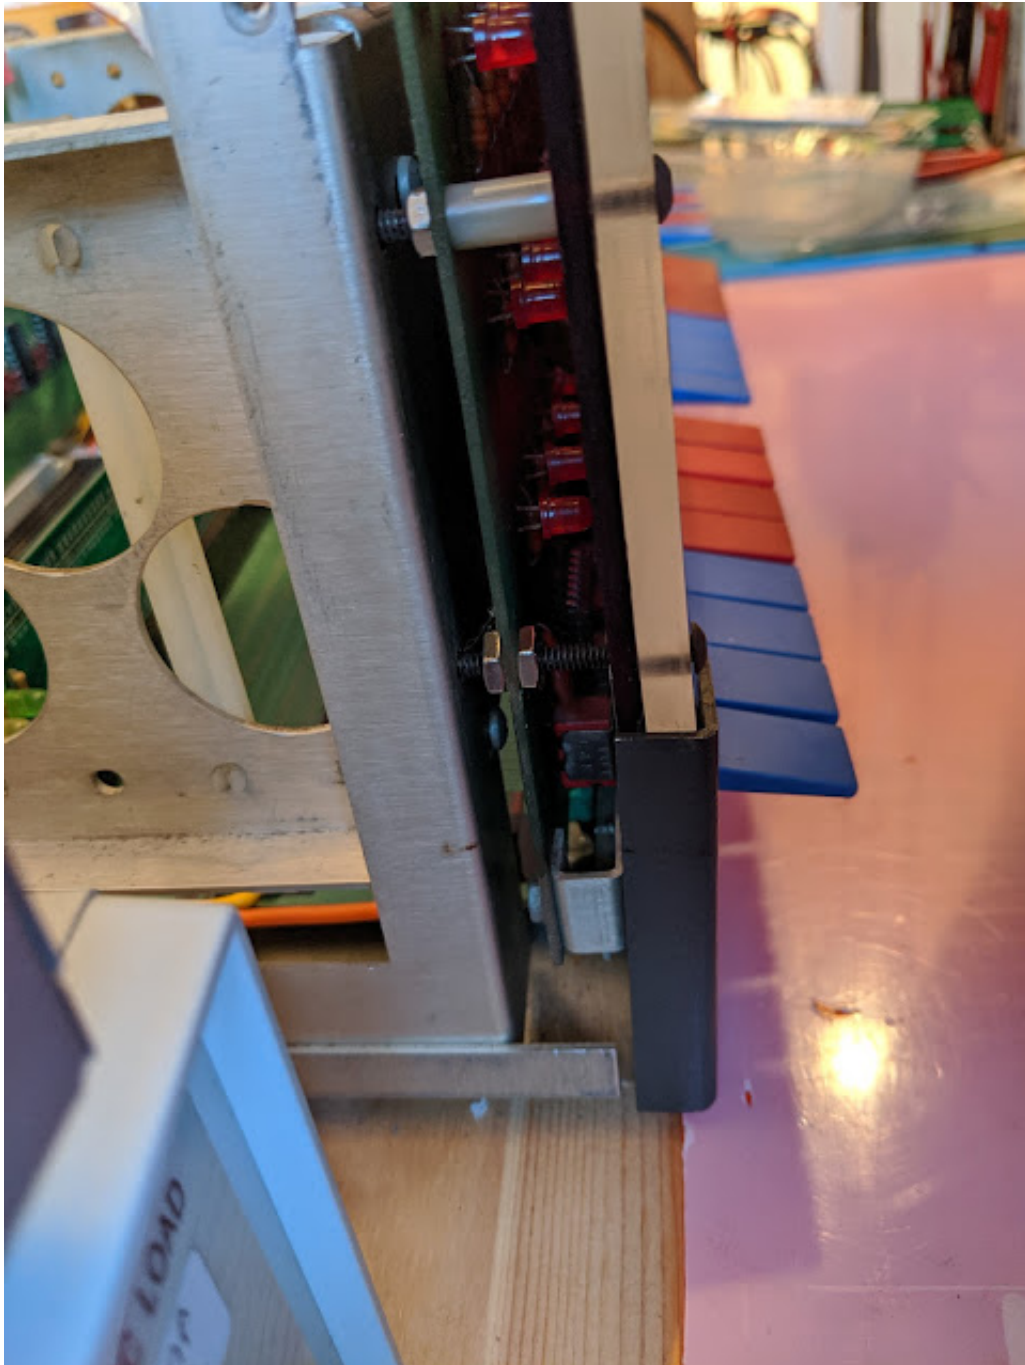
In our case, on the other mounting points, we are using nuts on the innermost part, instead of the small plastic spacers. This is because those supplied with this machine are too small, and a non-standard size, for some reason.

Two nuts on a grounding point for Front Panel.

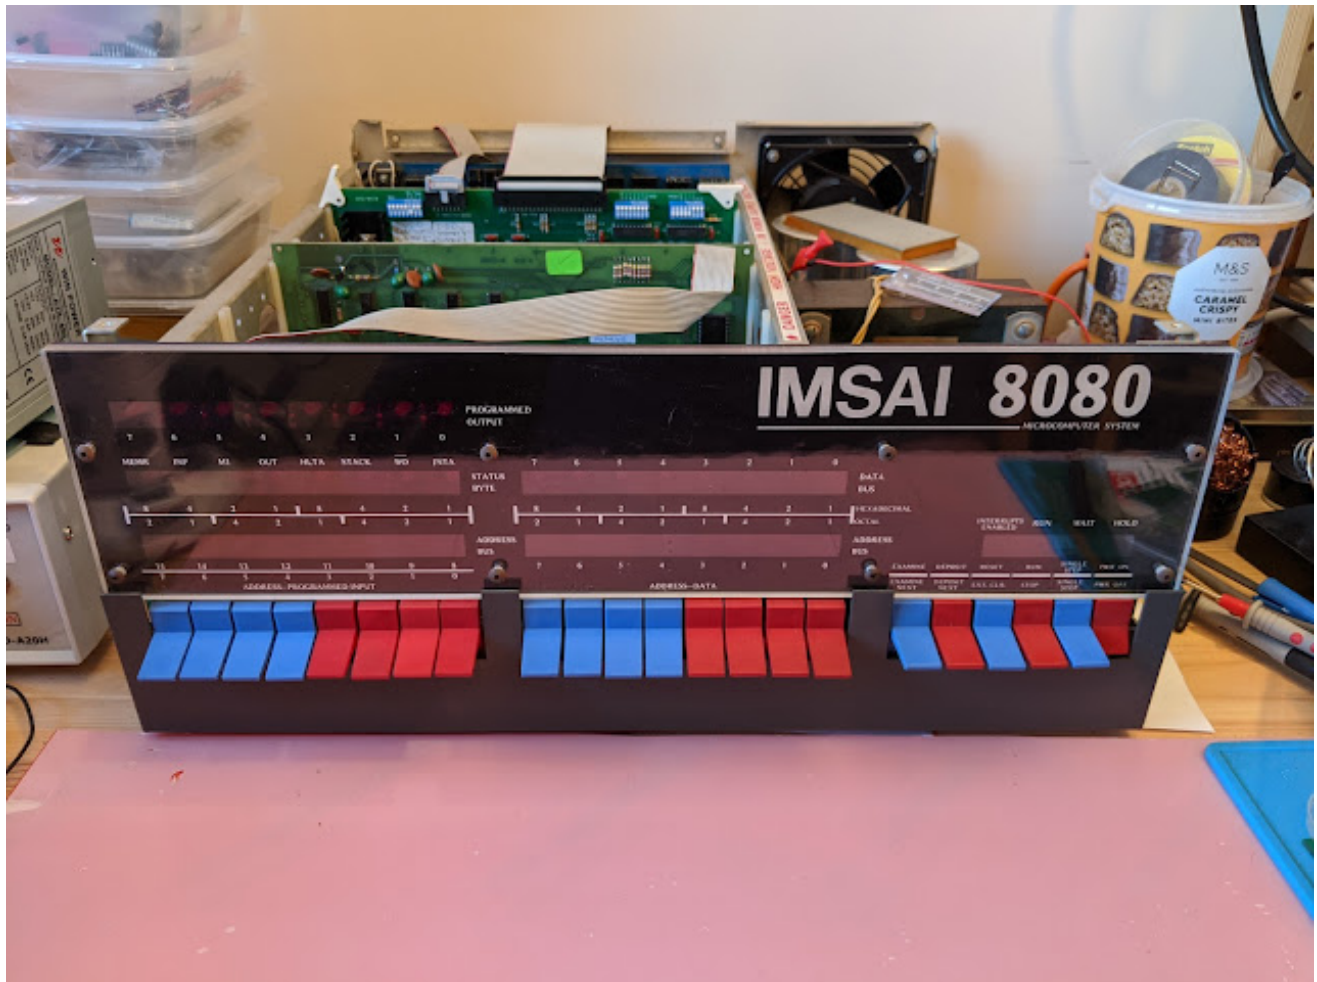
The Fascia is now cleaned and installed once more.

Cleaned Fascia re-installed.

Foam Cleaner and some furniture polish are carefully applied. The black plastic sheet with the white legends is cleaned using warm water with little washing up liquid/mild detergent. The plastic degrades over time and great care should be taken not to rub it, should it become sticky, otherwise it will lose its shine.

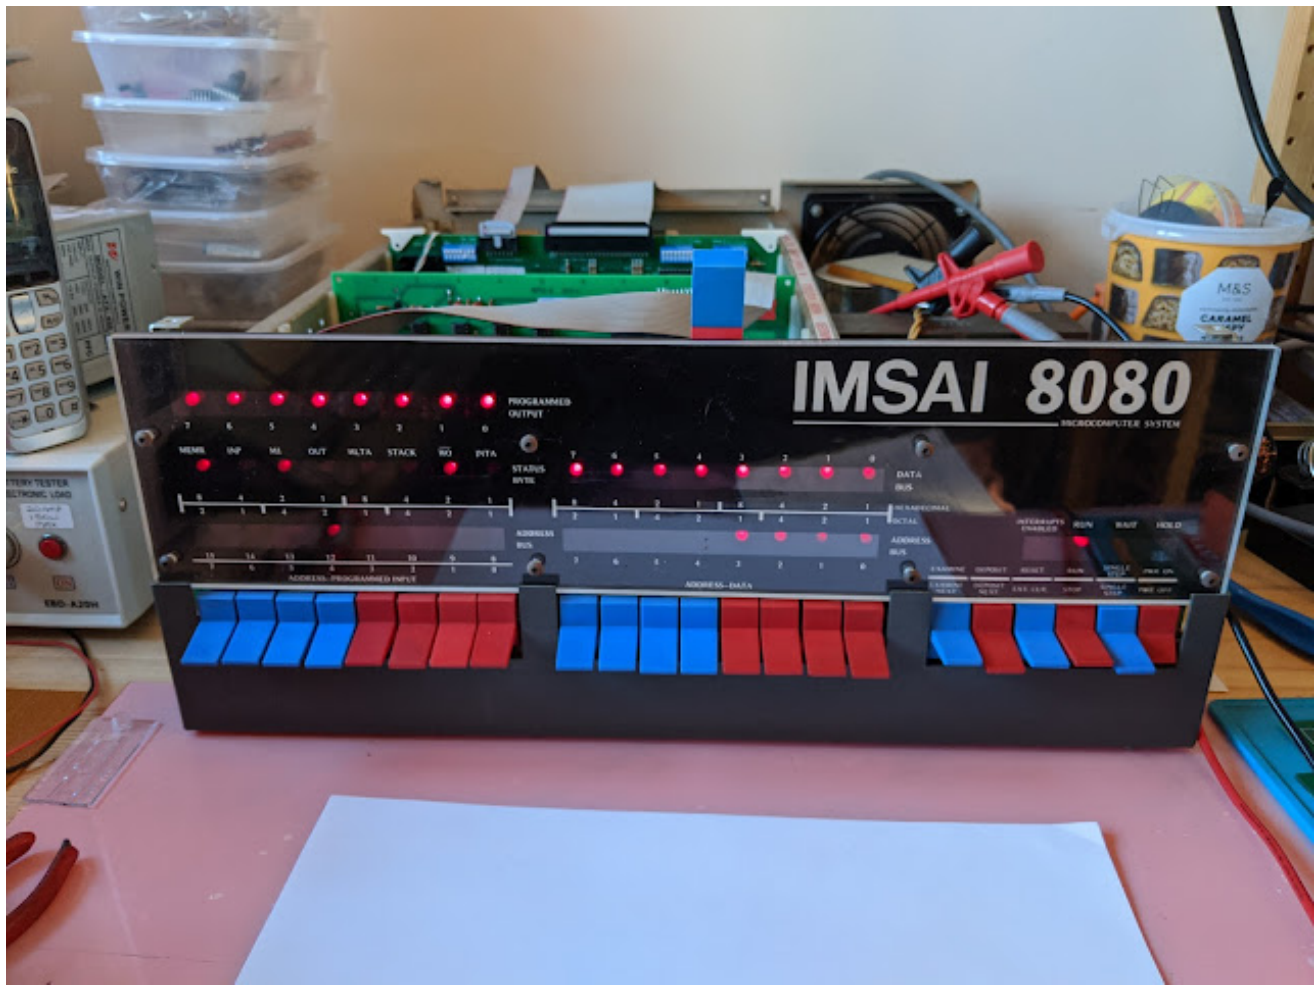
We now enter and run 'Kill the Bit', which runs fine.

Running 'Kill the Bit'.

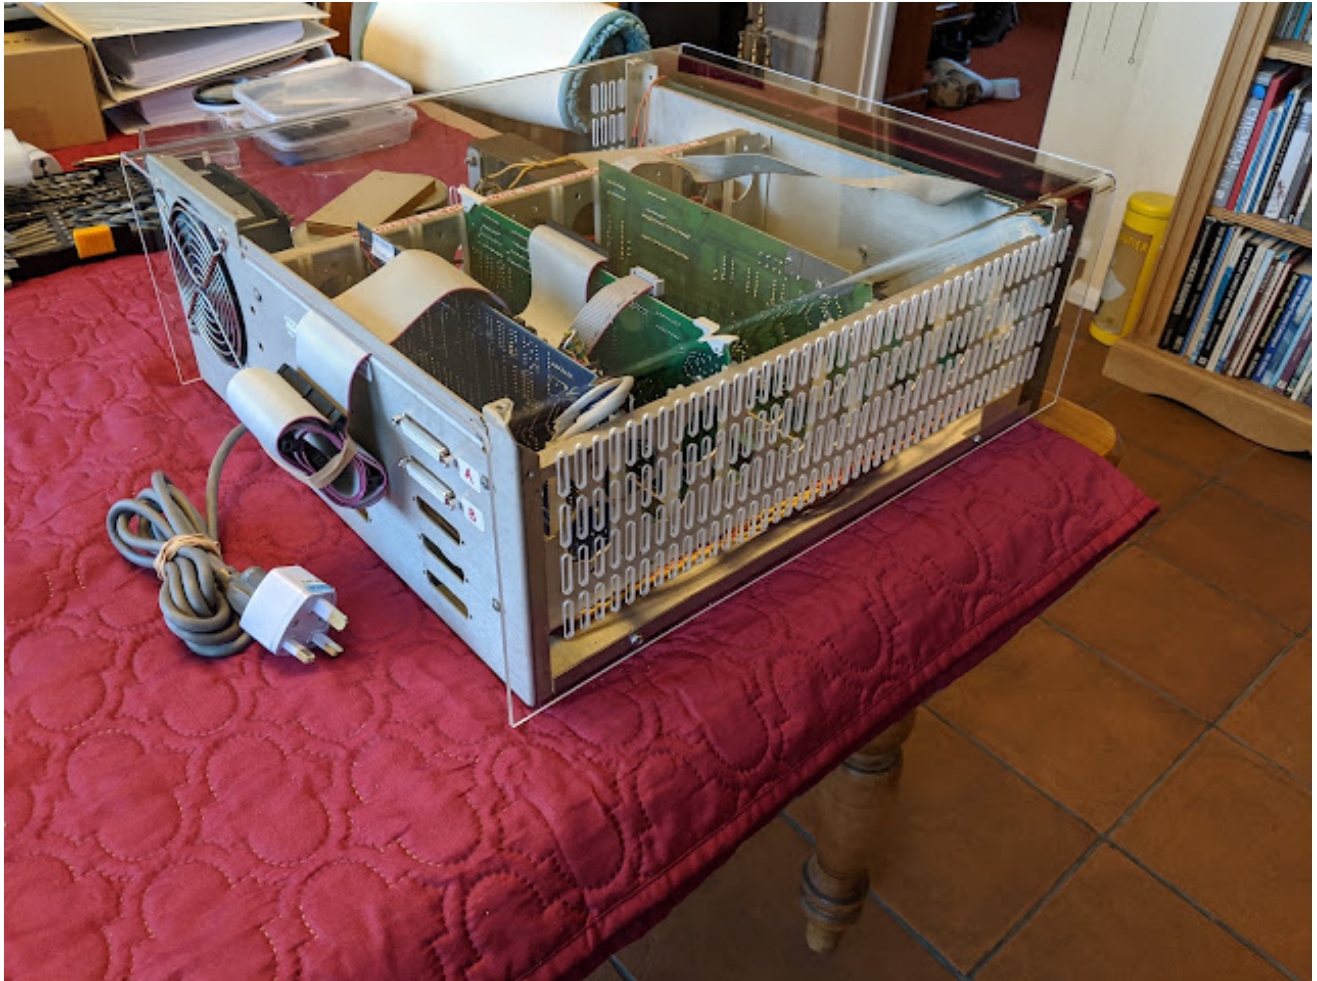
An acrylic lid was manufactured to the same specification as the original aluminium one. This allows the contents to be viewed when running, safely, yet retains the same airflow for cooling purposes.

Acrylic lid - rear view.
